Health & Safety Executive

A report by HM Factory Inspectorate

# The explosion and fire at Chemstar Limited 6 September 1981

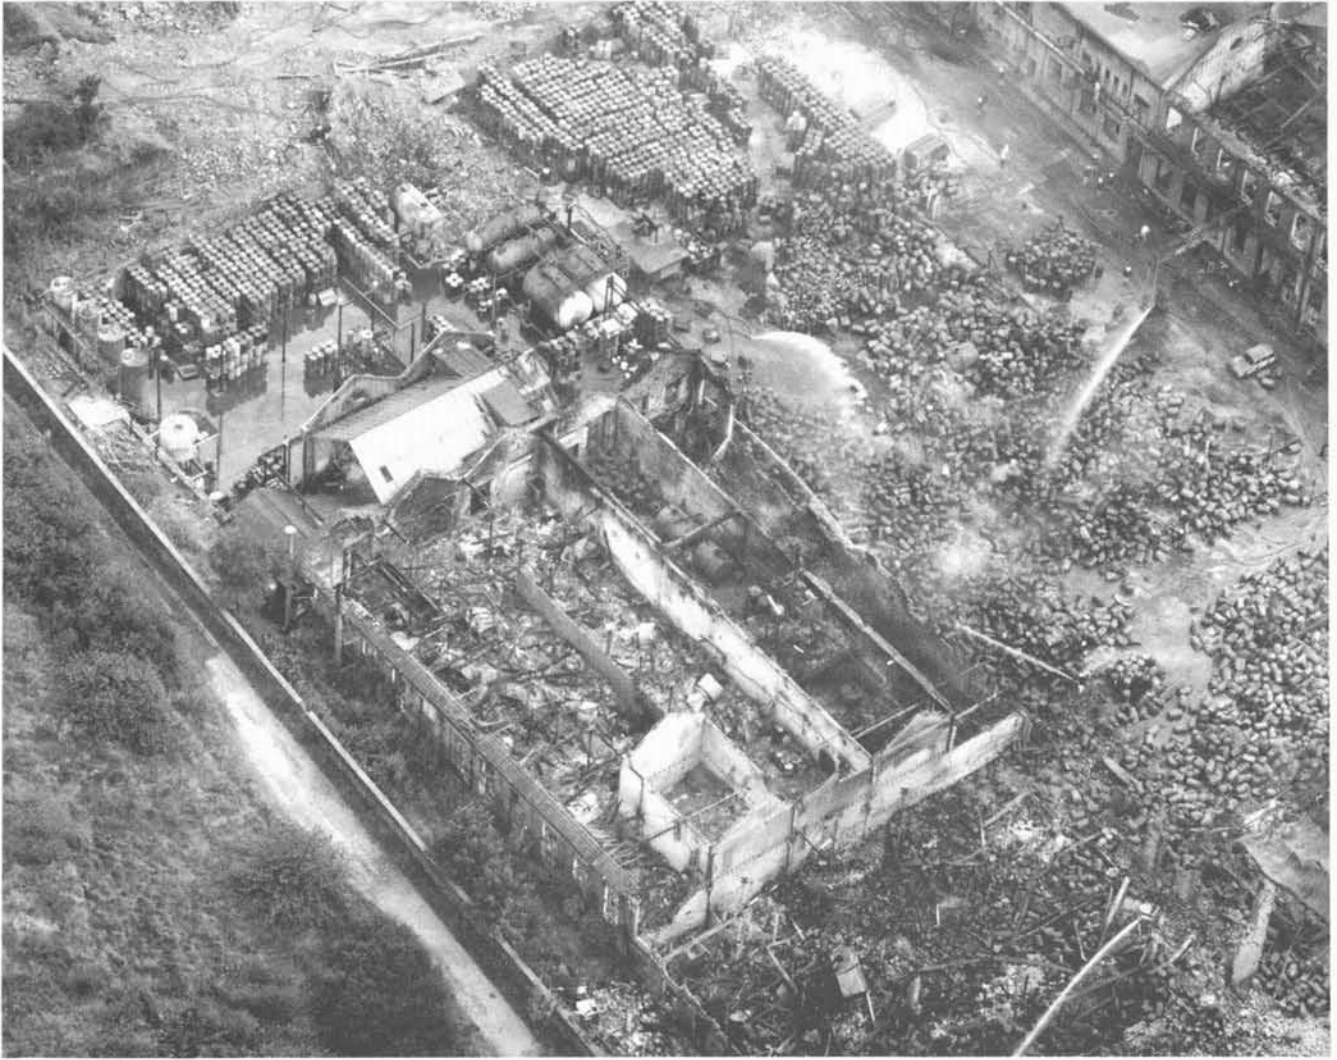
Aerial view of site after explosion

48 The damage within the Chemstar site was extensive and only the eastern yard and associated plant and storages were not affected. The maximum structural damage occurred within the flameproof room and despatch area. There was significant charring with examples of plastic deformation of steel work and columns within the flameproof room. The wall behind the pot stills was in position up to ground floor ceiling level, the first floor section having been blown out almost as one piece onto the ground outside. The walls forming the western and southern edges of the building and the internal walls creating the division between the despatch room and the flameproof room were demolished. A large portion of the south facing wall of the boiler room was still in position as were the shell of the boiler and most of its associated equipment. The internal dividing wall and rest of the building was mostly intact although severely damaged and considered to be in a dangerous state.

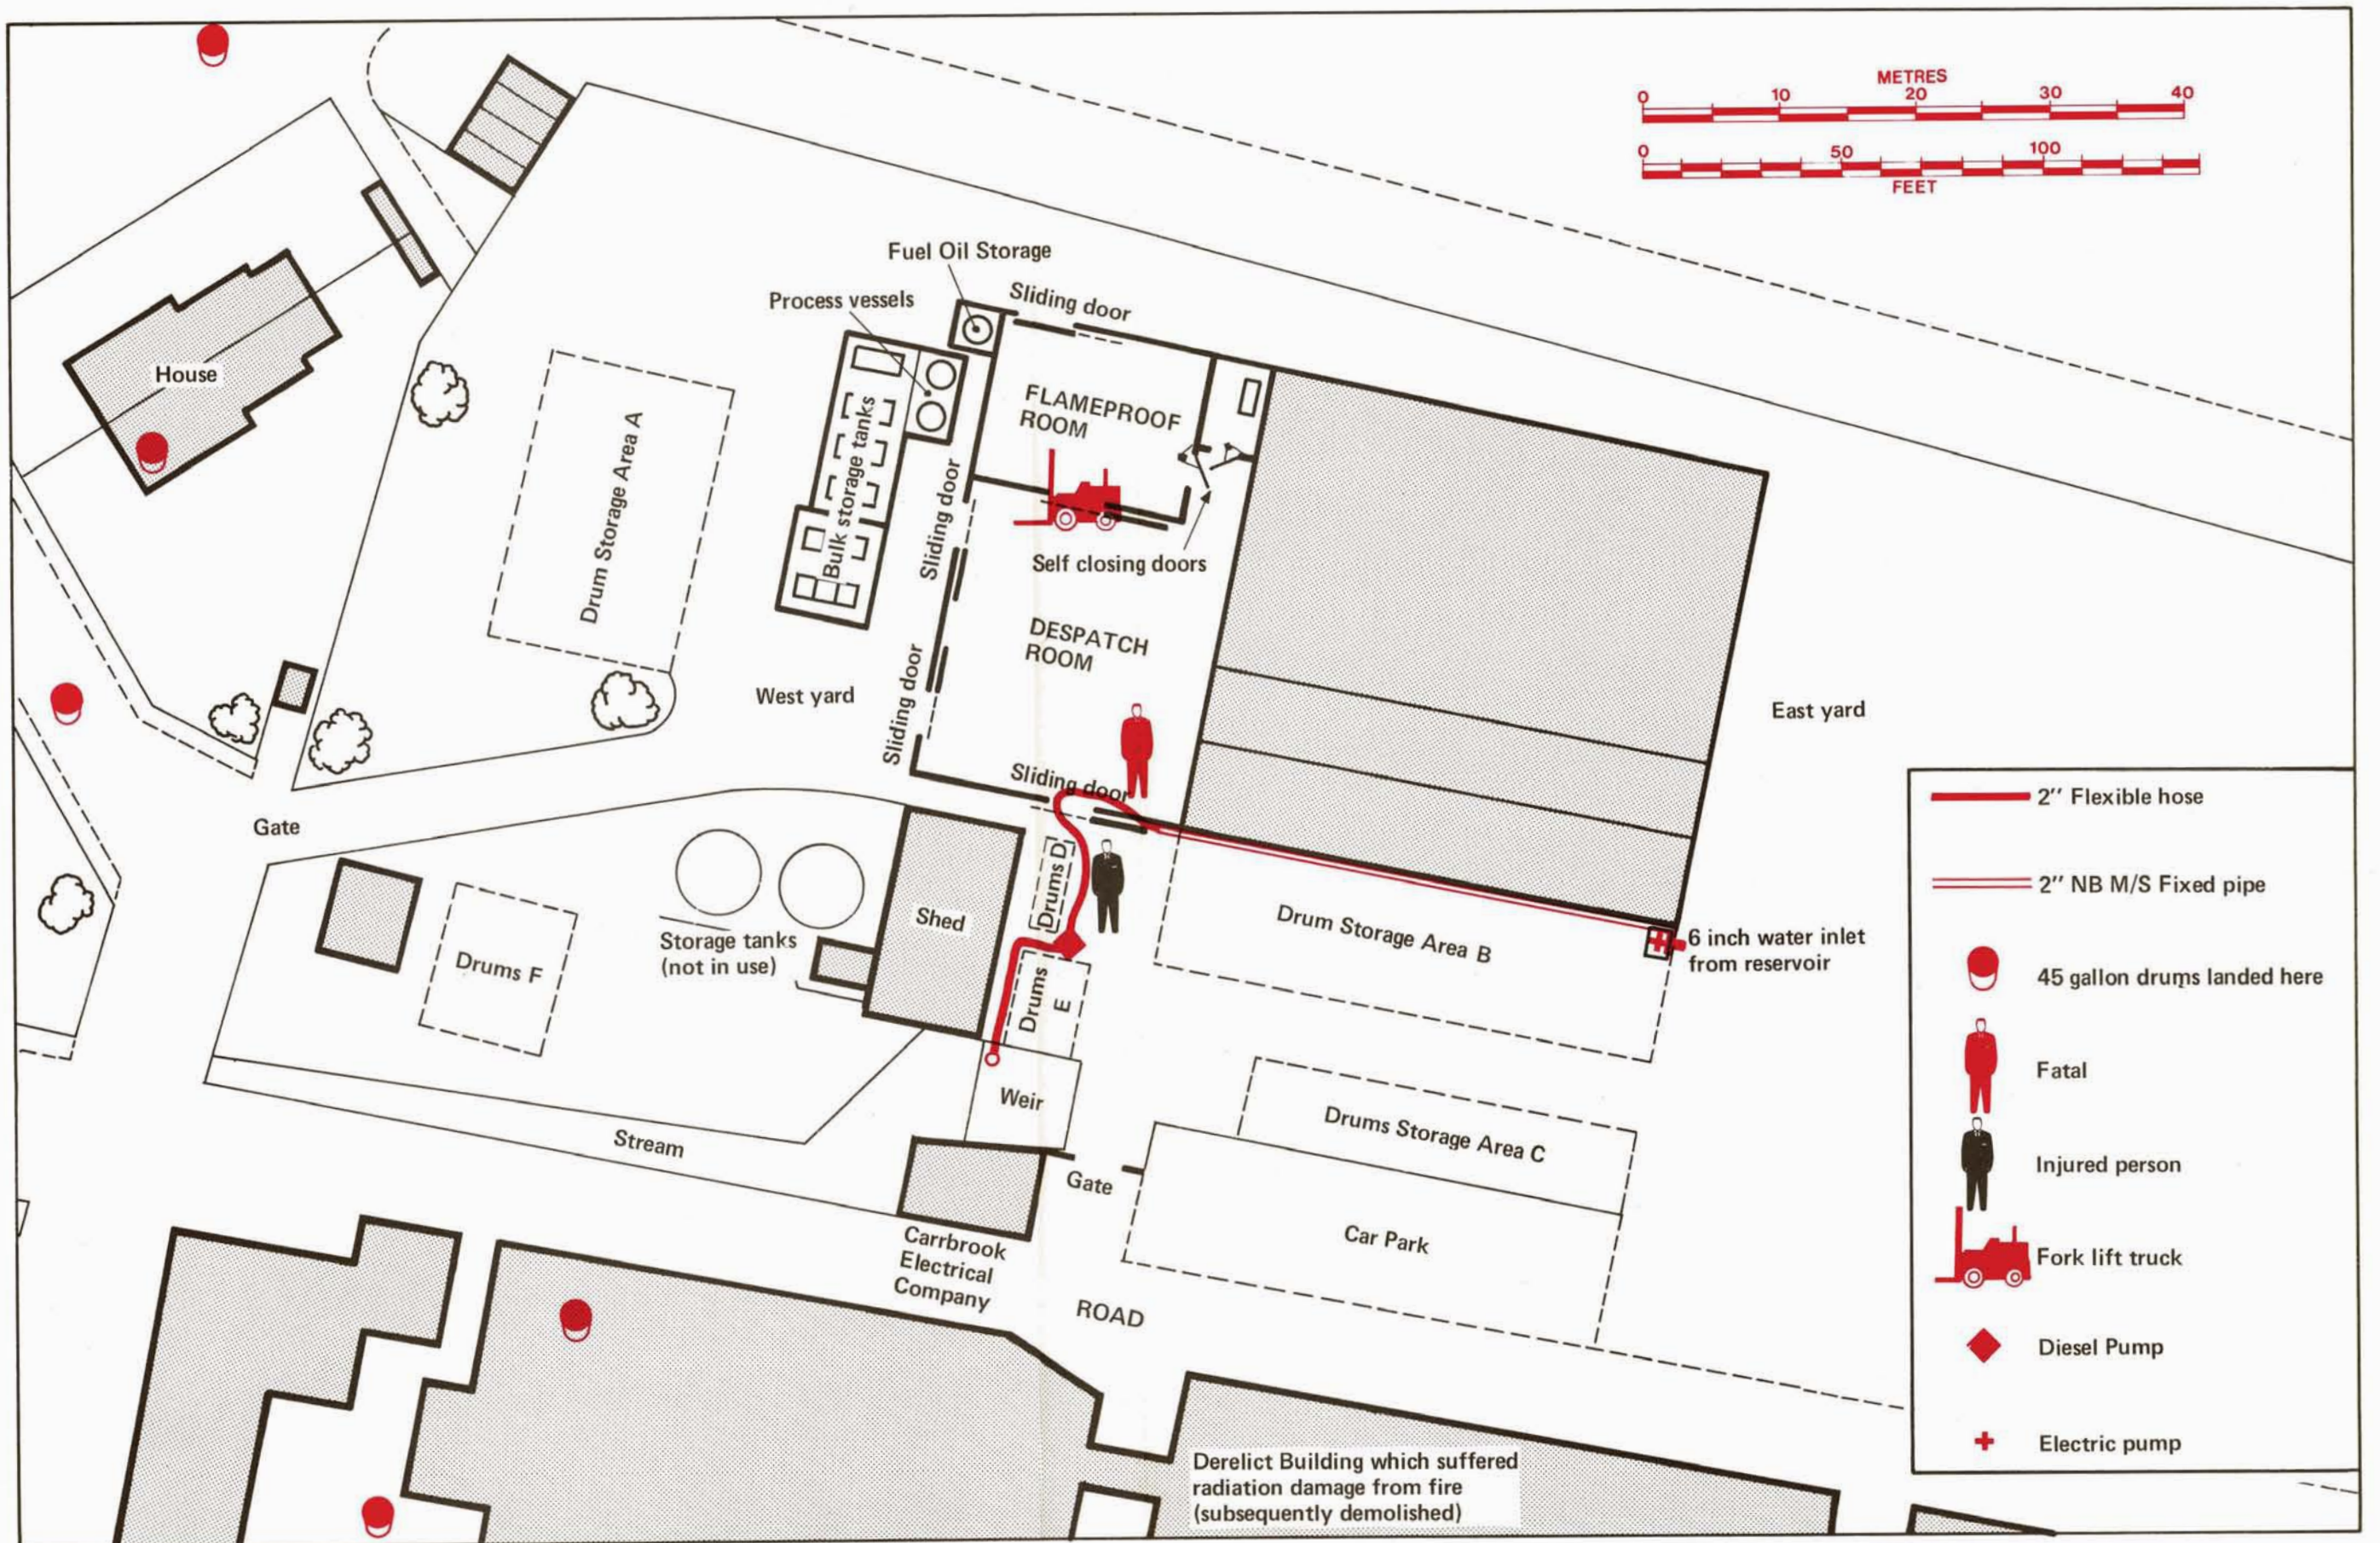
Fig 1 Layout of site

28 This temporary water supply was tested and found to be pumping water up to the electric pump (see Fig 1). However there was insufficient water to run both the large continuous plant at the eastern end of the site and the stills in the flameproof room. As a result the water was directed, by means of existing valves, to the continuous plant in the east yard. At this time the pot stills were not being used.

62 Although there were more than 4 m between the open boundary fence and drum storage area B (see Fig 1) the separation between the building and the storage area was less than 4 m. However a reduction in this recommended distance is considered permissible (see para 44 of the guidance note) when the storage outside the process building in enclosed portable containers is temporary for early use and if further conditions relating to the fire resistance of the building, proximity to building openings and means of escape are also met. These conditions were considered to have been fulfilled.

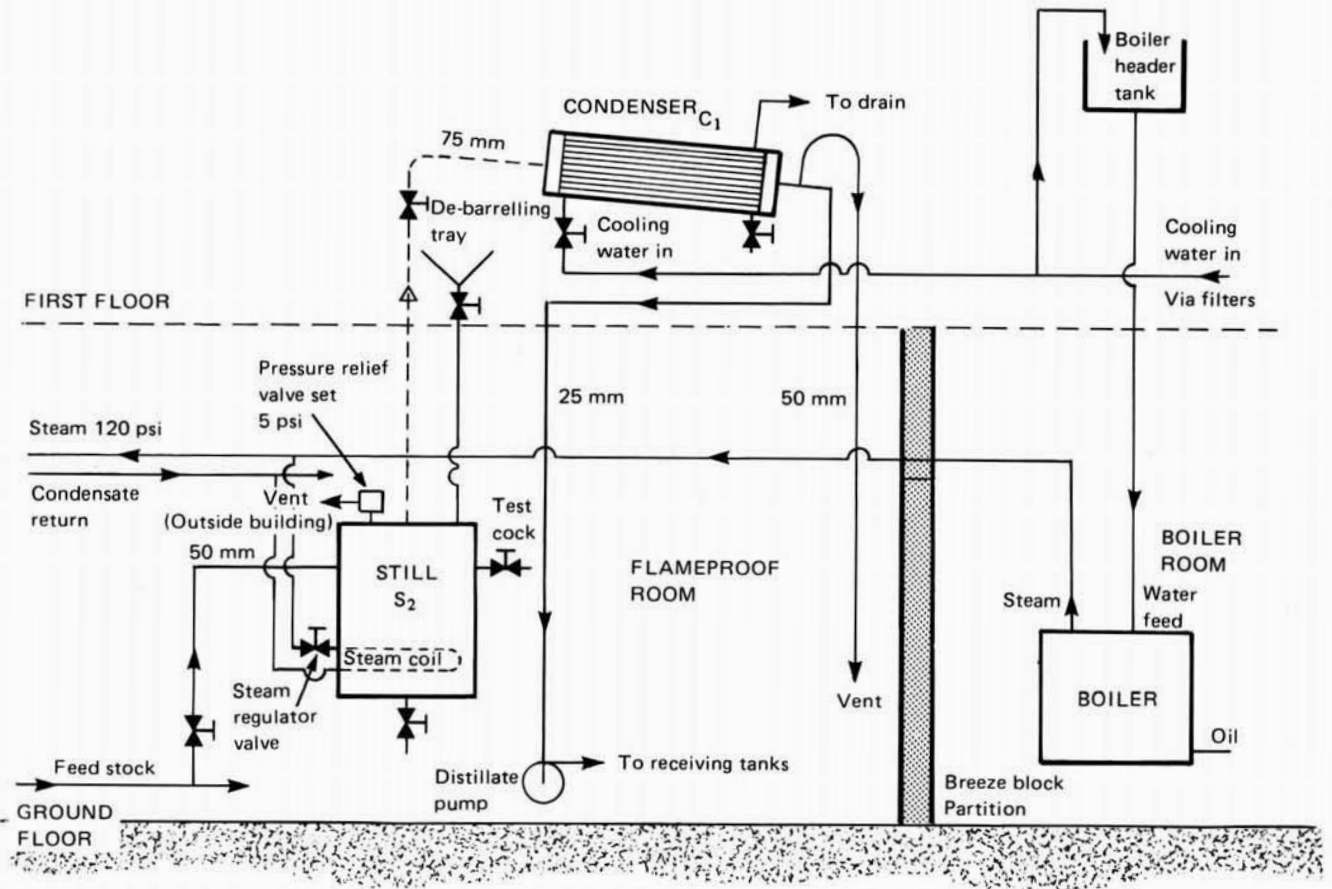
Fig 2 Flow diagram of plant

13 The 75 mm pipework connecting the stills to the two condensers was so arranged that it was possible for either of the condensers to be used. Condenser C1 had a mild steel jacket with phosphor bronze tubes; the water passed through the shell of the condenser and the recovered solvent through the tubes. On the outlet side of each condenser there was an atmospheric vent pipe and both pipes terminated near stills S3 and S4 about 1.5 m above the floor of the flameproof room. The distillate from each condenser was pumped through 25 mm pipework to the receiving vessels (see flow diagram at Fig 2).

16 For the actual process of solvent recovery the 7700 litre capacity pot still was filled with 6000 litres of contaminated solvent up to the level of the test cock either from the external bulk storage tanks or from the debarrelling tray (see Fig 2).
