Health and Safety Executive

## *The Brightside Lane Warehouse Fire*

A report of the investigation by the  
Health and Safety Executive into the  
effects of the fire at the National Freight  
Consortium warehouse building, Brightside Lane,  
Sheffield, on 14 December 1984.

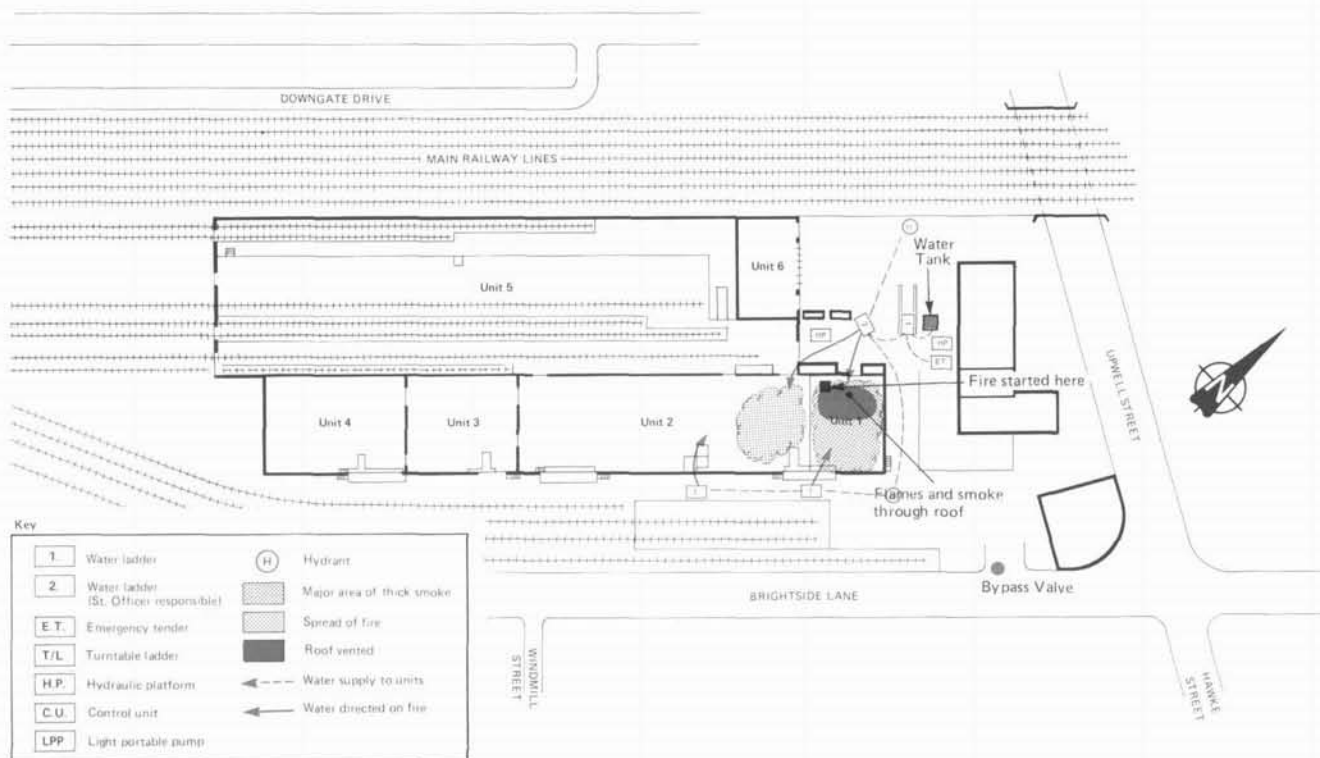
Fig 4 Fire at 1310 hrs on 14 December 1984

53 The Officer-in-Charge of the fireground activity had sent a message to “make pumps four” (ie to increase the number of pumping appliances attending the site to a total of four) at 1302 hrs. They arrived at 1308 hrs. One set into an internal hydrant at the approach corner of Unit 1 which also fed water up to the crews in the depot yard. The second pump, fed from this hydrant by the first pump, was deployed along the front of the building and the crew entered Unit 2 through an office from which the staff were evacuated (Figure 4).

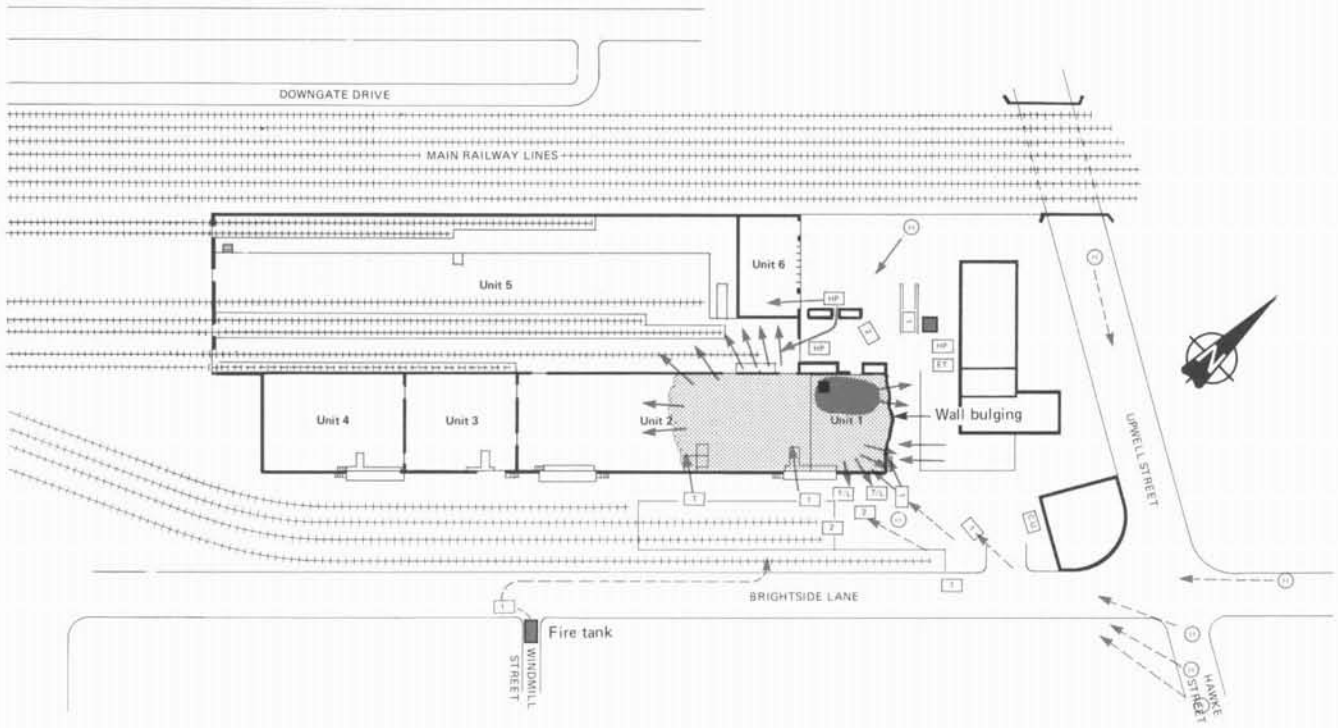
Fig 5 Fire at 1335 hrs on 14 December 1984

58 The fire was advancing along Unit 2 at walking pace and crews sought to extend hoselines to get ahead of the flames and make a ‘stop’ — a point at which the fire could be checked. It was difficult to keep pace with the fire, particularly since flames were spreading at roof level into Unit 5 above the fire crews. Unit 1 was totally engulfed: the front roller shutter door had collapsed, fire had broken through some of the external wall sheets and the gable wall which was bulging outwards collapsed shortly afterwards. Figure 5 shows the position at 1335 hrs.

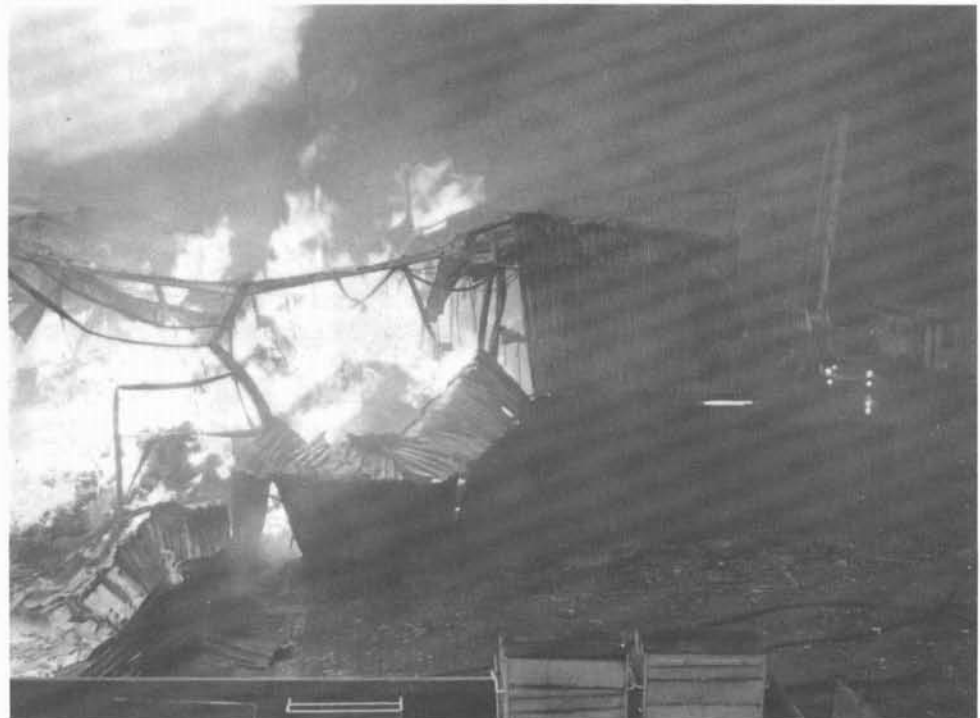
Fire in Unit 1 with collapse of the gable wall  
*South Yorkshire Constabulary*

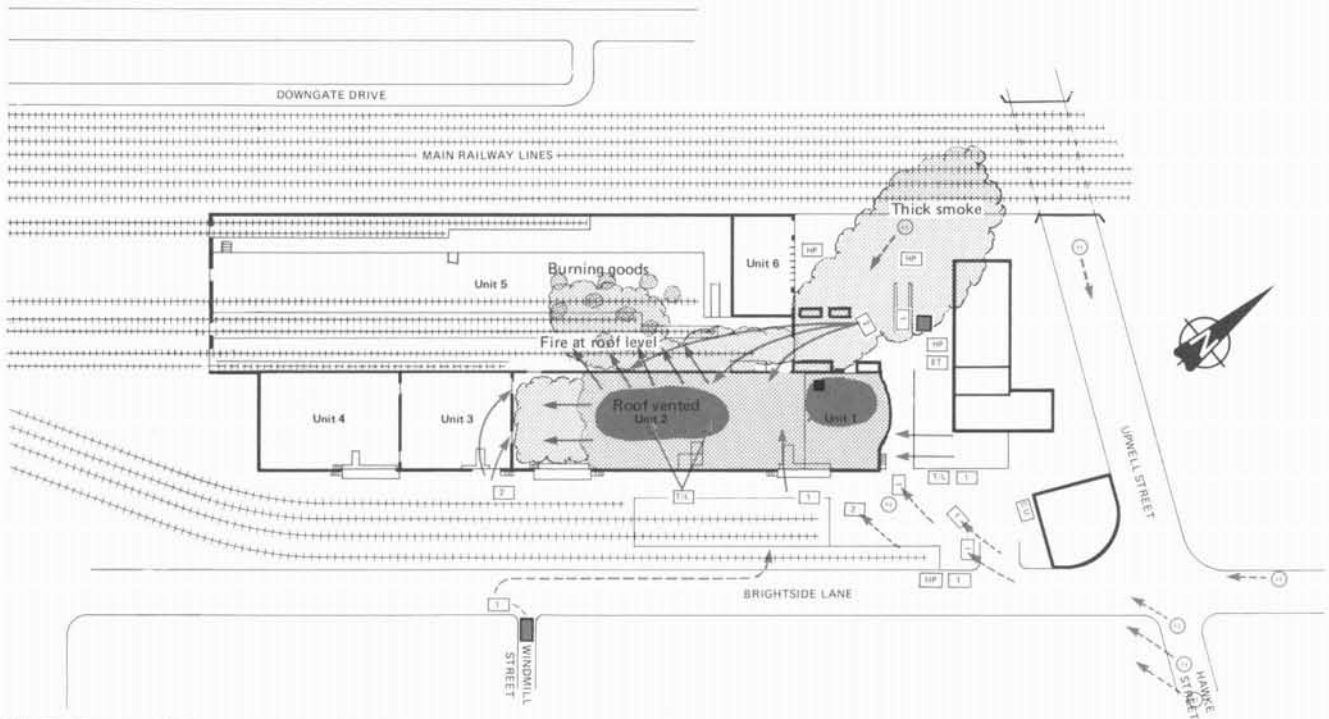
Fig 6 Fire at 1400 hrs on 14 December 1984

61 By 1400 hrs the fire had spread throughout Unit 2 and the central part of the roof had vented

(ie collapsed allowing gases and smoke to escape). Many small fires burnt among the stored goods in Unit 5. By 1400 hrs (Figure 6) the number of pumping appliances had been increased to 12 and another hydraulic platform had arrived. Water supplies were still unsatisfactory so one of the extra pumping appliances was used to relay hydrant supplies from the site entrance to the yard area. The other pump was sent to a hydrant in Downgate Drive. Delay occurred in

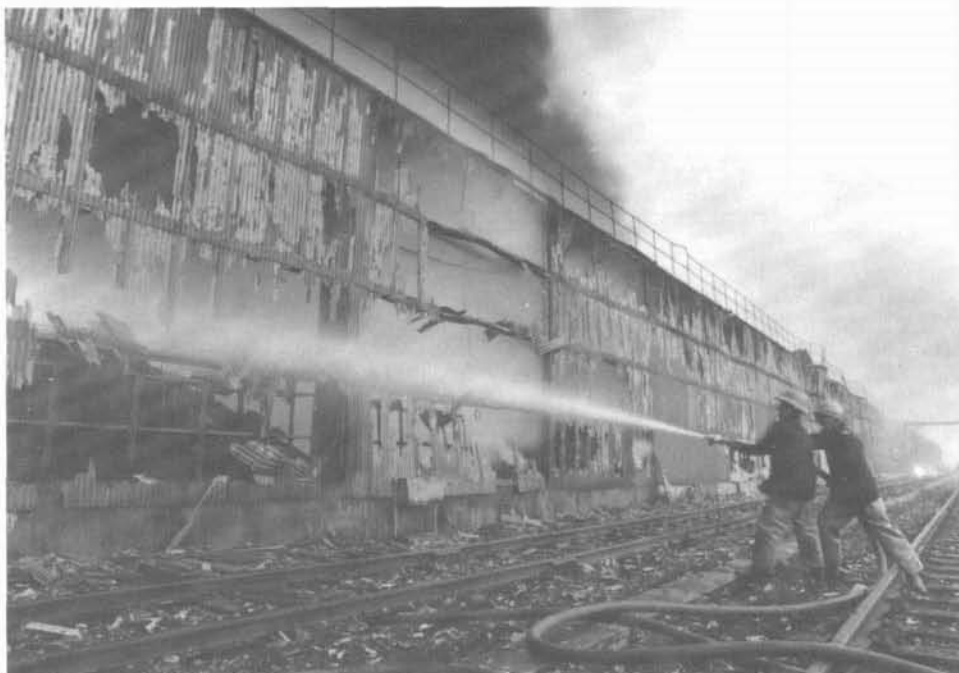
Railway elevation showing exploded asbestos cement sheeting and buckled structure  
*Sheffield City Council*

65 The fire continued to spread in Unit 5, causing explosive cracking of the asbestos cement wall cladding adjacent to the railway. Crews were deployed along this elevation, playing jets through holes in the sheets. Railway lines prevented close approach of appliances, so water supplies were brought from Downgate Drive, Sanderson Street, Newhall Road and also from the depot yard.

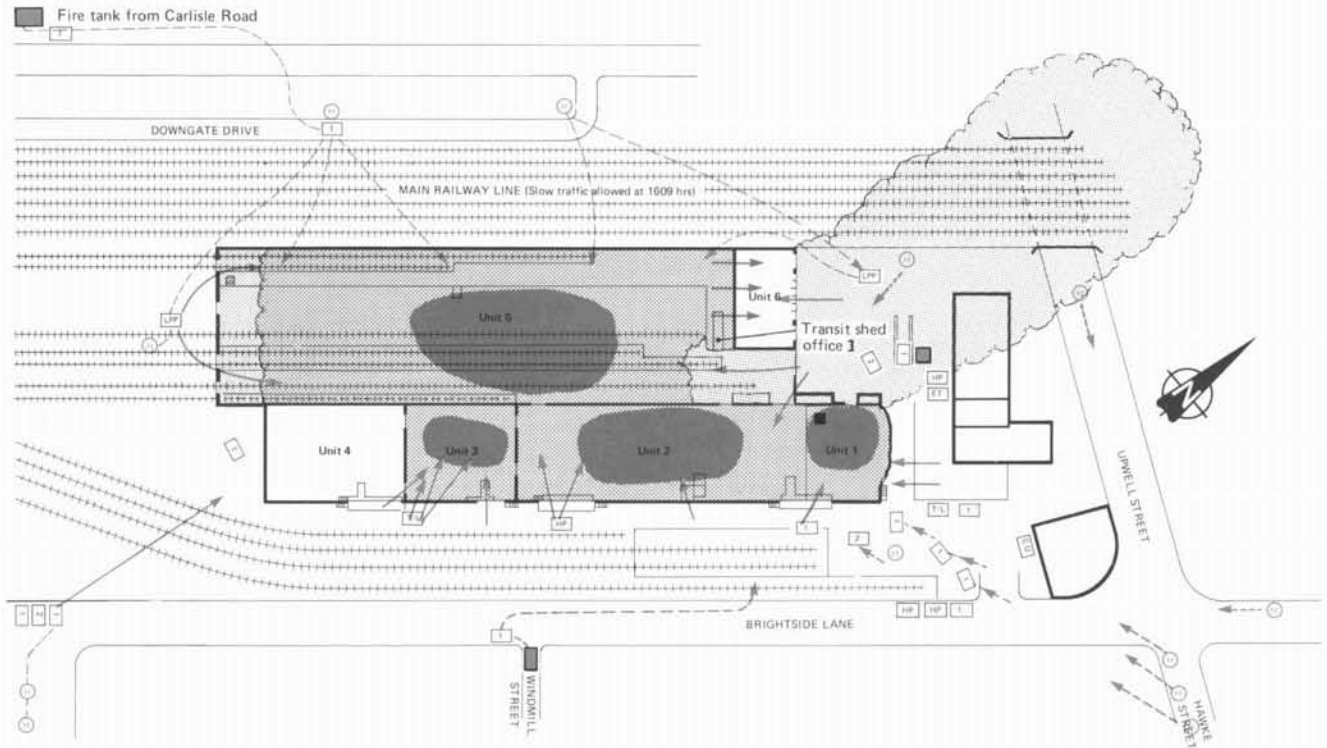
Fig 8 Fire at 1615 hrs on 14 December 1984

67 The whole of the transit shed was burning by 1540 hrs and fire then spread over the roof of Unit 6, to involve the whole of the premises except Unit 4. The office containing the goods manifest records, situated near the division between Units 5 and 6, was accessible until just before this time. Figure 8 shows the situation at 1615 hrs.

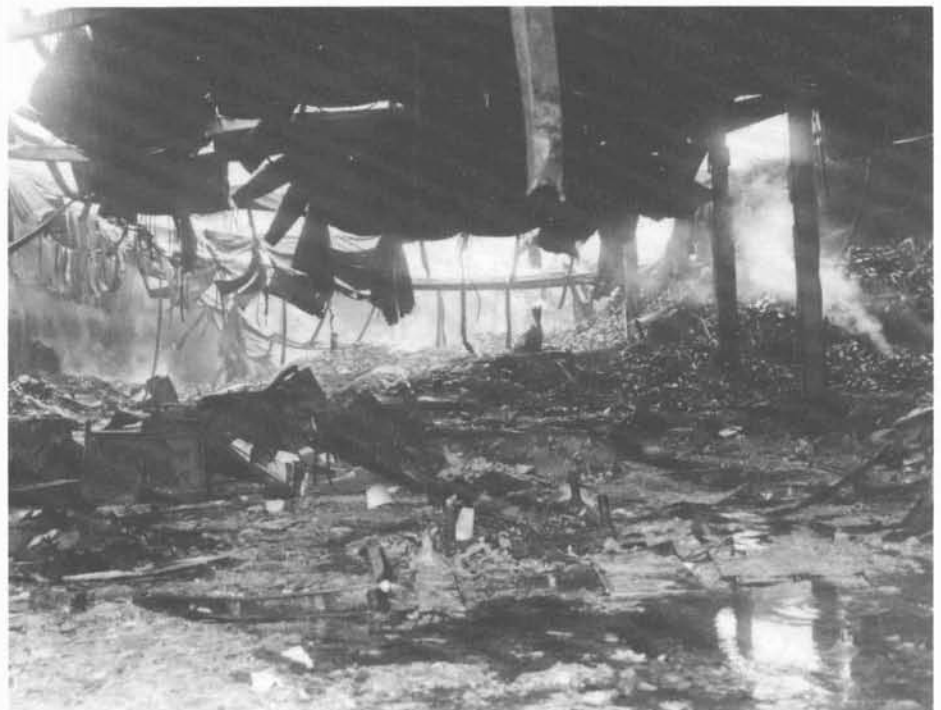
The scene on Saturday  
South Yorkshire Constabulary

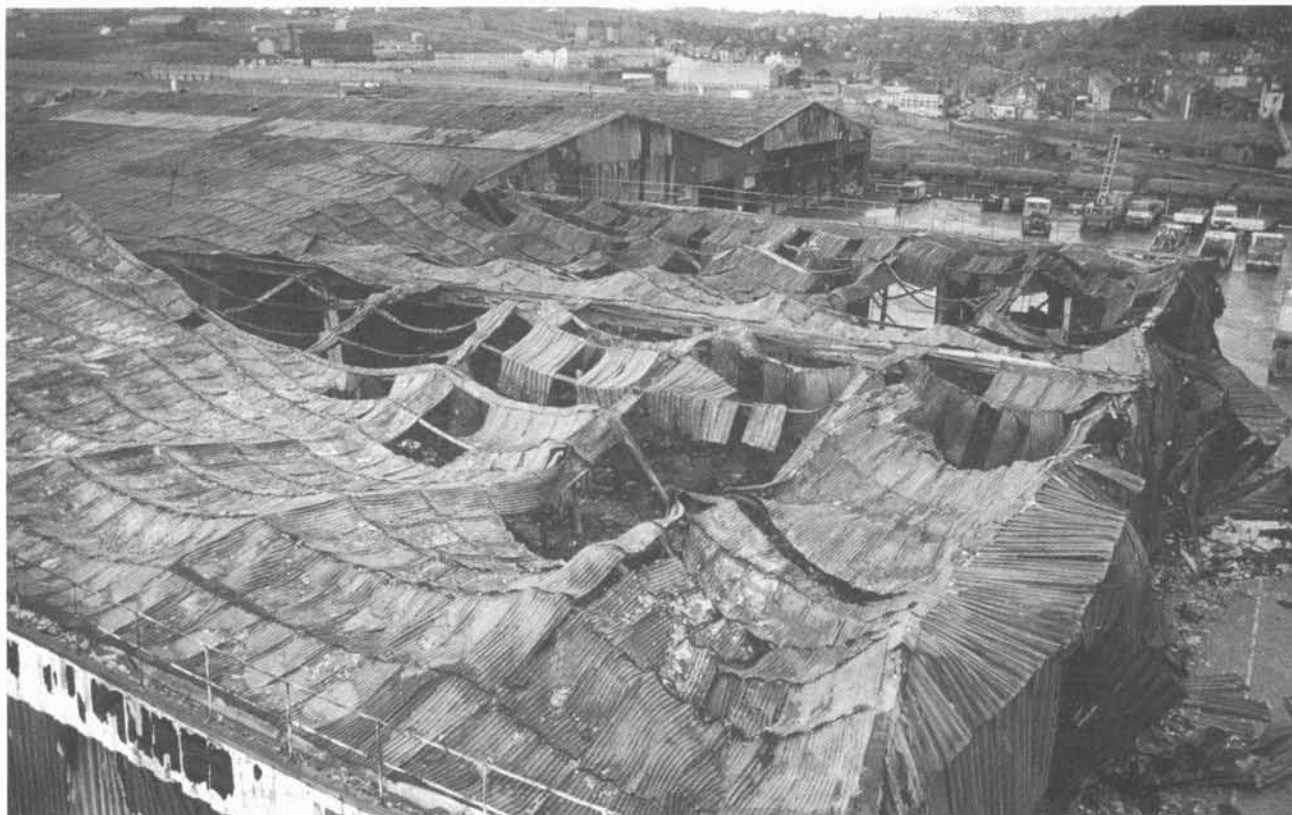
71 Despite the intensity and duration of the fire the main columns were mostly undistorted; the worst-distorted rafters were those located over areas where hundreds of tons of stored plastic granules had generated intense heat and caused a rapid failure of structural members. The roof cladding and underdrawn lining in the north east corner of the warehouse failed as a result of the heat produced by the burning furniture in Unit 1. The profiled steel sheets forming the security division between the furniture store and Unit 2 were melted and distorted. The rafters of Unit 1, however, were largely undamaged.

Effects of the fire on Unit 1  
*Chief Fire Officer, South Yorkshire County Fire Service*

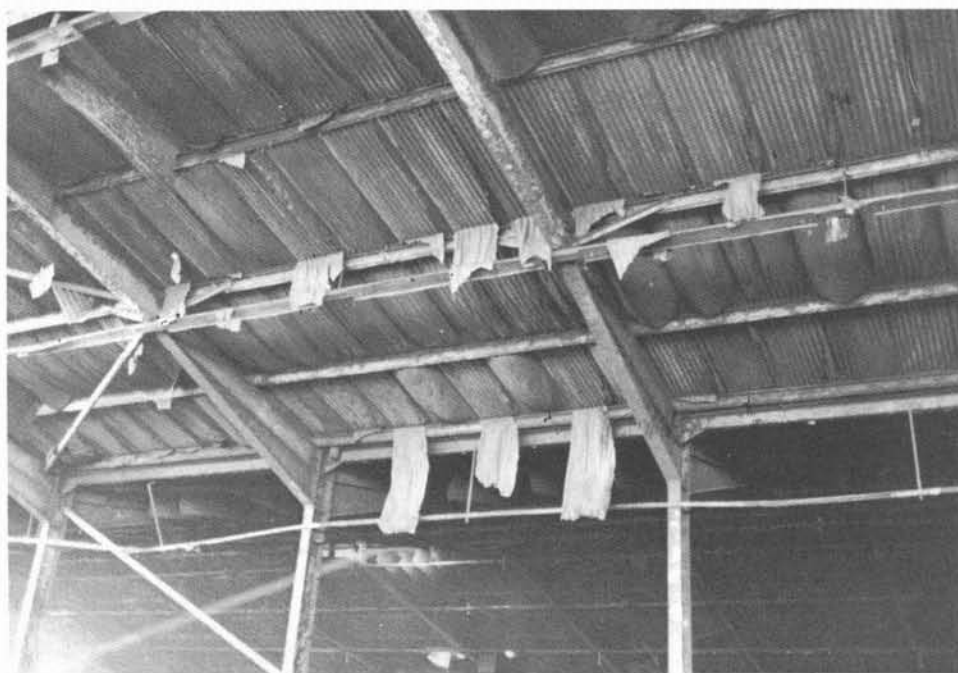
Coating peeled off underside of roof sheets in transit shed

75 A contributory factor in the spread of fire was burning material falling from the underside of the roof sheeting which ignited materials stored below. Current test procedures for assessing the fire risk of such sheets

(BS 476) did not accurately predict their behaviour during this fire. A further characteristic of Cellactite sheeting revealed in the fire was the propensity for the bitumen and asbestos coating to peel off the steel sheet. Depending on the extent to which the bitumen content was burnt away the resulting paper-like material either fell to the ground locally or floated on thermal currents in large pieces, to deposit itself down

110 It was reported that the burning bituminous material easily ignited stored goods heated by radiant heat and so contributed to the spread of fire at ground level. The roof sheeting had been tested in accordance with the standards specified in BS 476, Fire Tests on Building Materials and Structures, and met the requirements of Section E of the Building Regulations. The latest revision of BS 476 takes into account any dripping from a test specimen but does not provide for any such phenomenon to be indicated in the classification category.

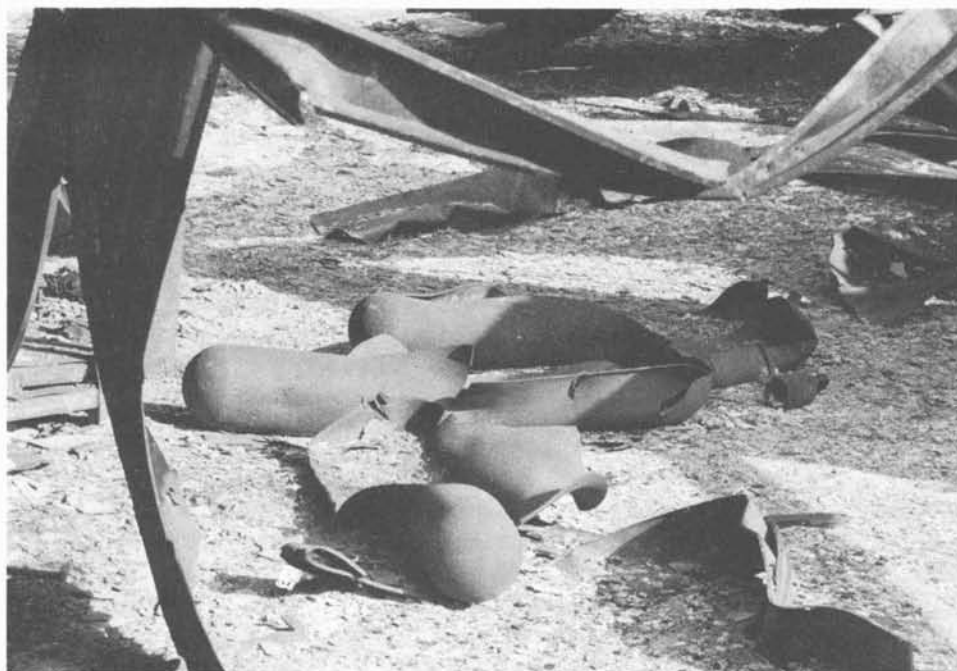
Exploded acetylene cylinders in Unit 5

exploded, while the fifth vented itself when the valving burnt out. In the central area all the timber was consumed, including some of the rail sleepers. The rail line alongside the main traffic road in the shed distorted and some of the structural steel work in the collapsed roof section was so affected that it had no residual strength. Three aluminium containers for transporting the polypropylene granules were almost completely burnt away and several vehicles were destroyed. The large rolls of PVC conveyor belting had been virtually baked and were badly charred. Three of the 60 drums of anthraquinone disulphonic acid salts leaked slightly.

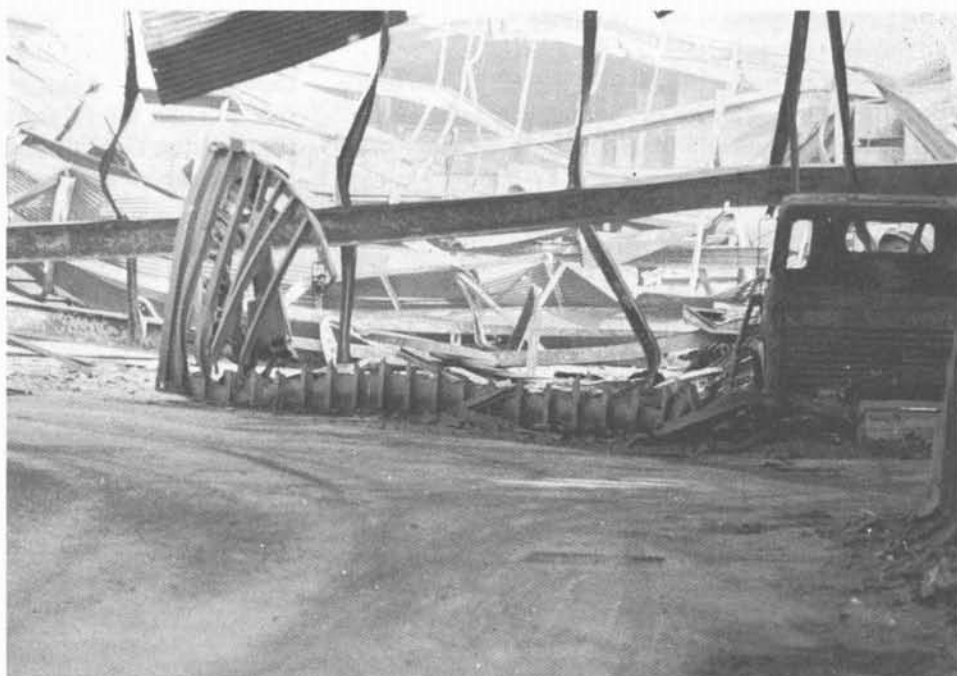
Aluminium container in Unit 5 burnt away

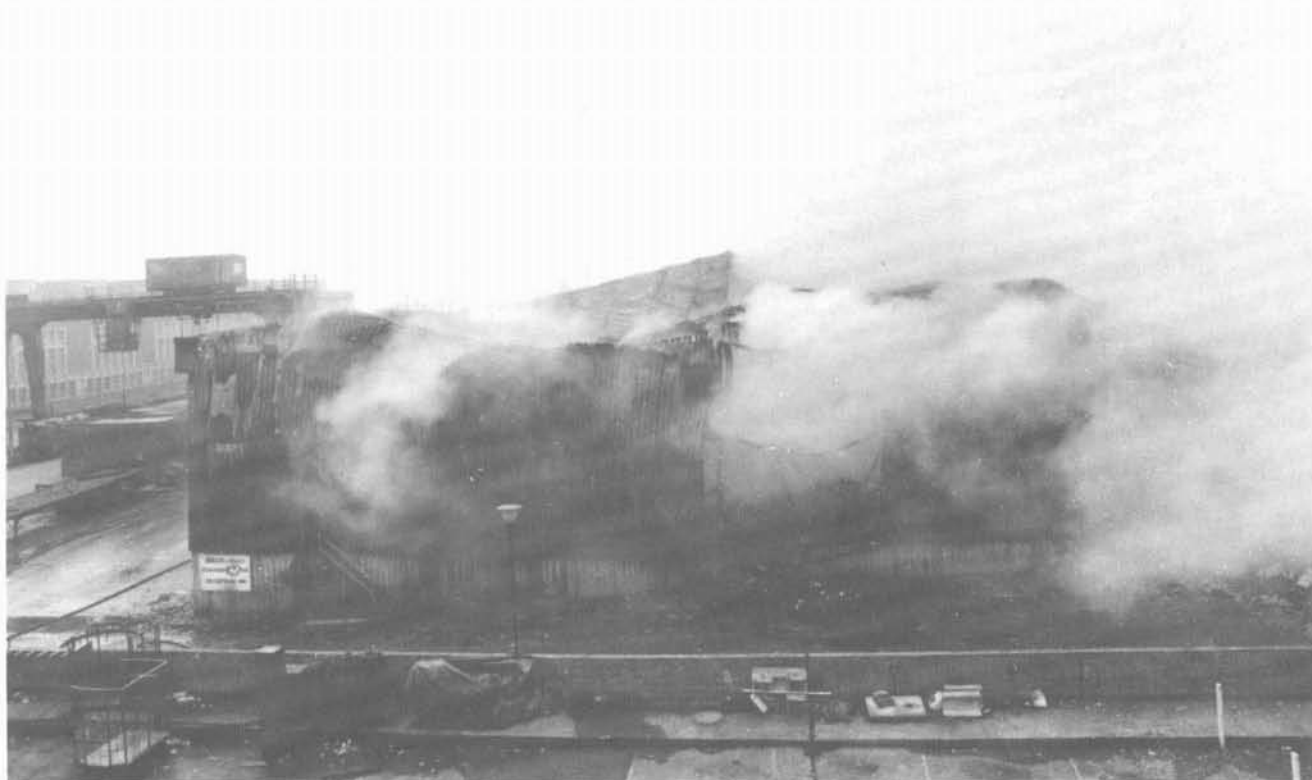
Unit 1 on Saturday 15 December

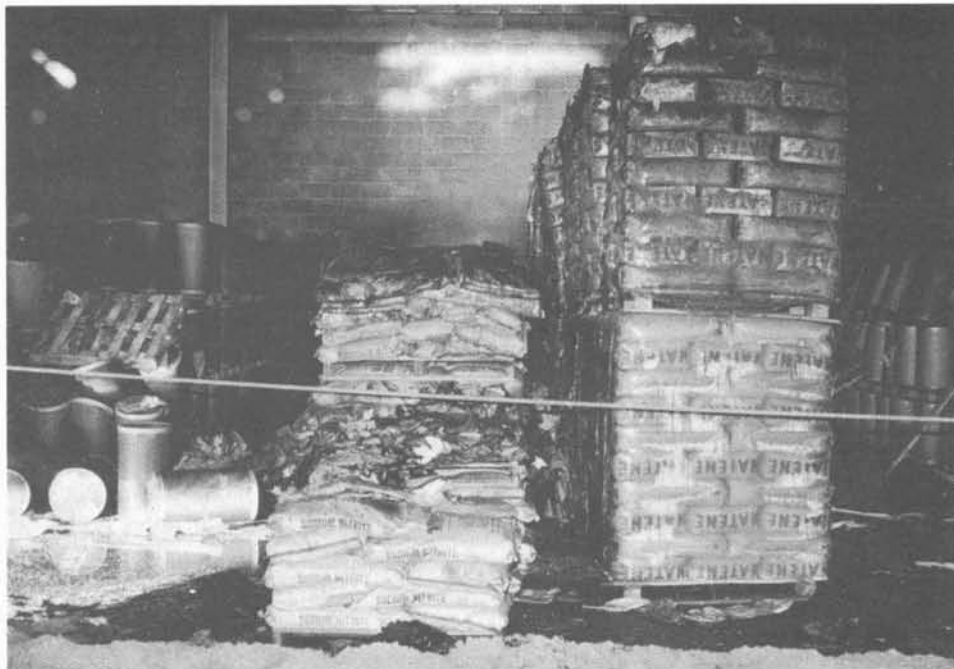
82 The chemicals stored near the entrance survived the fire almost intact — scorched on the outside wrapping, but not substantially burnt. Some damage was done to the paper sacks of sodium nitrite, while several of the cardboard drums were split by being knocked over. There was some water damage, but most of the material was fit for recovery after the fire.

Scorched sacks of sodium nitrite.  
Sand bund to retain surface water.  
Slight scorching of shrink-wrapping  
on Natene (polyethylene) sacks.  
*Sheffield City Council*

89 The Principal Inspector advised the Divisional Commander of the Fire Service to construct a sand bund wall around chemicals in Unit 5 to minimise escape of contaminated water, and to arrange for firemen handling hoses in this area to wear PVC gloves instead of conventional leather firegloves. This advice was quickly implemented.
