The fires and explosion at BP Oil (Grangemouth) Refinery Ltd

A report of the investigations by the
Health and Safety Executive into the fires and
explosion at Grangemouth and Dalmeny,
Scotland, 13 March, 22 March and 11 June
1987

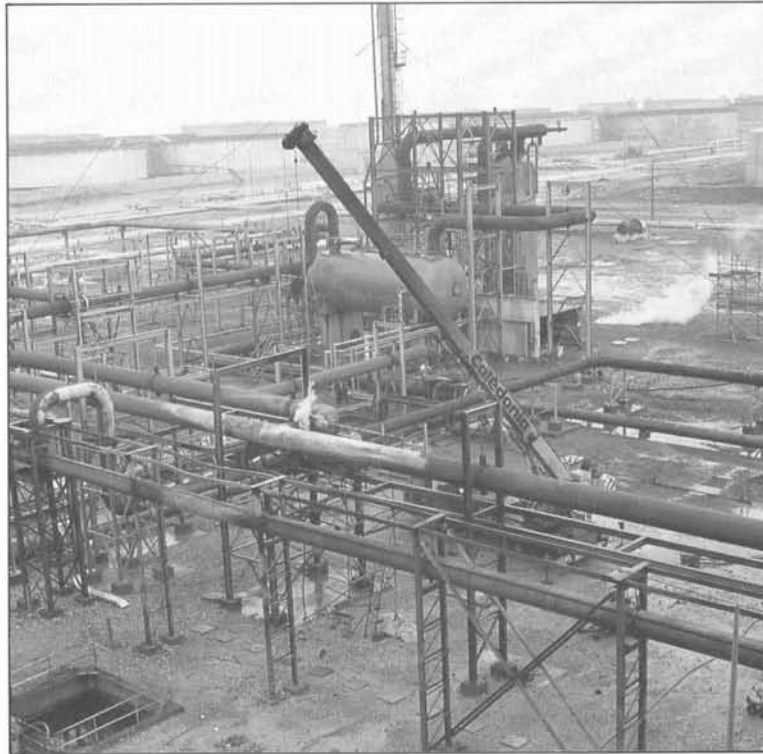
Photograph 1 Cross-over valve area on 14 March. Flare No 1 and knock-out drum No 1 in background. *Courtesy of British Petroleum*

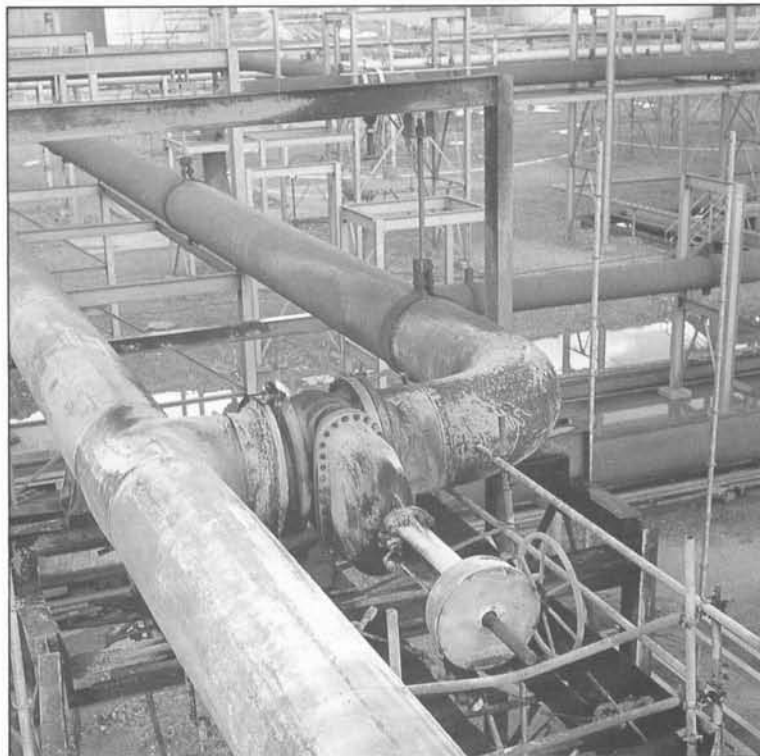
Photograph 2 Cross-over valve V17. *Courtesy of British Petroleum*

valves, taking rigorous safety precautions. The valves were subjected to careful examination by HSE. On many of them pyrophoric scale, which is spontaneously combustible in air, was found to have compacted in the wedge guides. The effect of this is illustrated in Fig 3. Wedge gate valves can be closed through minor accumulations of scale or sludge, but eventually build up will prevent them from closing fully. They then no longer seal effectively and hence pipeline isolation may be prevented even though the valves are apparently closed. This problem is more likely to arise when valves are mounted horizontally with their wedge gates in the vertical position. V6, V10, V12 and V17 were installed in this manner. Flare line valves had nothing fitted to indicate whether or not they were fully closed and operators therefore assumed that they were closed when they could turn the handwheels no further even using wheel keys to give increased torque. In some cases, the screwed valve spindles protruded at least 150 mm, which was excessive. It is now recognised that sludge build up in V17 was the probable reason it allowed gas to pass.

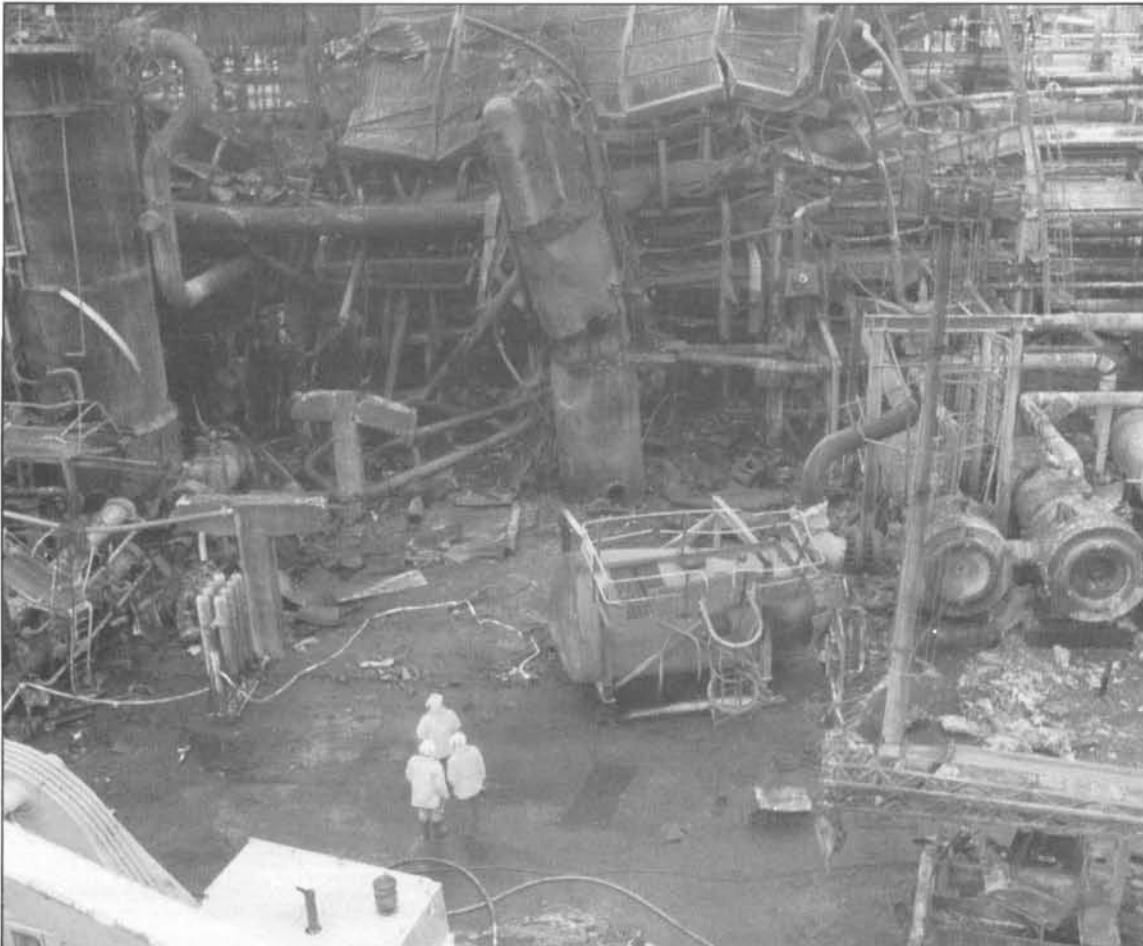
49 The potential consequences of the incident could have been much greater. It occurred on a Sunday morning when few people were on site. V306 ruptured at support saddles underneath the vessel and the blast force was directed downwards with fragments being projected upwards. Had it been otherwise, the control and mess room building could have been destroyed, increasing the likelihood of death and injury. Fortunately none of the fragments hit vulnerable plant nor did they strike anyone. The risk did not warrant evacuating local residents but non essential personnel left the site. As a precaution traffic on the adjacent road was diverted.

Photograph 4 LP separator support plinths

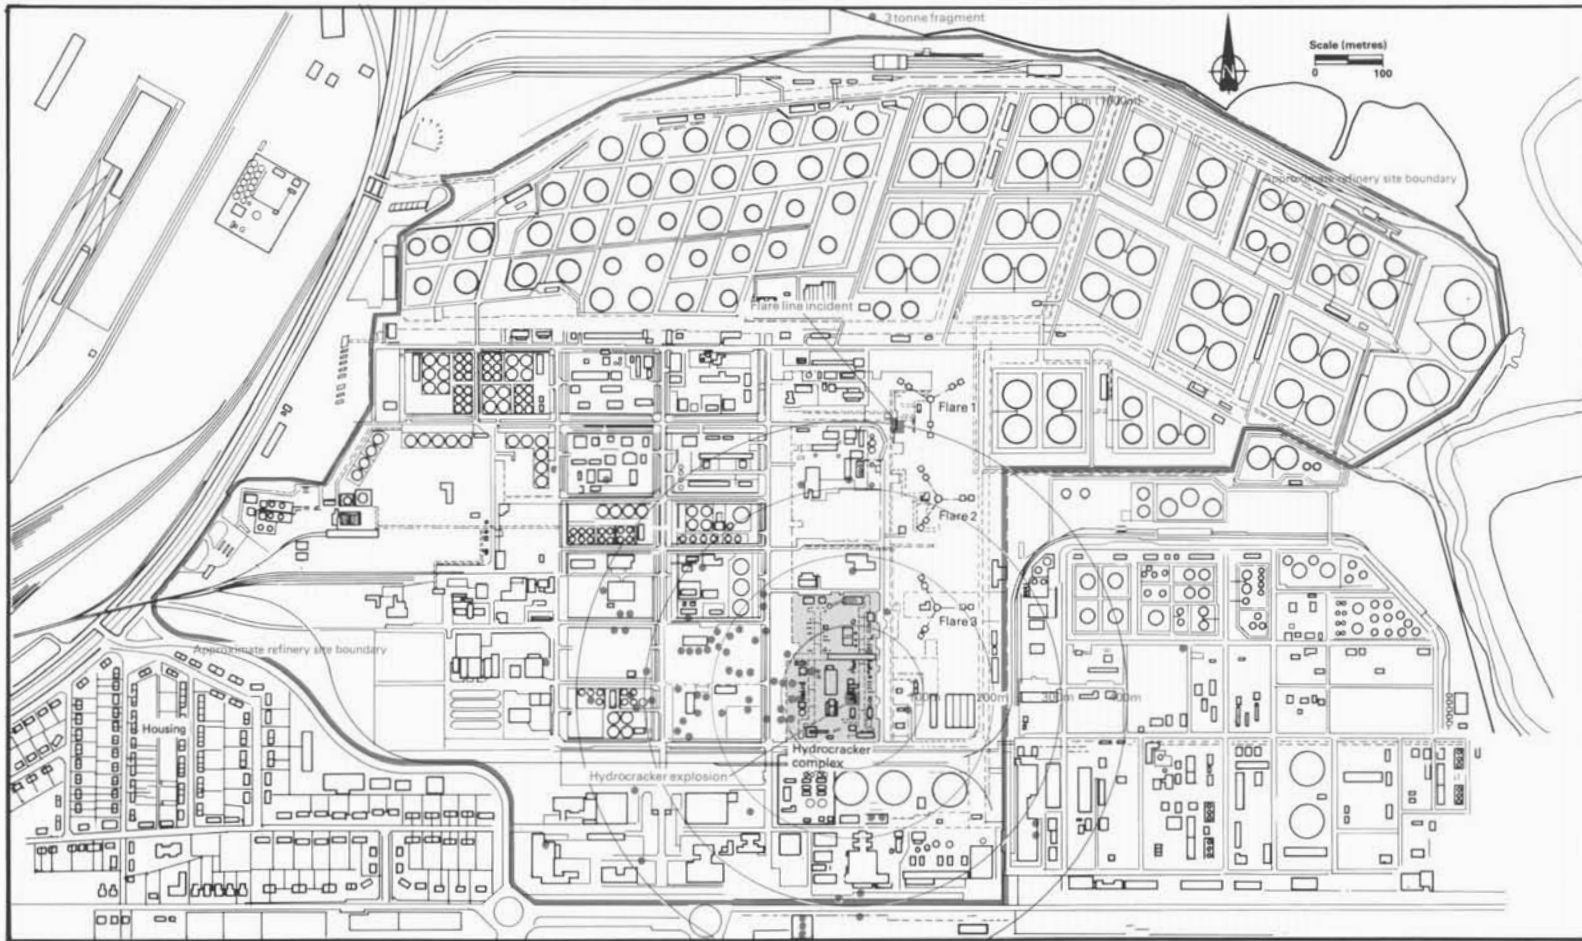
Fig 9 Refinery plan showing location of hydrocracker explosion and debris, and location of flare line incident

explosion was heard and felt 30 km away and it caused considerable local concern. A contractor who had just left the mess-room was killed. The explosion centred on V306 which was constructed from 18 mm steel plate and weighed 20 tonnes. Photograph 4 shows the hydrocracker area with two T-shaped plinths on which V306 stood to the left of centre. The vertical HP separator (V305) is on the far left. V306 had disintegrated and large fragments were projected considerable distances. A piece weighing nearly 3 tonnes was found on the foreshore 1 km away. Another was projected over a main road into a factory where it severed a steam line. A third went through the roof of a workshop on an adjacent site. During the investigation almost all of V306 was recovered and the positions where the main fragments landed are shown in Fig 9.

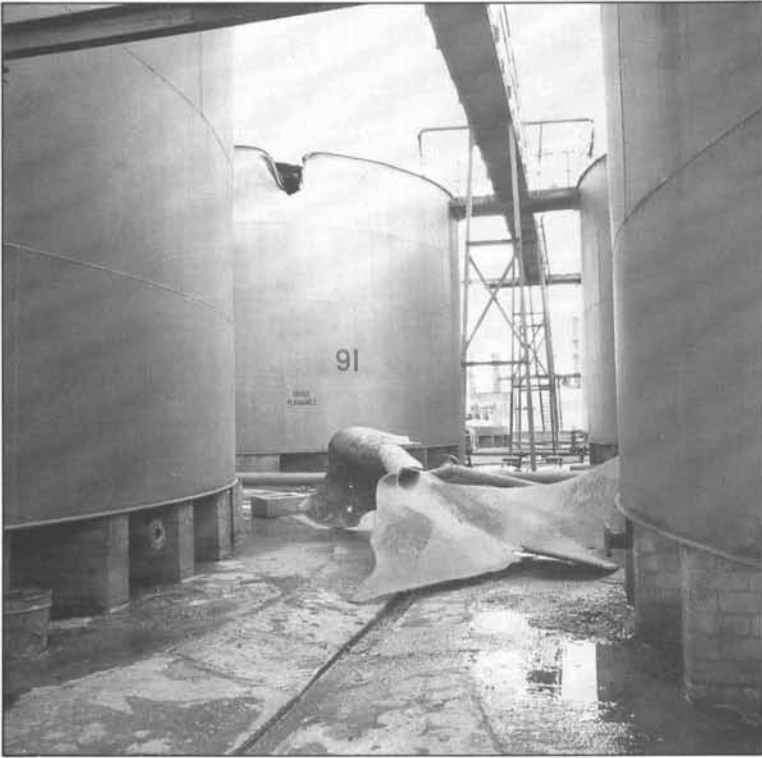
Photograph 5 Fragment from LP separator; distance 340 metres

54 The fragments of V306 were located, weighed and their positions logged. The explosive forces were calculated using ballistic techniques based on fragment trajectories which confirmed that rupture was caused by over-pressurisation. The results correlated well with the calculated theoretical burst pressure of 50 bar (750 psig). Blast damage established that the force of the explosion was equivalent to approximately 90 kg of TNT.

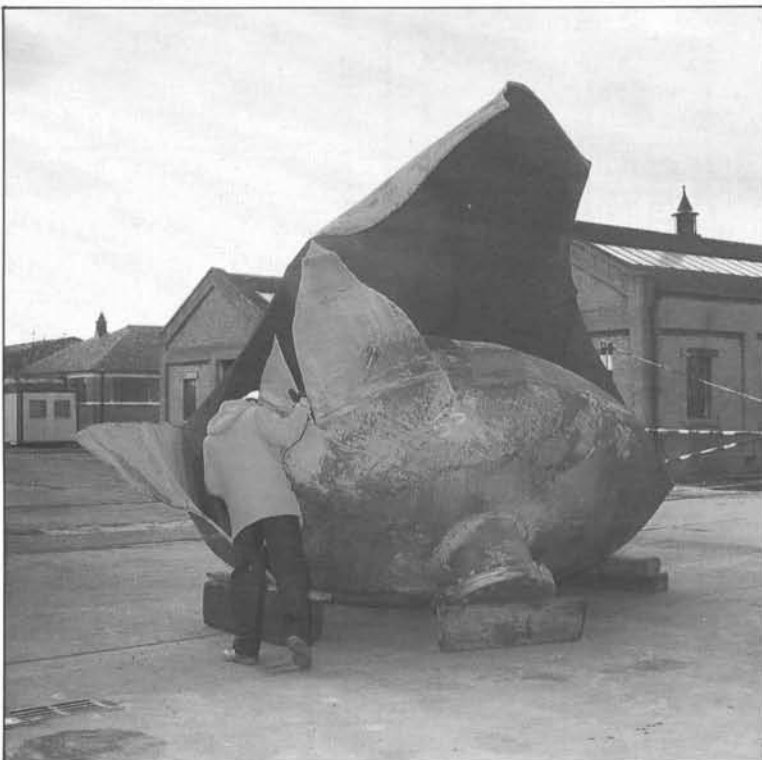
Photograph 6 LP separator end section projected 75 metres over control room building

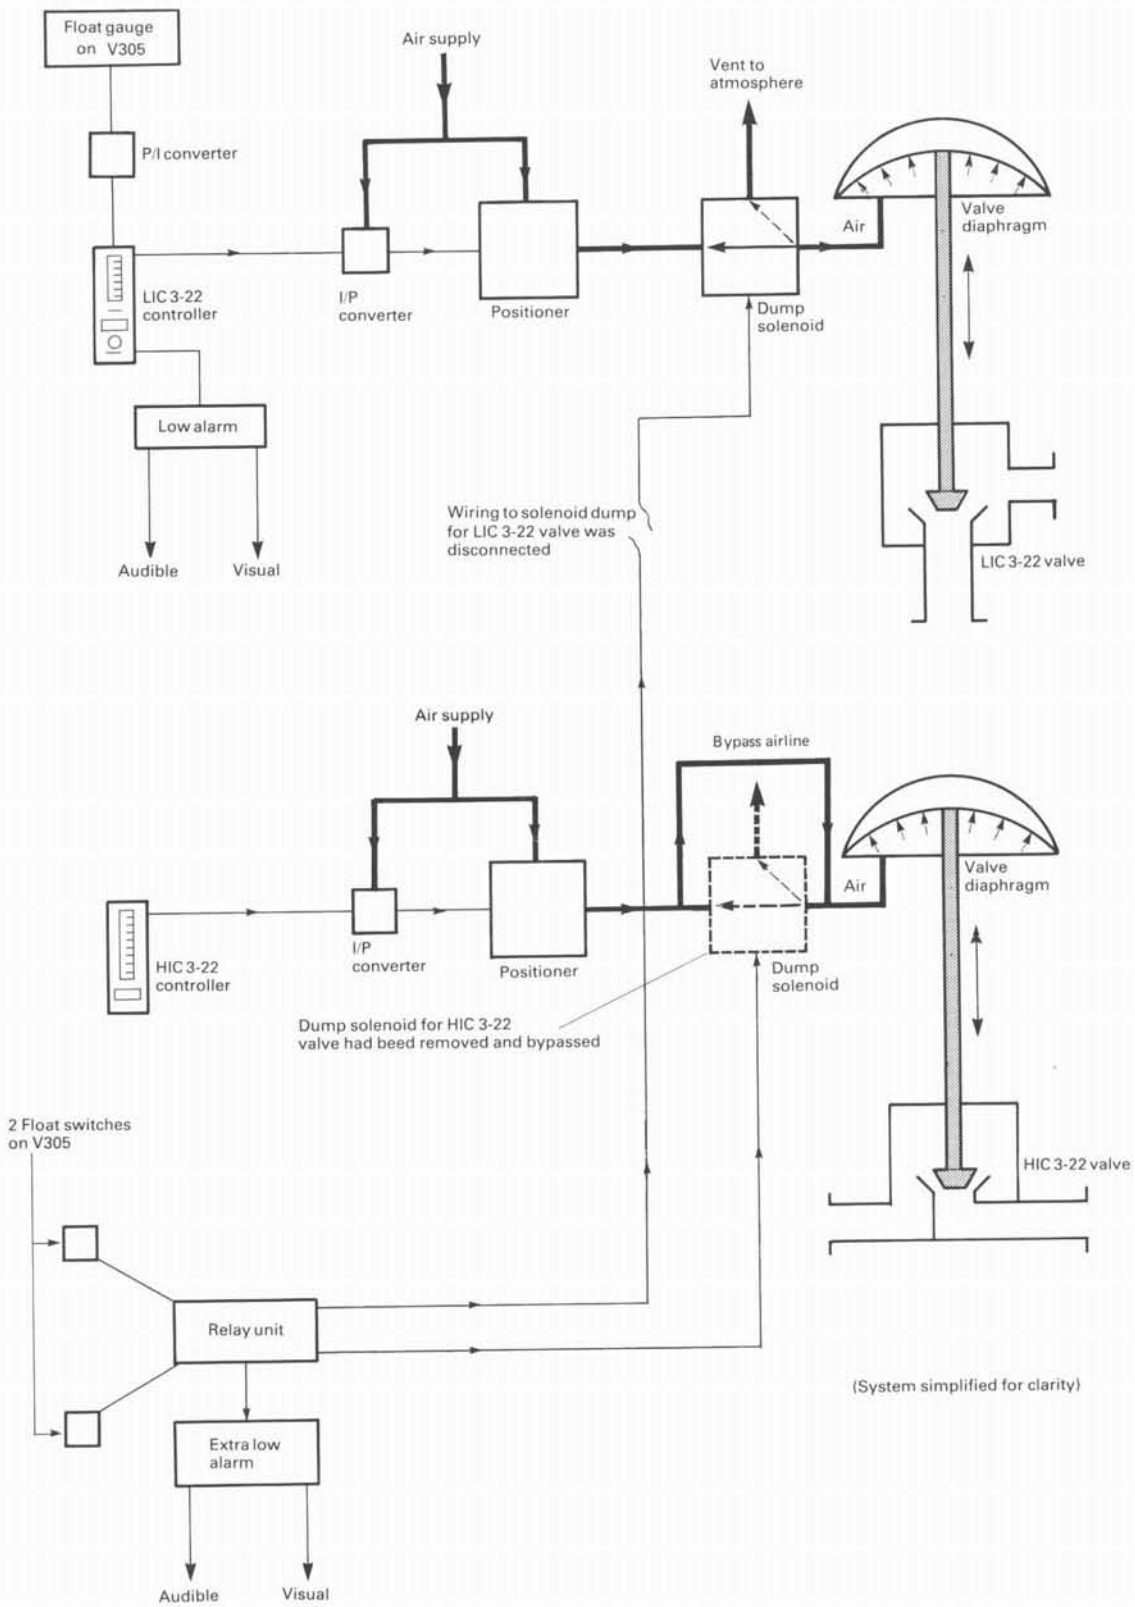
Fig 11 LIC 3-22 & HIC 3-22 valve control system

58 Fig 11 shows the LIC 3-22 and HIC 3-22 valve control system. A pneumatic diaphragm assembly opened each valve. On removal of air pressure the valve was closed by a spring. Its position was selected by a control unit from which an electrical signal passed to an I/P (electrical current/air pressure) converter. A pneumatic signal was then sent to a positioner unit at the valve. By this means air pressure was applied to the diaphragm. Two hand-wheel-operated valves (SP25) in series provided a manual by-pass to the control valves. One was found open but the other was shut and found to be gas tight. Gas breakthrough,

59 HSE tested the HIC 3-22 and LIC 3-22 valves. Apart from fire damage to the diaphragm assembly and positioner on LIC 3-22, they were found to be in working order and sealing reasonably effectively when in their closed positions. When valves were removed, waxy material was found in all except LIC 3-22 evidence that gas had passed through it purging it of wax.

68 The electrical supply wiring to the LIC 3-22 trip solenoid was found to have been deliberately disconnected at the control room and on HIC 3-22 the trip solenoid had been removed and bypassed. In consequence neither of these flow control valves could trip to close on extra-low levels in V305. It was thus possible to open the valves with little or no liquid in V305. Safety of this part of the plant had for many years thus depended solely on the vigilance of operators.

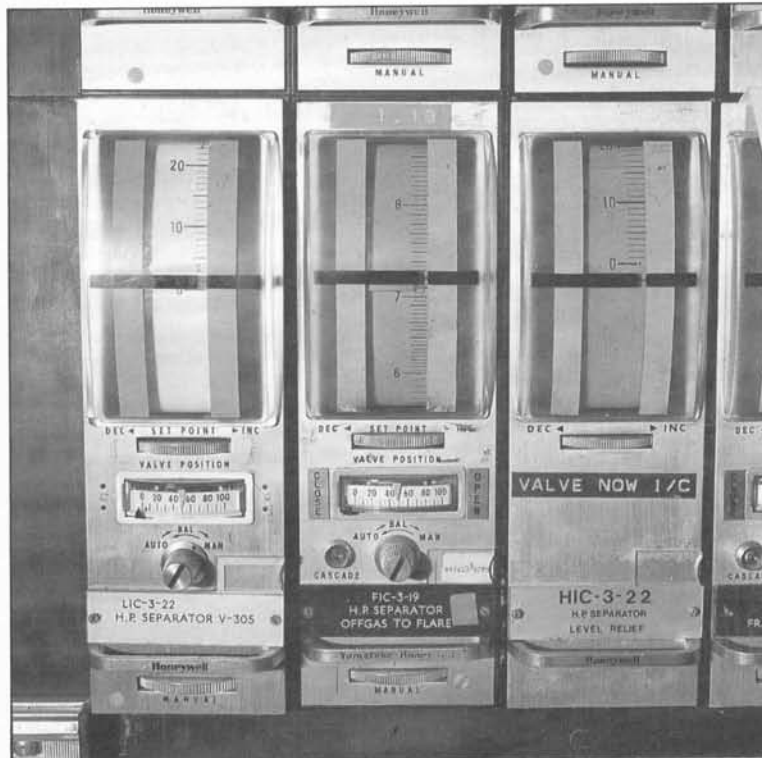
Photograph 7 LIC 3-22 and HIC 3-22 controllers

- (c) Errors could occur as controls of a similar appearance carried out different functions. If one controller was adjusted when the intention was to adjust another, a valve could move to a position not anticipated.

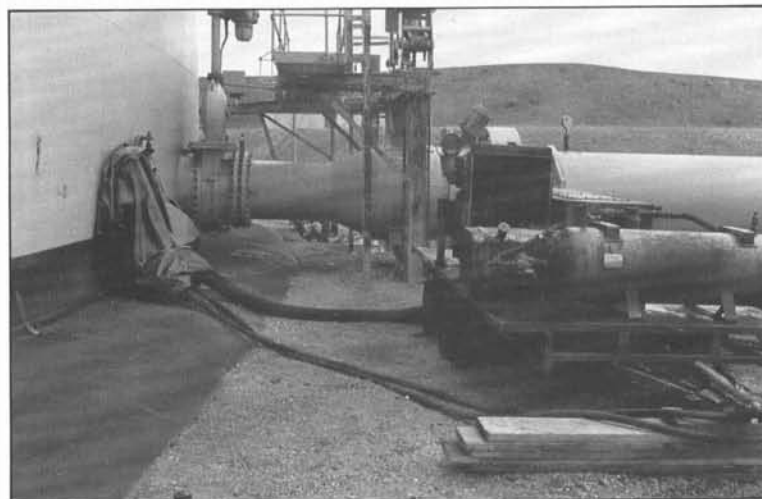
Photograph 9 Diesel engined unit near to T807 manway
