## *The Peterborough Explosion*

A report of the investigation by  
the Health and Safety Executive into  
the explosion of a vehicle carrying explosives  
at Fengate Industrial Estate, Peterborough  
on 22 March 1989

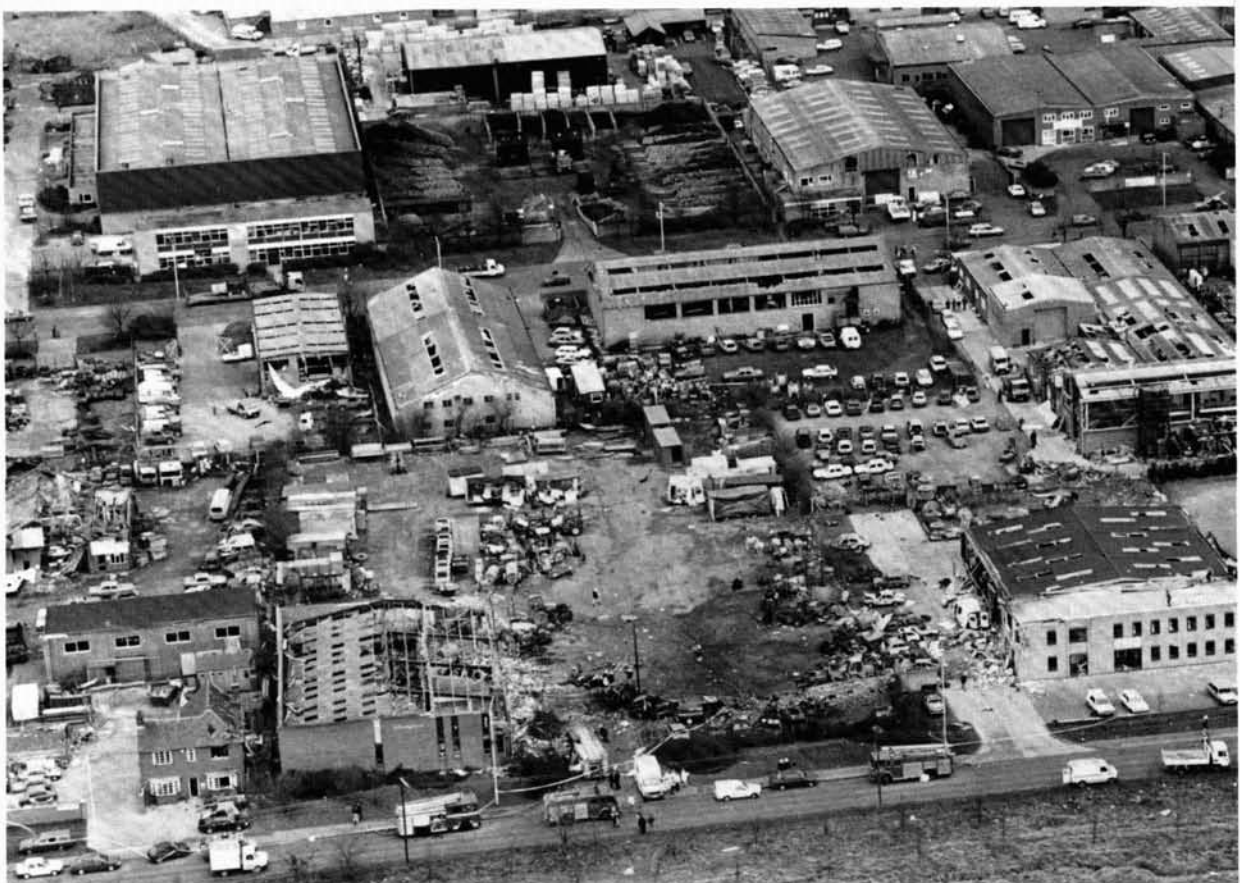
**Figure 3** Aerial photograph of area after explosion (*Photograph reproduced by kind permission of Peterborough Evening Telegraph*)

29 The epicentre of the explosion was marked by a depression 46 cm deep and 7 m across in the tarmac surface of the yard. Structural damage to the two buildings on either side of the explosion was considerable and the Vibroplant building to the south west had later to be demolished. About 150 buildings further afield received significant damage with large doors blown in, metal cladding damaged or removed, asbestos roofs collapsed, window frames blown in and extensive window damage. About 130 cars were also damaged to varying degrees - around 60 beyond repair, 13 badly, 51 slightly and the remainder superficially. Figure 3 shows the scene after the explosion.

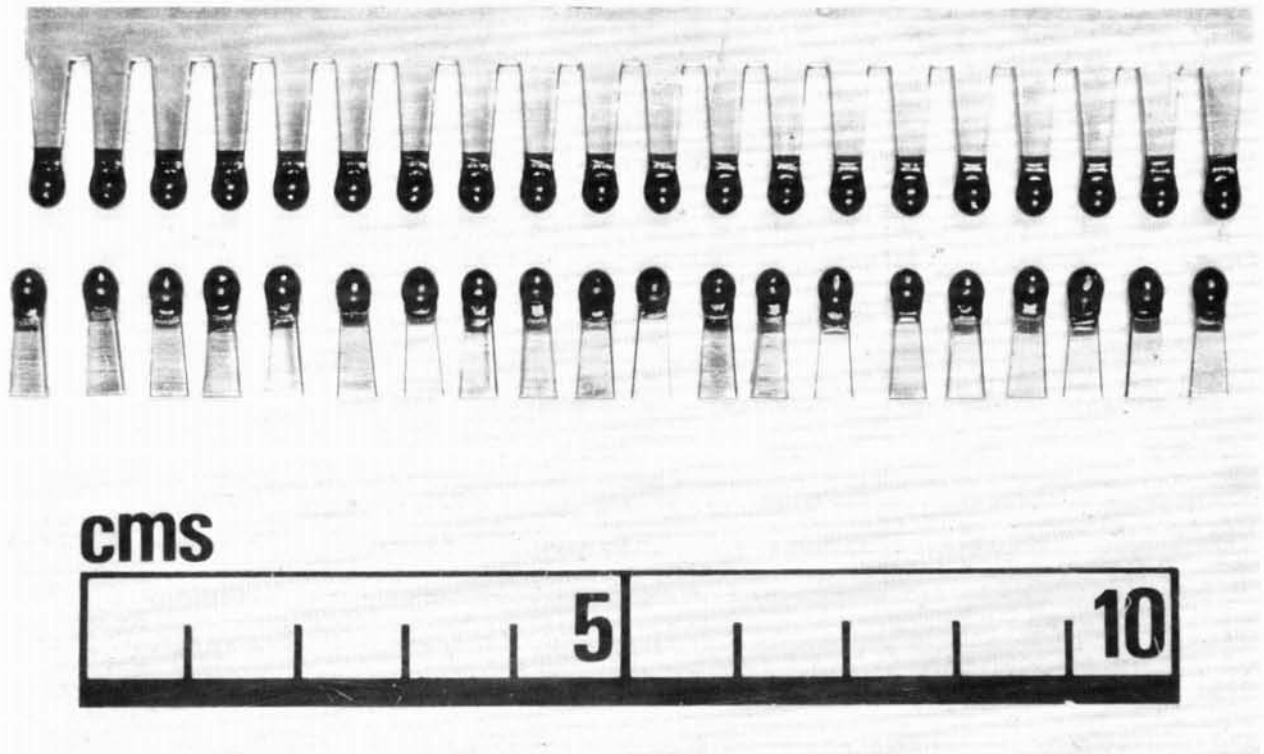
Figure 5 Cerium fusehead comb (above) and (below) cut fuseheads

42 The *Cerium fusehead combs*, however, were found to be packed in unauthorised and unsafe packagings. Samples of the tinned metal box containers taken from Ardeer were found to contain rust on the inner surfaces and holes in the corner. Samples from Le Maitre contained debris and loose composition which probably accumulated during transport from Ardeer. A total of 400 combs were packed in four layers with pressboard between into a tinned metal box. Two boxes each containing the equivalent of 8000 individual fuseheads were then packed with wood shavings in an outer wooden transit case. Gaps within the tins were filled with paper, a sheet of cardboard placed on top, and the lids taped into position. Further commentary on compliance with legal requirements is given in paragraphs 57 to 61.

43 Cerium fusehead composition was examined and found to be sensitive to impact and extremely sensitive to friction. Mixtures with small quantities of rust (1%) were found to be ten times more sensitive to impact than composition alone. No friction test was carried out on the mixture containing rust, but the rust particles would have been expected to increase the sensitiveness even further.

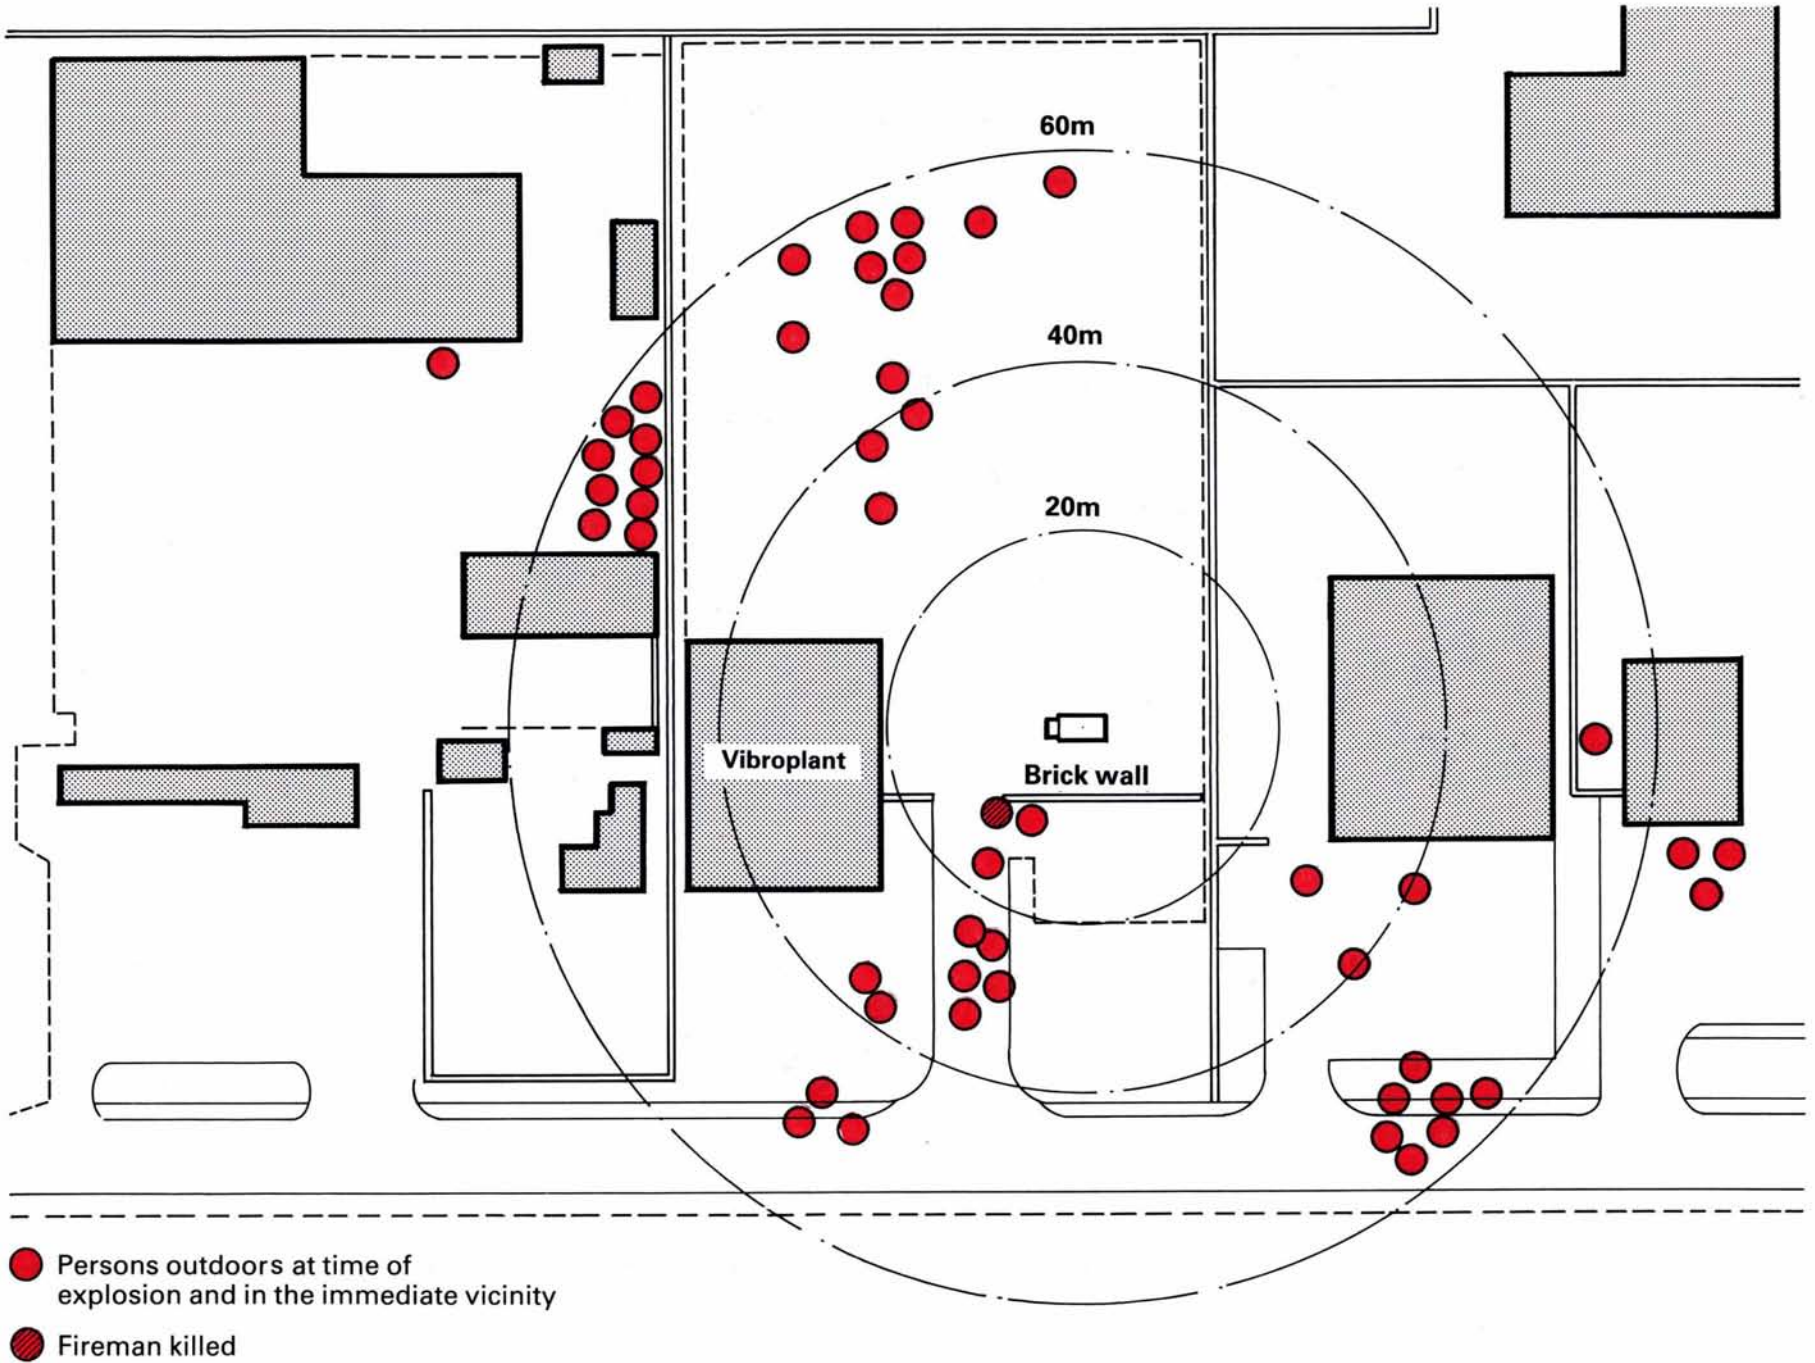
Figure 12 Plan showing people outdoors at time of explosion

15 In the period between the onset of fire and the explosion, numbers of people congregated outside near to the van (see Figure 12), and indoors against windows which overlooked the Vibroplant yard. Many of those outdoors were blown off their feet (Figure 13), sustaining hearing damage (Figure 14) or injuries by fragments. Those indoors received serious cuts from flying glass, injuries from falling, or from collapsing ceilings and associated debris. Most of the people who were kept in hospital had suffered cuts. It might have been expected that the delay between the onset of the fire and the final explosion would have given people the chance to move well away from the area. This did not happen.
