**RELEASE OF
CHEMICALS**
from
**INTERNATIONAL
BIOSYNTHETICS LTD**

A report of the investigation by the Health and Safety Executive
into the chemical emission from International Biosynthetics Ltd
on 7 December 1991

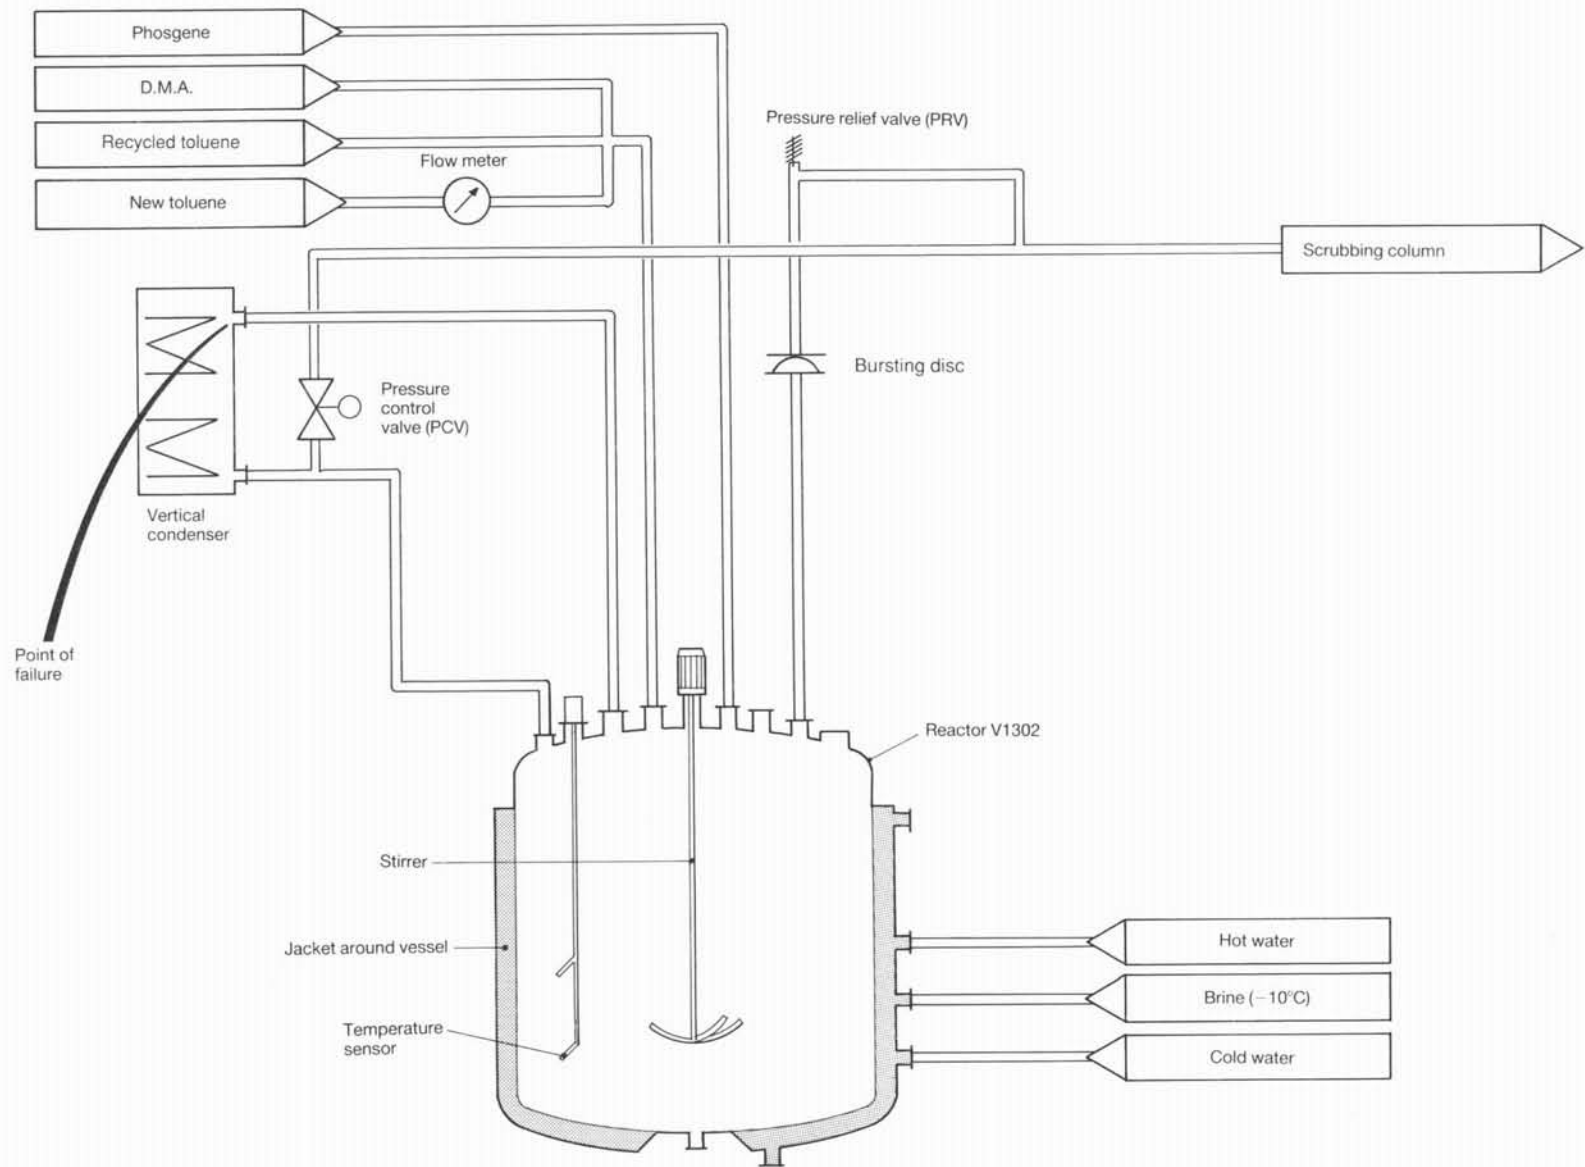
Figure 1 Phosgenation plant (simplified schematic diagram)

13 The part of the site used to carry out phosgenations, ie reactions involving phosgene, was known as Unit (U) 1000. The unit had two reaction vessels (known as reactors, and identified as V1301 and V1302) in which phosgenations were carried out, and further vessels for subsequent processes and solvent recovery/recirculation. The plant was computer-controlled from a control room situated at the edge of U1000. An outline of the plant is shown at Figure 1.

27 Each reactor was constructed from glass-lined carbon steel and was of 6.3 cubic metres volume. Each was provided with a stirrer to ensure agitation of the contents and a surrounding jacket through which chilled brine, hot water, or mains cold water could be circulated as required by the process. After the incident, it was found that a build-up of sediment in the jacket reduced its effective volume and impaired heat transfer.

28 There were no hardwired trips on the plant. V1301/2 were protected against overpressure by a pressure control valve and a bursting disc/pressure relief valve. Both pressure relief systems were connected to a scrubbing system to remove phosgene from the emissions. Each reactor was connected by a 250 mm diameter line to the top of a vertical condenser. Toluene was pumped to the reactor from a bulk storage tank, the quantity being measured by a flow meter. Alternatively toluene could also be recycled from within Unit 1000. Five phosgene detectors were positioned around the plant to detect any leaks.

31 Emergency water cooling was programmed to come on when reactor temperature exceeded 100°C but due to a programme error this happened only if the jacket was under 'hot water circulation' conditions. Under other conditions, as in this incident, when 100°C was reached the computer isolated the coolant flow, which then had to be manually switched back on. Although not contributing to this incident, this defect had potentially dangerous consequences.

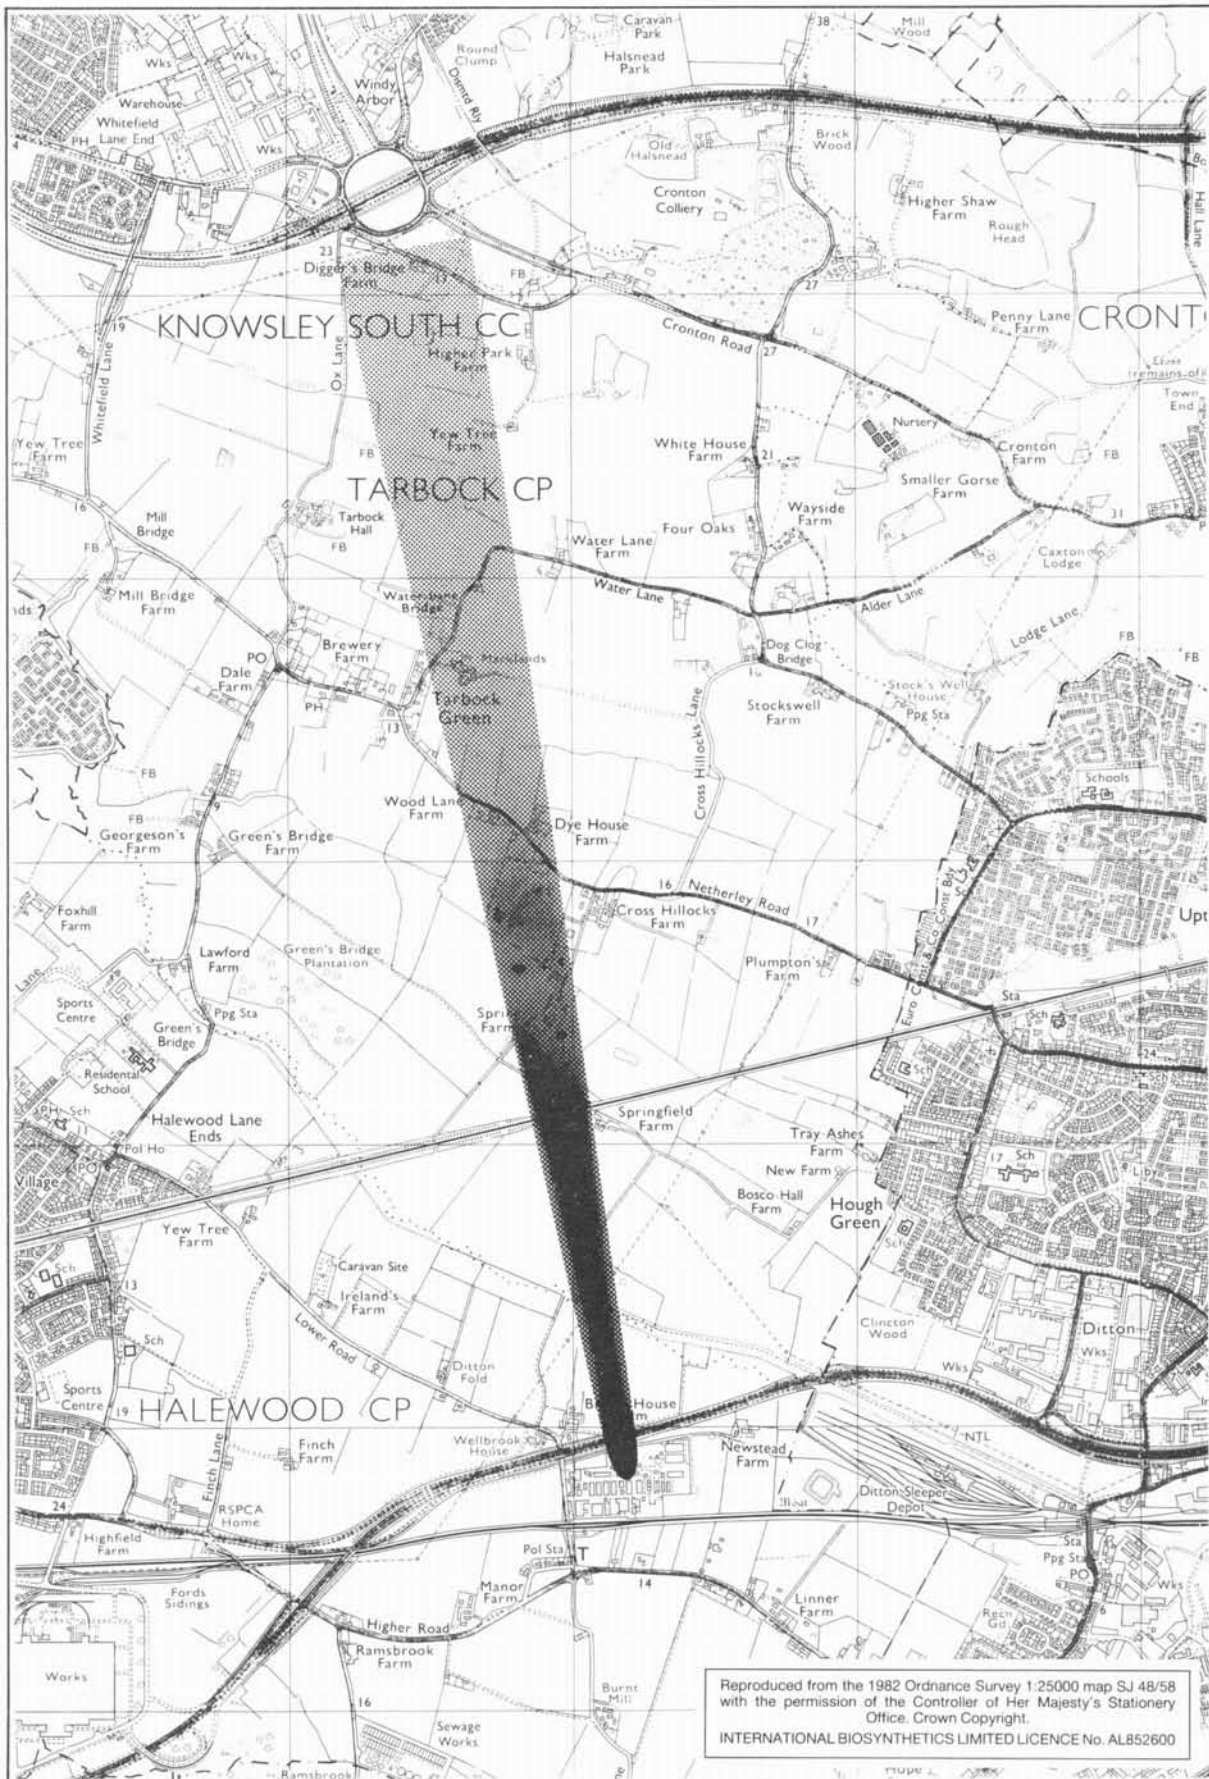
Figure 2 Path of cloud

52 The path of the reactor contents was visible as a result of the blue dye produced as a by-product of the reaction. Some properties, crops and vehicles were marked over an area 4 km long by 500 m wide (Appendix 1). The cloud caused considerable alarm to people who were engulfed by it, some suffering streaming eyes and coughing. Some 35 people reported to hospital for treatment, of whom ten were detained overnight for observation and three were referred to Alder Hey Childrens' Hospital. Almost 60 people were thought to have been affected by the cloud but there were no serious injuries or long term environmental effects. The Department of Public Health Medicine of St Helens and Knowsley Health Authority has carried out a descriptive study of exposure to the chemical plume and its report has been presented to the Authority.
