The fire at **HICKSON & WELCH LTD**

A report of the investigation by the
Health and Safety Executive into the fatal
fire at Hickson & Welch Ltd, Castleford
on 21 September 1992

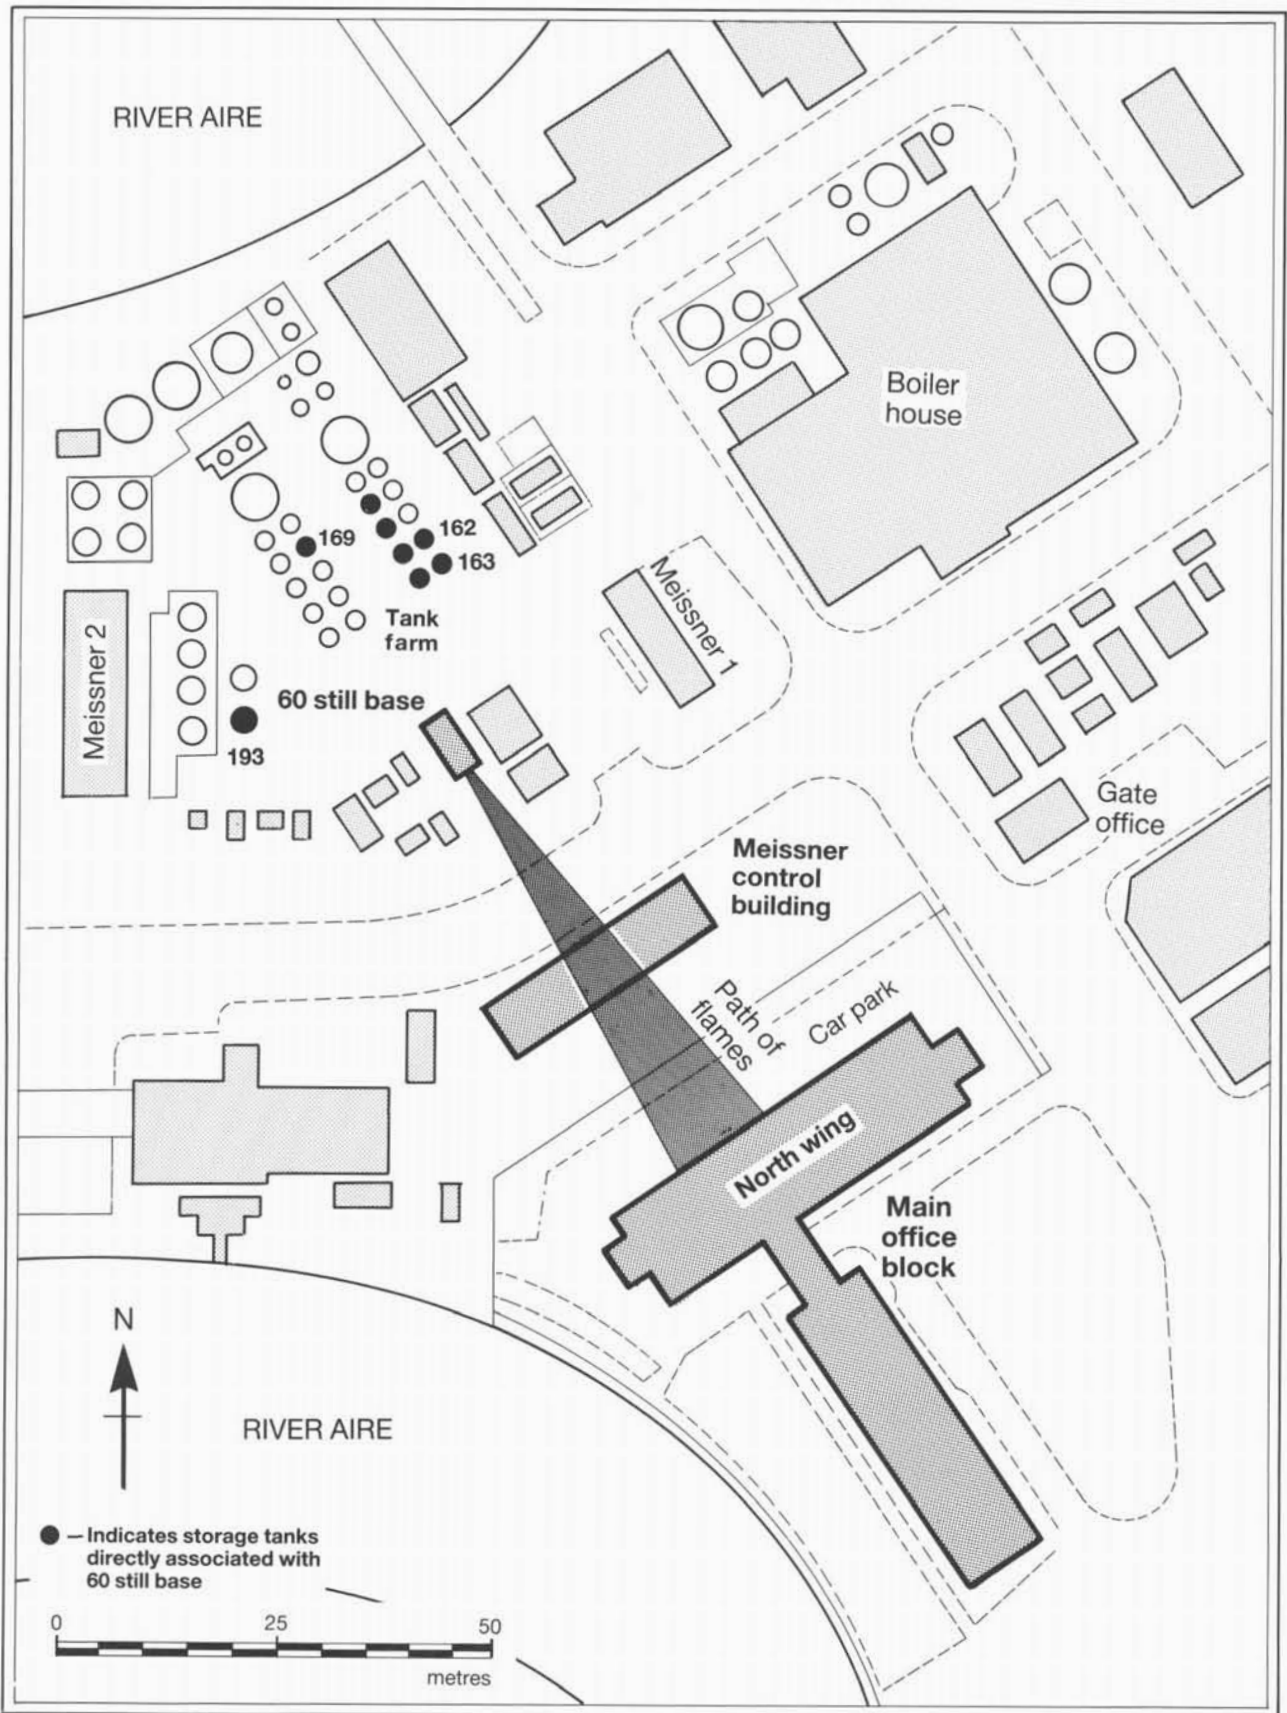
Figure 1 Plan of area around 60 still base showing path of the jet of flame

- 44 Most of the main fire damage was roughly in a V-shape emanating from the still base to an area where the flame hit the main office block 55 m away (Figure 1). However, there was some damage to scaffolding on the adjacent vertical still, caused by the jet which came out of the rear vent. The panel room beside the still base was scorched and windows were broken (Figure 8).

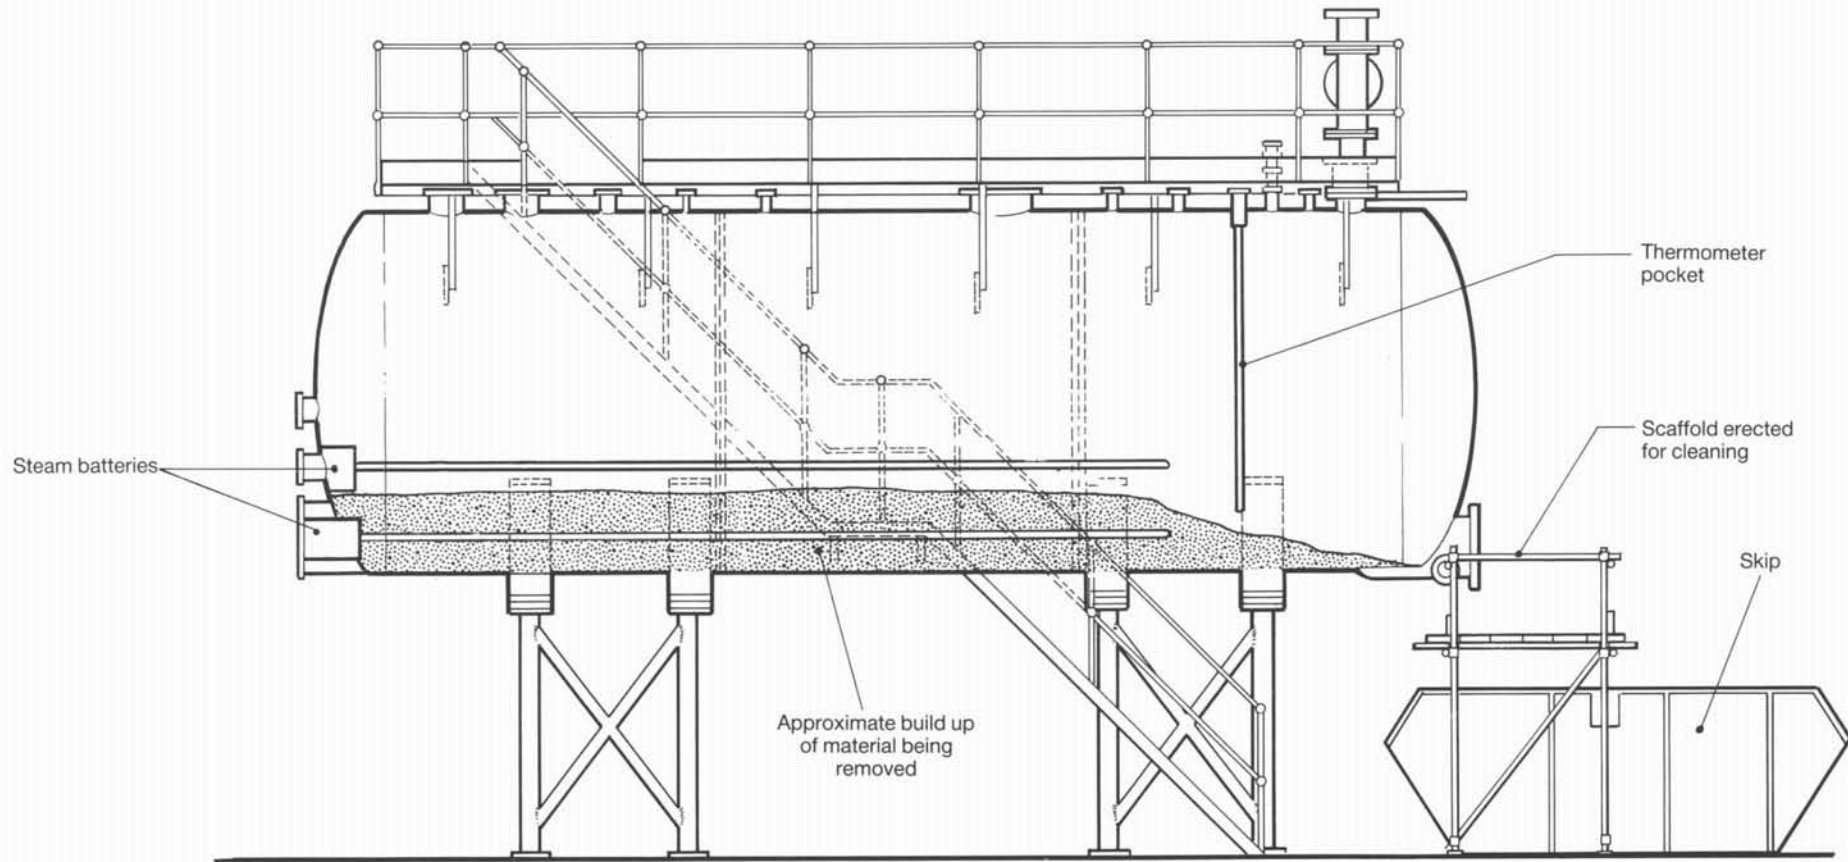
Figure 5 Longitudinal section of 60 still base showing estimated sludge accumulation and position of the thermometer pocket

- 26 Since it was first installed in the nitrotoluenes area, in 1961, 60 still base had never been opened for cleaning. Following the process change in 1988, manufacturing problems affecting quality and production were experienced in the nitrotoluenes area. The continuous stills were stripped and cleaned to remove residues and operators working on 60 still base began to notice and reported a build up of sludge in this vessel which was slowing the rate of distillation. Various estimates were made about the depth of sludge but the general consensus was that there was as much as 1820 litres equivalent to a uniform depth of about 10 cm (4 in). A senior employee had reported a depth of 29 cm (12 in) several months before the incident and on 21 September 1992, the day of the accident, the same employee dipped the still base on the instructions of his area manager. He used a metal dipping rod and estimated that the sludge was approximately 34 cm (14 in) deep.

- 27 After the incident management at the factory offered another theory to explain why this depth of sludge had accumulated. They suggested that ordinarily the sludge level in the still base ebbed and flowed leaving about 1820 litres in the still base between successive distillations. However, the company claimed that the higher than expected level noted on 21 September was attributable to material removed from whizzer oil storage tanks

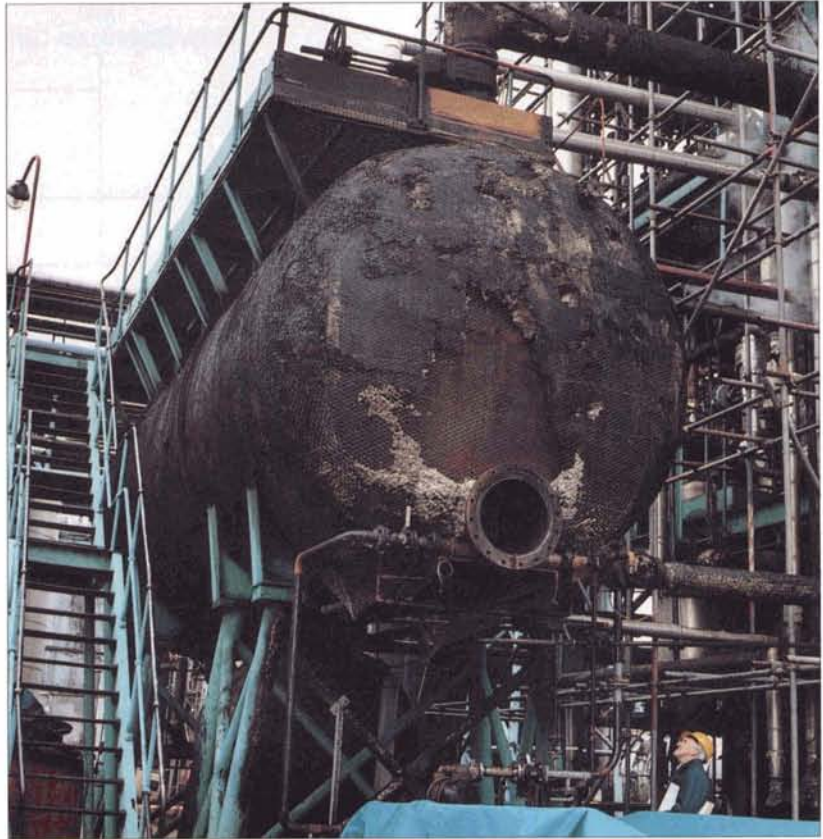
Figure 7 Photograph of the still base

- 1 At approximately 1.20 pm on 21 September 1992 a jet of flame erupted from a manway (access opening - see front cover and Figure 7) on the side of a batch still at the factory of Hickson & Welch Ltd, Wheldon Road, Castleford, West Yorkshire. The flame cut through an office/control building nearby killing two employees, David Wilby and George Potter, instantly. Three other employees in these offices sustained severe burns but escaped. Two later died in hospital (Neil Gafney and John Hopson).

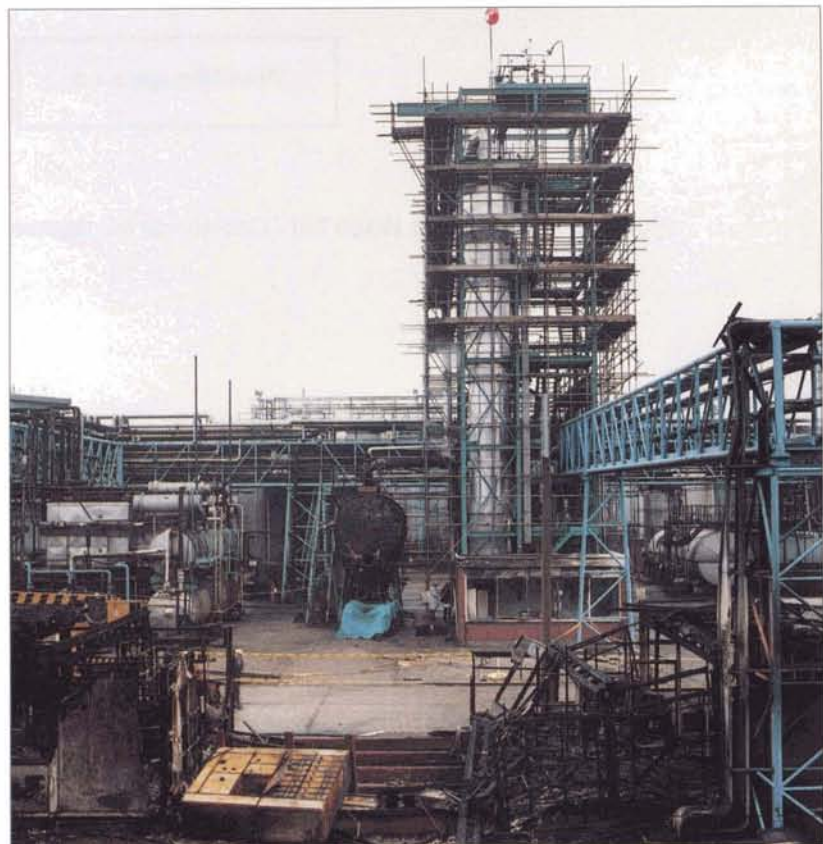
Figure 8 Photograph of the still base, associated plant and panel room

- 62 The scientific work undertaken by RLSD examined the thermal stability of substances processed in 60 still base and looked at the most likely sequence of events leading to ignition and the jet of flame. In addition, work was also undertaken to assess the duration and radiant output of the flame. The laboratory work was based on chemical samples taken from pipework and storage tanks up and downstream of the still base, although samples were also taken from the still and the skip. Flame duration work was based on fire damaged scaffold boards and painted barge boards from below the roof of the still control panel room (Figure 8).

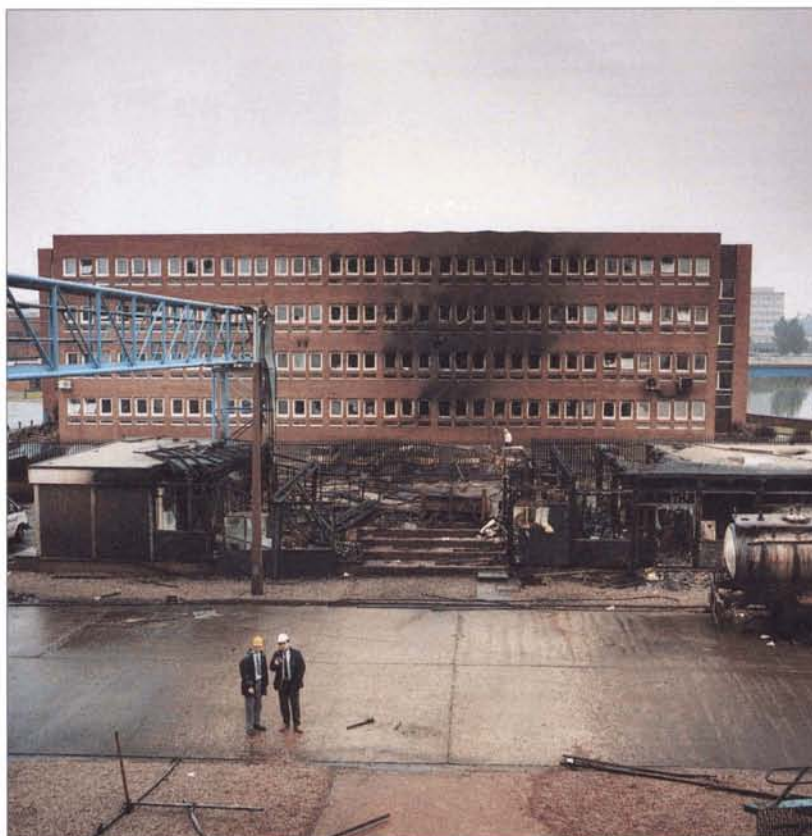
Figure 9 Photograph of roadway and buildings showing direction of the flame and scorch marks on roadway and main office block

- 45 The central section of the lightly constructed Meissner control building took the initial impact. An area approximately 6 m wide was consumed and to either side there was extensive fire damage (Figure 9 and Appendix 2). At the rear of the centre section a metal control panel weighing 1040 kg was found on its side.

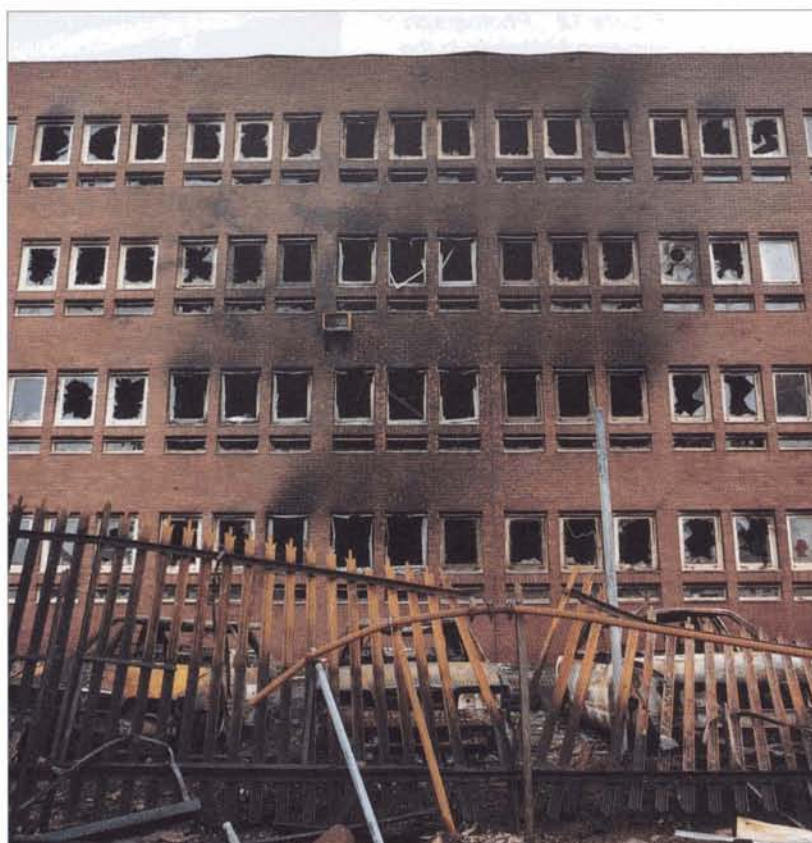
Figure 10 Photograph of the north wing of the main office building and adjoining car park

- 46 Behind the control building a section of palisade fence was demolished and a number of vehicles in the adjoining car park were gutted.
- 47 The exterior of the north wing of the four-storey main office building was scorched (see Figure 10). Brickwork in the centre of the fire damage zone was spalled, windows shattered and their frames melted. The most severe damage extended upwards to the second floor, immediately outside the big sales office, where employees were congregating after lunch. Flame and fire spread horizontally through the north facing offices but did not penetrate to the middle corridors which linked the means of escape (Appendix 3).

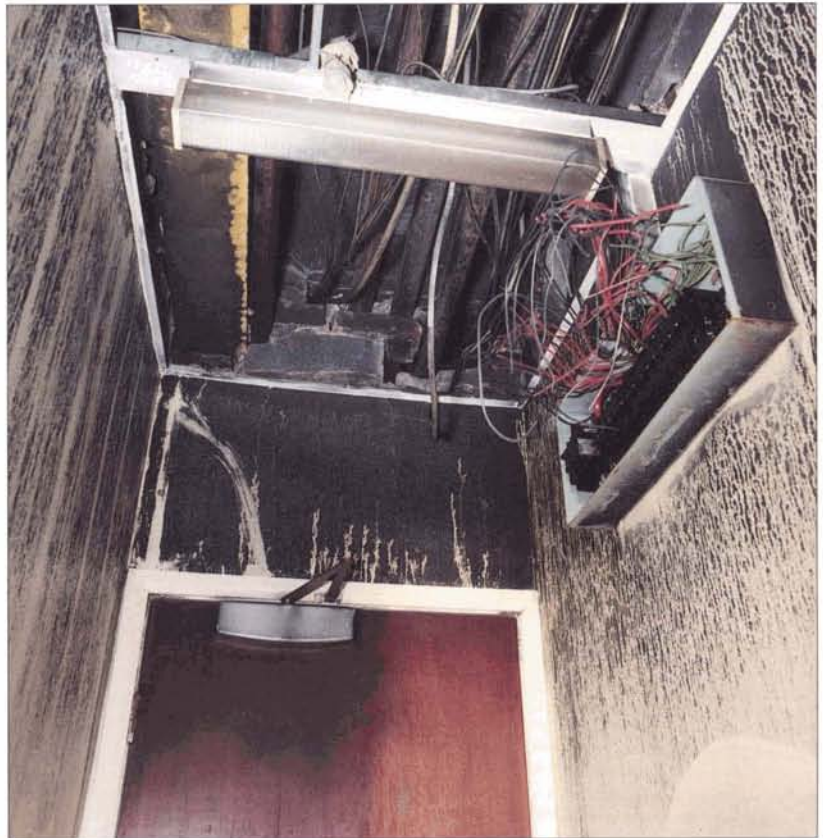
Figure 11 Photograph of smoke damage in the second floor women's toilets

jet flame had impacted, through protected route C into the toilet accommodation. These breaches and the false ceiling provided a direct path for smoke into the women's toilet. Smoke damage in the women's toilet is shown in Figure 11 and it was here that an office worker was found. The probable direction of smoke travel is illustrated in Figure 12 and Appendix 4.

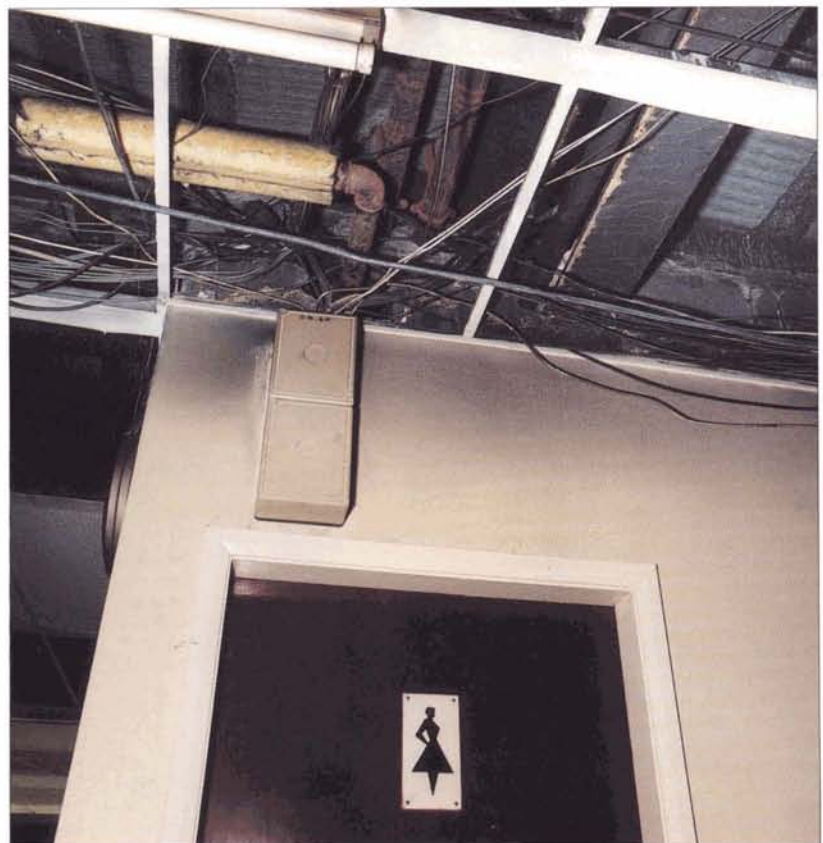
Figure 12 Photograph showing breaches in the fire-resisting enclosure around pipework and cables

- 106 With regard to the main office building reference has previously been made to breaches in the fire-resisting enclosure defined in the relevant section of the fire certificate as protected route C (paragraph 48). Investigation failed to reveal when these holes, which are illustrated in Appendix 4 and Figures 11 and 12, were made. They may have resulted from internal alterations and could have been left following installation of a new fire alarm system in 1990. It was concluded that if the required level of integrity of the protected route had been maintained rapid ingress of smoke into this and particularly the toilet accommodation might not have occurred.

- 115 Examination of the means of escape from the main office building revealed breaches in the fire-resisting structure on the second floor of protected route C. These breaches above a false ceiling led to smoke logging of the means of escape and also probably caused smoke logging in an adjacent toilet. Inspection and examination following alterations (see paragraph 106) and regular monitoring of performance standards prescribed in the firm's fire certificate should have been carried out by the company to ensure that the integrity of escape routes was maintained. Furthermore, although the company had formal procedures to provide and record 'fire training' (required by their fire certificate) there was no written confirmation that the fifth fatality, a temporary office worker, had been so trained.
