The explosion and fires at the Texaco Refinery, Milford Haven, 24 July 1994

A report of the investigation by the Health and Safety Executive into the explosion and fires on the Pembroke Cracking Company Plant at the Texaco Refinery, Milford Haven on 24 July 1994

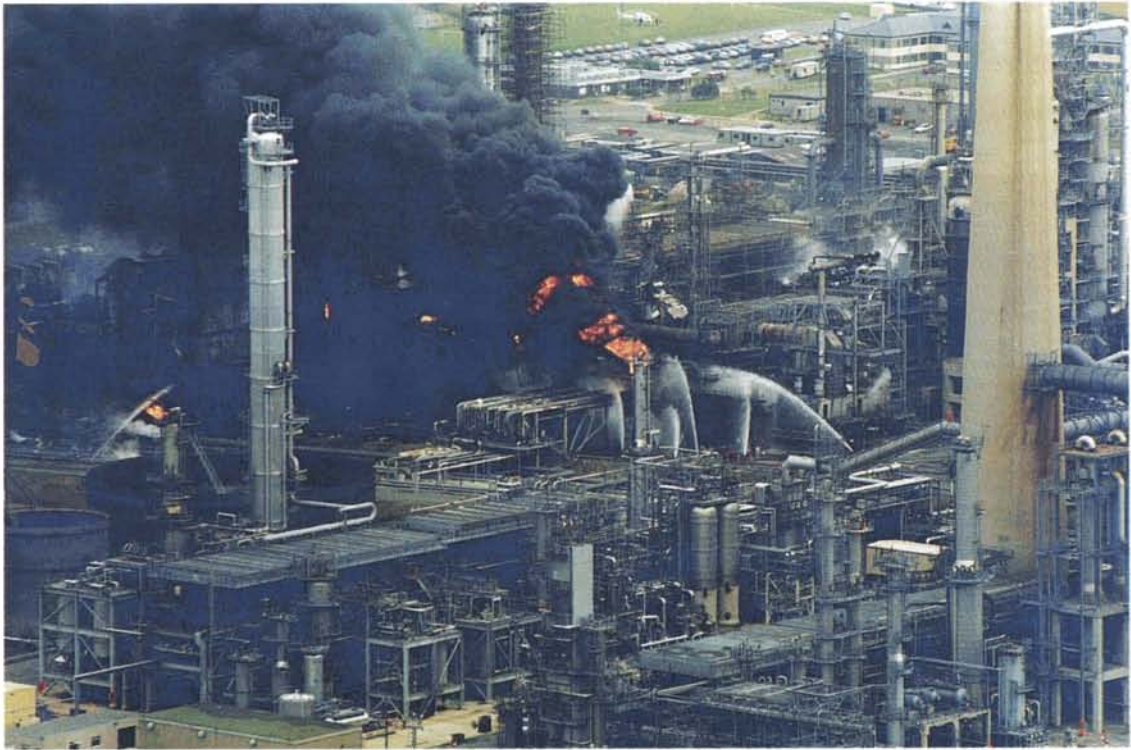
View from south west showing fire at flare drum (photograph courtesy of the Western Mail and Echo Ltd)

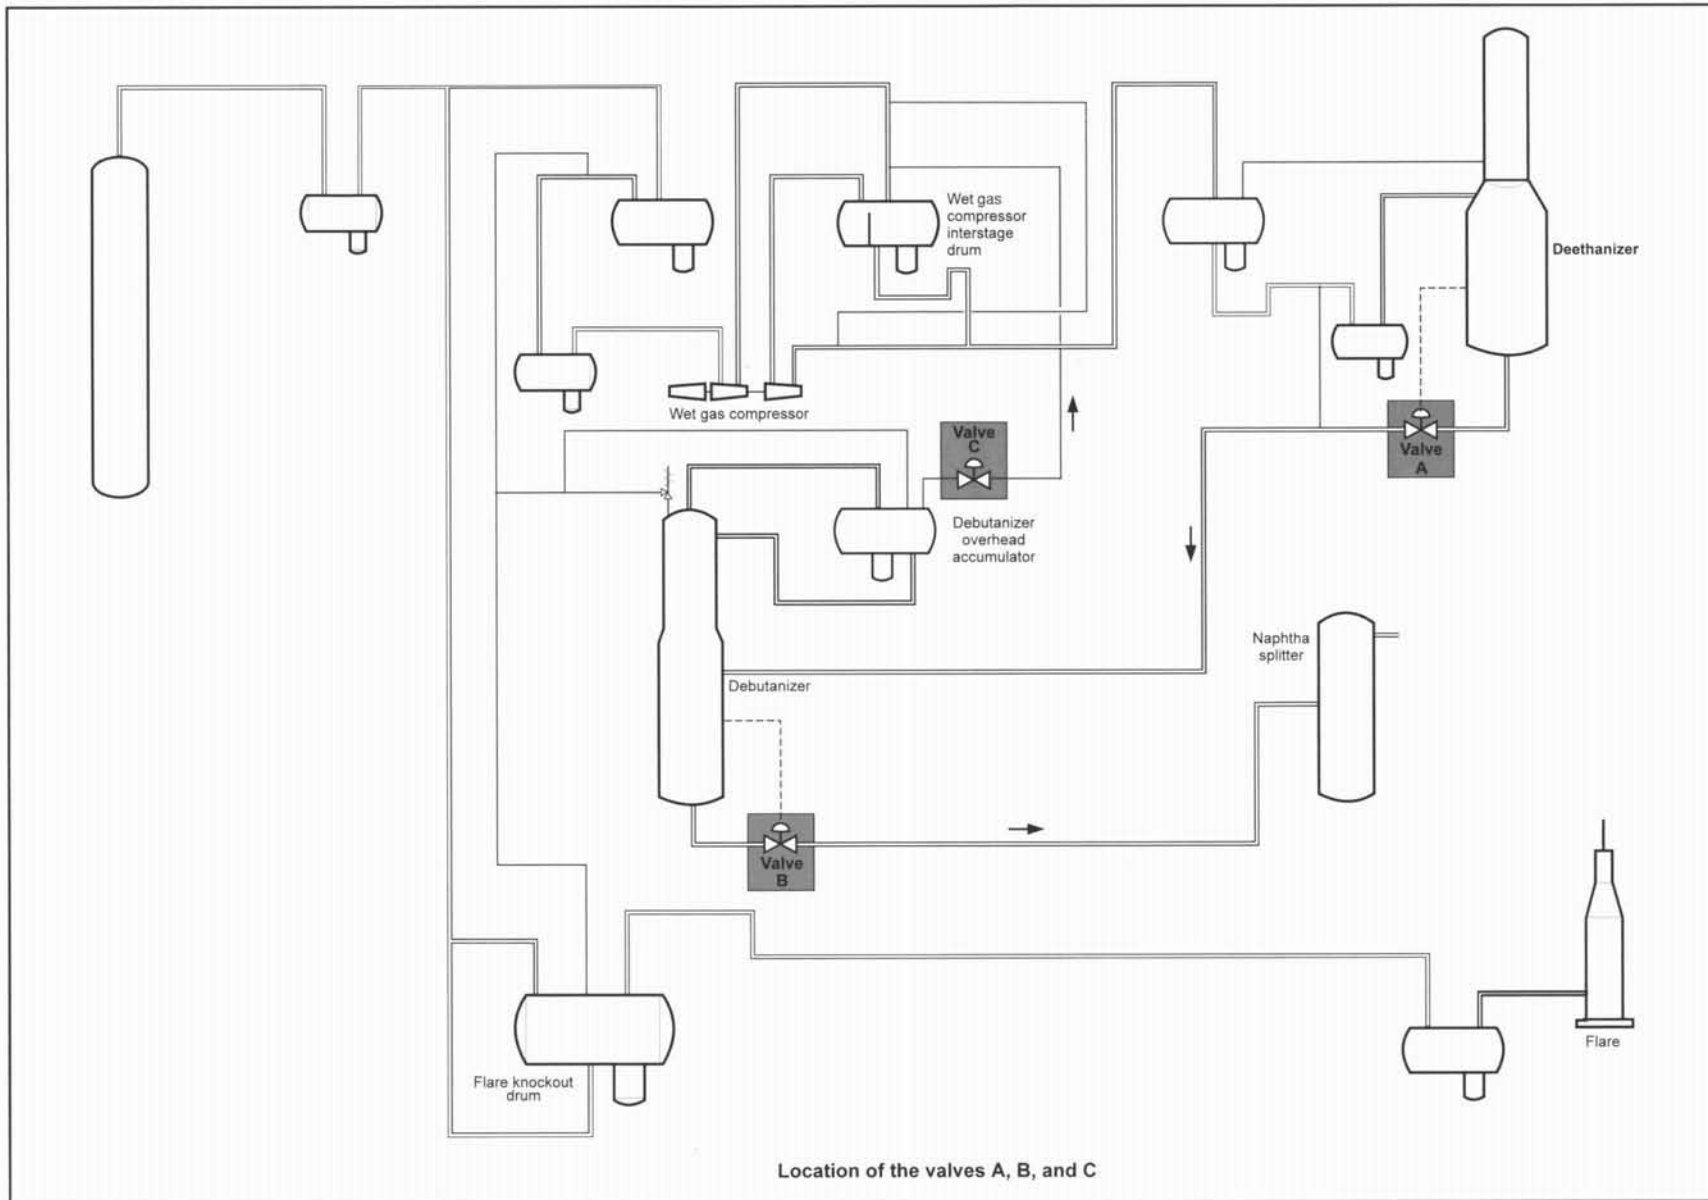
Figure 4 Simplified process diagram, to illustrate the interaction of the key valves and vessels that led to the incident (paragraphs 61 to 70)

- 62 Just before 09.00 hydrocarbon flow was lost to the deethaniser, a vessel in the FCCU recovery section where lower molecular weight vapour fractions are separated. This caused the liquid in the deethaniser to empty into the next vessel along, the debutaniser (with its associated overhead accumulator vessel), where further fractionation takes place. The system was set up to prevent total liquid loss in vessels so the falling liquid level in the deethaniser caused **valve A** to close, thus preventing hydrocarbon leaving the vessel. This had the knock-on effect of starving the debutaniser of feed so the falling liquid levels in this vessel caused the outlet valve, **valve B**, to close. The hydrocarbon in the debutaniser was now blocked-in. Although there was no additional flow into the debutaniser, the trapped liquid was still subject to heat. Therefore the liquid vaporised and the debutaniser pressure rose until it caused the pressure relief valves to open and the debutaniser to vent, for the first of three times, into the flare knock-out drum (intended to remove liquid from the hydrocarbon vapour stream passing from the relief valve to the flare stack) and on to the flare.

- 63 Shortly after 09.00 the liquid level in the deethaniser was restored so **valve A** opened and flow was restored to the debutaniser. This should have caused **valve B** to open and allow hydrocarbon out of the already pressurised debutaniser into the naphtha splitter. However, **valve B** never opened. Operators in the control room received signals wrongly indicating that it had opened and the debutaniser continued to fill with liquid while the naphtha splitter emptied.

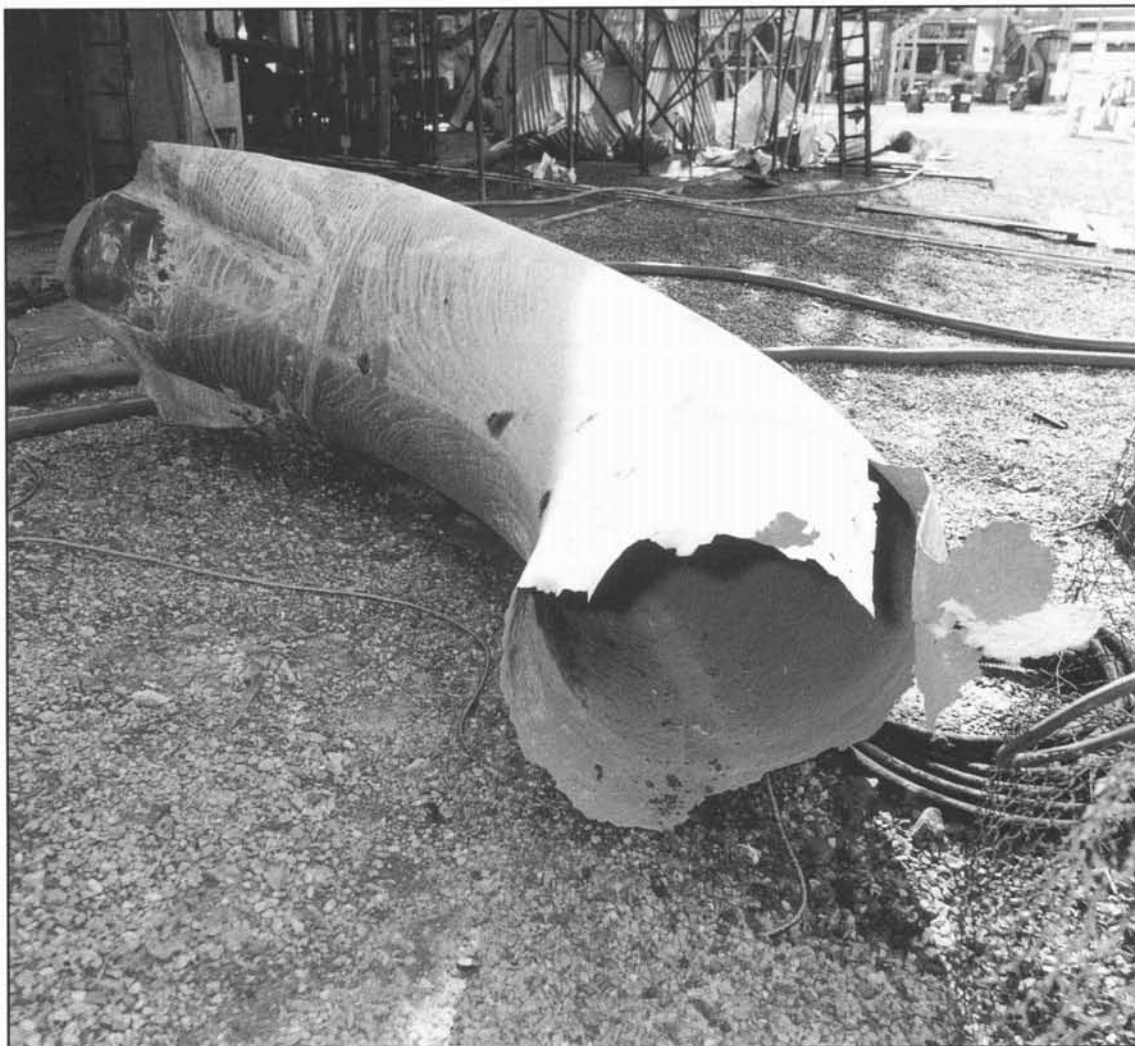
Figure 5 The 30 inch flare line elbow bend that failed and fell to the ground, releasing the hydrocarbon liquid and vapour

The flare drum outlet line which failed, releasing the hydrocarbon that exploded, was severely corroded. The presence of corrosion was known, but the full extent was not recognised because it had not been inspected at the point of failure, where there were inspection access difficulties. Although the flare line was clearly not properly maintained at this point, the investigation subsequently determined that this corrosion was not a direct cause of the incident.

remaining thicknesses down to 0.3 mm in the vicinity of the rupture were found when measurements of the failed elbow were made after the incident.

Inspection programmes for corrosion should err on the side of caution, with regard to the number and location of measurement sample points, concentrating on measurement sample points where greater (or less uniform) metal loss is foreseeable.

All foreseeable operational conditions, not just pressure, should be taken into account when setting the minimum acceptable thickness for pipe and vessel walls.

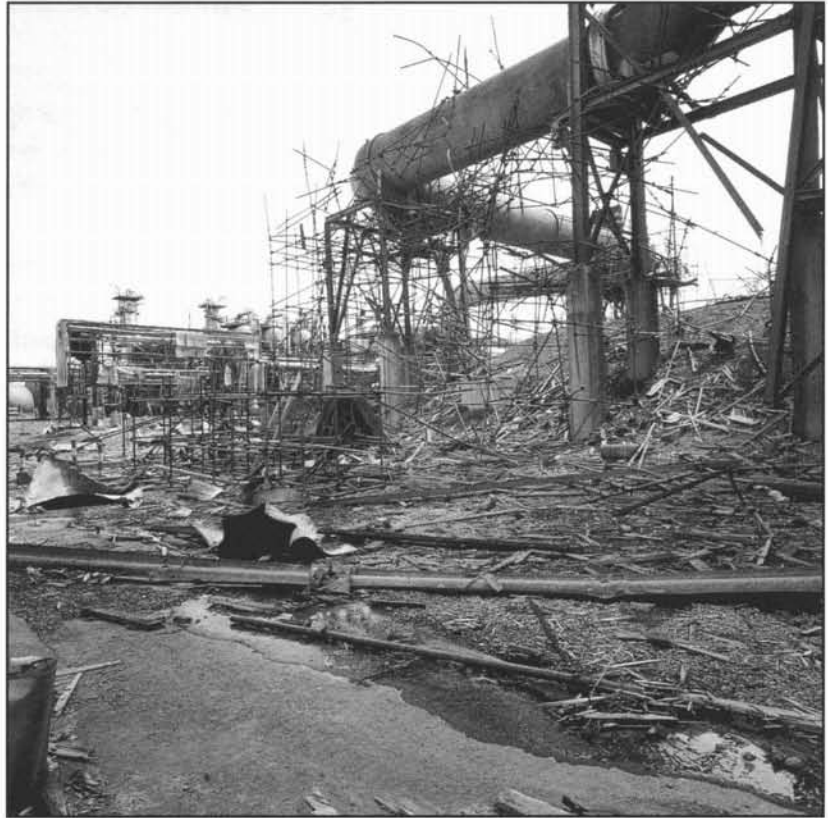
Figure 6 Widespread site damage caused by the explosion

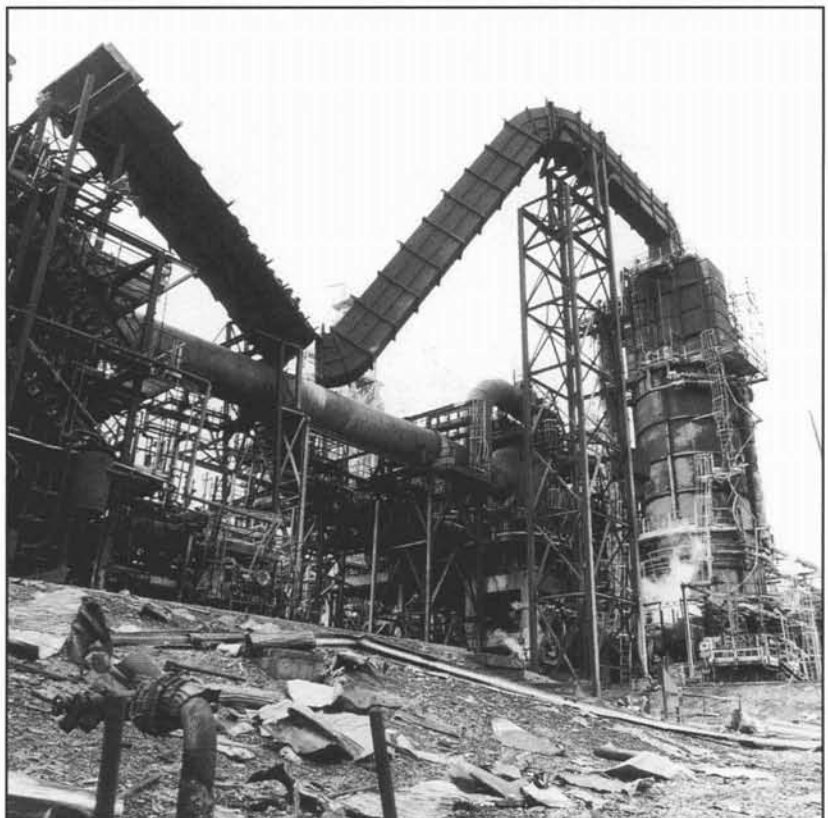
Figure 7 Some very large structures, such as the ducting weighing several tonnes shown here, were left balanced in dangerous positions after the explosion

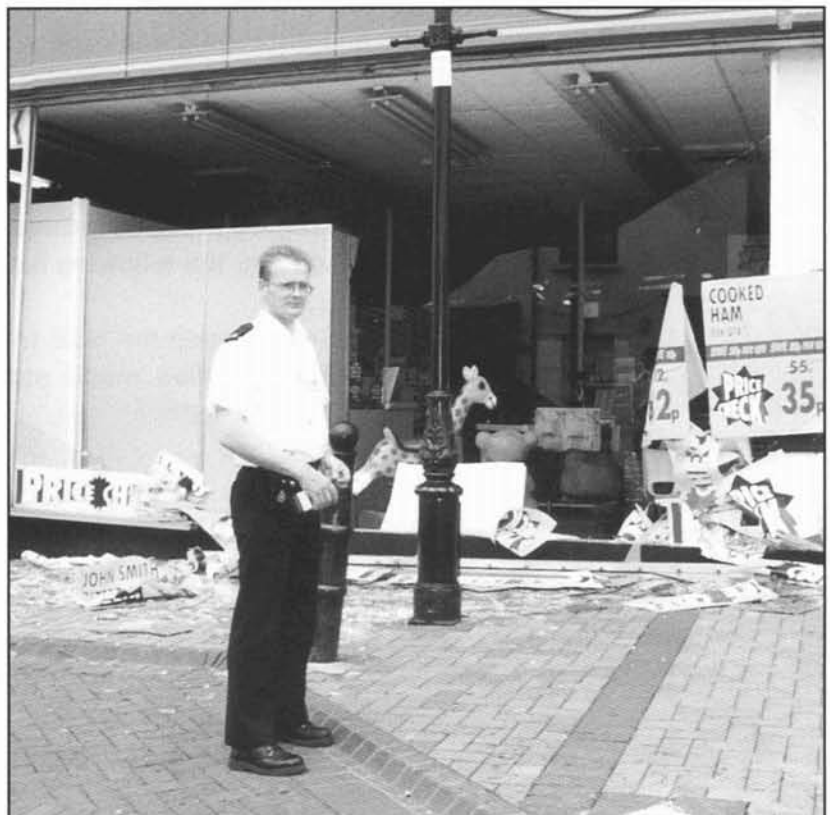
Figure 9 One of the damaged shop fronts in Milford Haven town, where many properties had glass broken

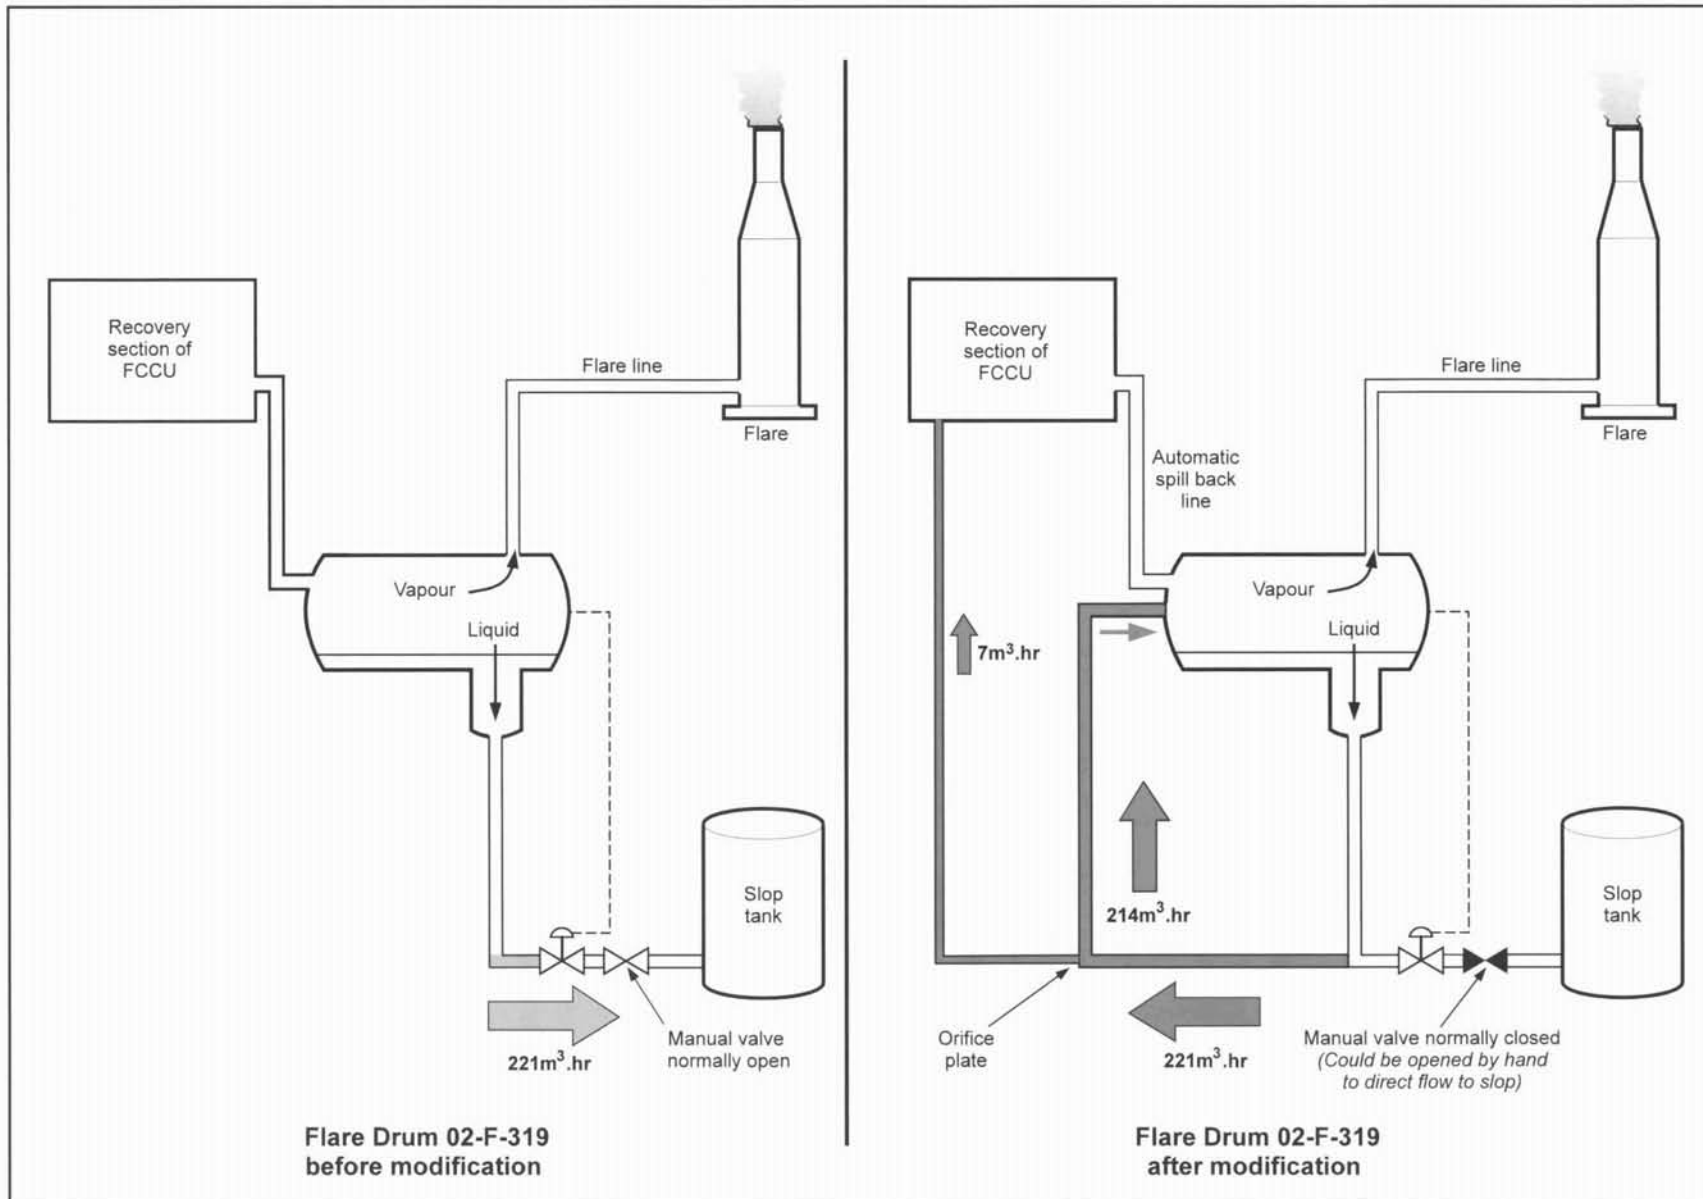
Figure 10 Diagrams to illustrate the modification to the flare knock-out drum pump-out arrangements

The flare drum is an important part of the flare system, which during the incident was relieving overfilled vessels. An earlier modification to its pump-out system severely reduced its automatic liquid handling capacity. It overflowed, causing liquid to enter an outlet designed for gas only. This consequently failed, releasing the flammable hydrocarbon in a cloud which exploded.

- 112 Following the 1991 modification the sour water and other liquid that collected in the boot (lowest) section of flare drum F-319, was pumped back into the recovery section of the FCCU. This meant that hydrocarbon accumulating in the unit, because of abnormal conditions, was just recycled instead of being removed to off-plot slops. It was possible to reconfigure the system to its original efficiency by manually opening valves so that the liquid could be pumped to slops, but this had rarely been done in practice (in fact there were no written procedures to show how or in what circumstances it should be done).

- 113 Figure 10 explains the arrangement of the modified pump-out facility in more detail. The need for the modified control and routing of material to slops followed a company initiative to reduce pumping to slops, on perfectly reasonable grounds of efficiency and environmental improvements. The drum level transmitter⁽¹⁾ was retained, but the level controller⁽⁵⁾ now operated a switching valve which could initiate the pump-start by directing steam to the pump turbine and stop the pump when the level dropped. This level control was designed to regulate the drum boot-levels of liquid and consequently the start and stop controls would normally regulate the removal of approximately 5 m³ of
