## Area Zoning, its role in a Risk-Based Process Safety Program for Combustible Dusts

Stephen Garner, PhD, PE, CFEI, Senior Engineer, Exponent (Corresponding Author)

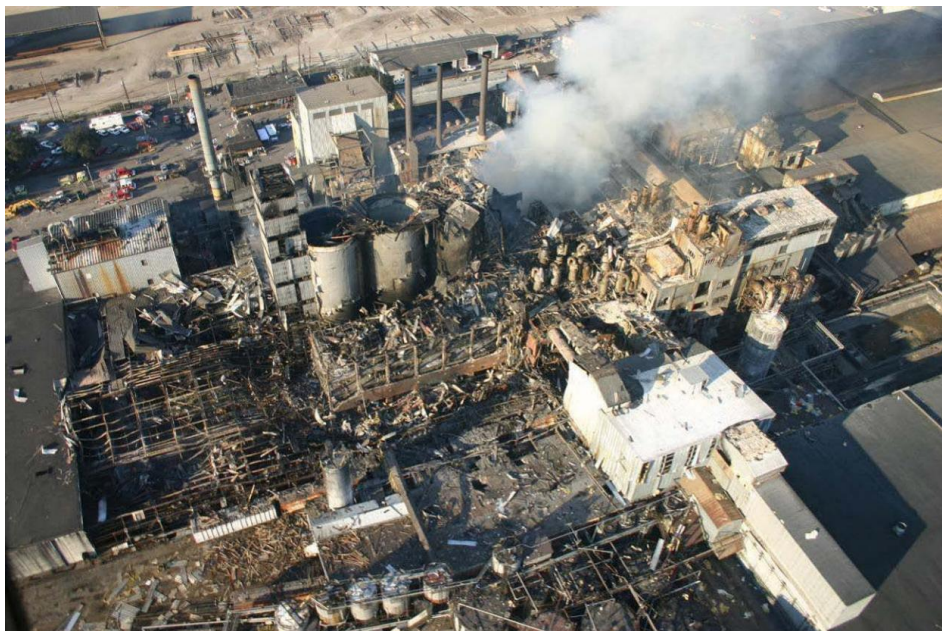
Figure 1. Imperial Sugar facility in Port Wentworth, Georgia following the February 7, 2008 explosion.

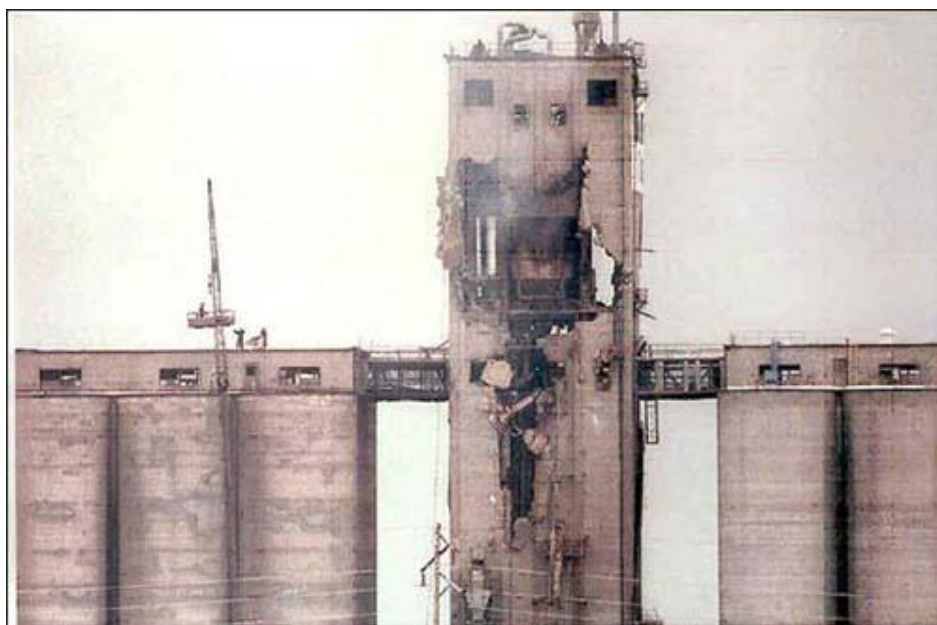
Figure 2. DeBruce Grain Elevator explosion, June 8, 1998.

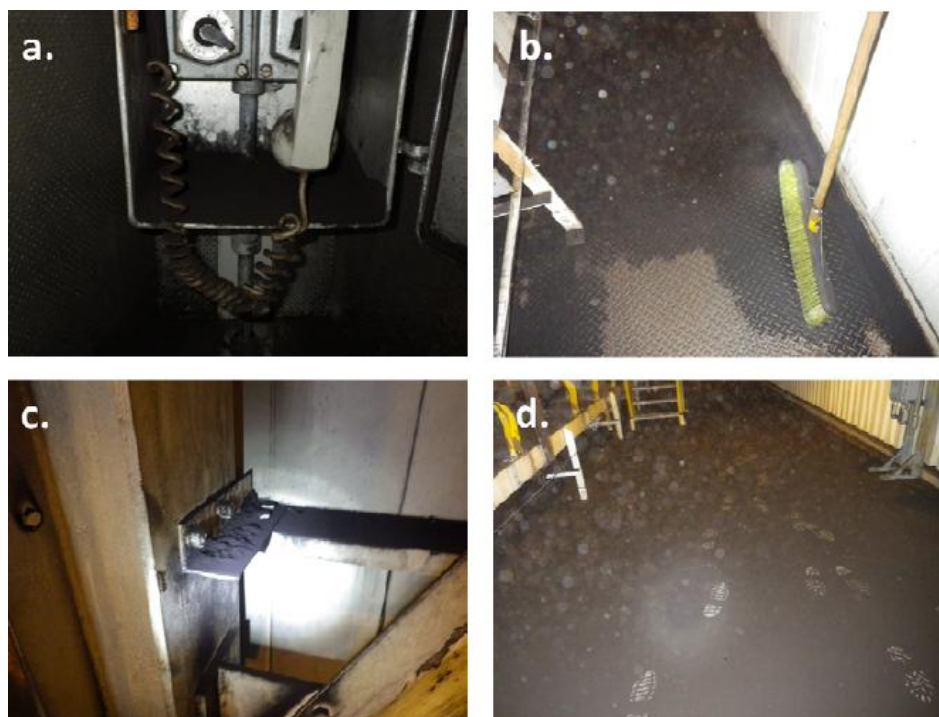
During Exponent's investigation, accumulated coal dust was observed throughout the coal galleries. The plant owner granted access to one of the non-incident power units which provided an example of the typical levels of coal dust accumulation expected during normal plant operation. Despite that the examined non-incident power unit had been cleaned 36 hours prior to the inspection, dust accumulation was observed on the floor and elevated surfaces within the coal handling system as illustrated in Figure 3. Additionally, an earlier report produced during the course of the investigation included a discussion of the importance of dust collection and suppression systems, and noted that the amount of dust in the air indicated the dust collection system was either not working or inadequate. The report also recommended the wash down of the coal handling areas needed to be more consistent and thorough. The amount of dust observed during the inspection indicated that poor housekeeping contributed to the accumulation of combustible dust within the units and that numerous deficiencies reported to the plant prior to the explosion had not been addressed.

Figure 3. Examples of dust accumulation of surfaces with the coal handling system.

As illustrated in Figure 3, fugitive coal dust accumulations were present throughout the facility and were being transported from zoned areas of a facility to an unzoned or under zoned area of the facility. The level of accumulations observed throughout the facility were likely a result of a combination of factors that included poor housekeeping, equipment maintenance, and the age of the operational equipment within the facility. Based on the observable dust accumulation in Figure 3, it may have been necessary to re-evaluate the zoning of areas within the facility and to complete a facility level evaluation and audit of the currently installed electrical equipment.

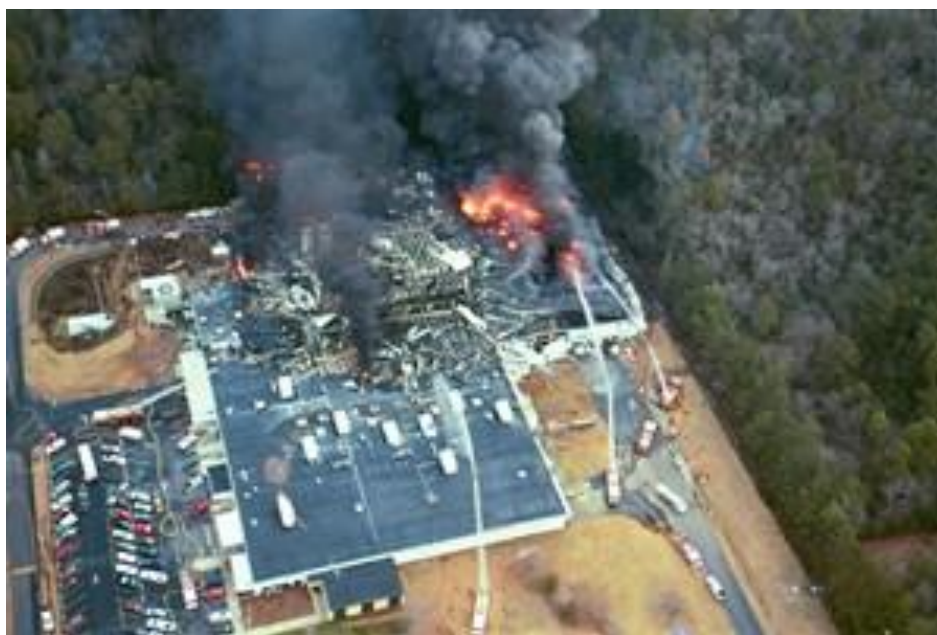
Figure 4. Aerial photograph of the facility post-explosion.

According to the US CSB contributing factors to the incident included a failure to recognize combustible dust hazard despite a process change that triggered a New Material Safety Review. This failure to recognize the combustible dust hazard resulted in the use of electrical equipment that was not appropriately rated for the specific area. Additionally, the facility did not have a protocol for identifying dust accumulation above the suspended ceiling, as recommended in this application. CSB observed that these accumulations were not readily apparent and were missed by several safety inspectors, including NIOSH two months before the explosion. Thus, depending on the actual ignition scenario, recognition of combustible dust hazard in conjunction with good engineering practices surrounding electrical classification may have prevented this incident
