How stressed is your facility?

Trish Kerin, Director, IChemE Safety Centre, Level 7, 455 Bourke St Melbourne, Australia

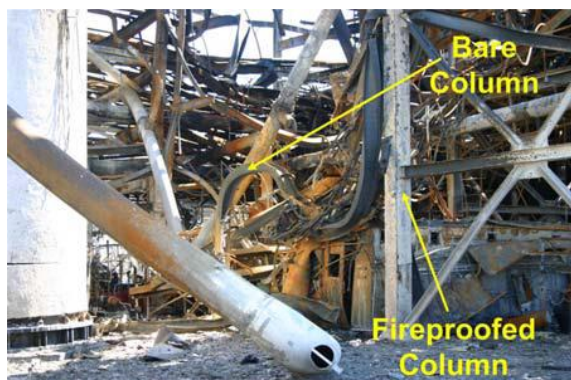
In 2005 at the Point Comfort Olefins II unit, a trailer being towed by a fork truck collided with a small drain valve on a liquid propylene system. This resulted in a leak that formed a vapour cloud and resulted in an unconfined low-speed deflagration. While the initial triggering event of damaging the valve assembly is not strictly a stress related incident, (although the impact resulted in sufficient force being applied to damage the valve) of more interest here is the impact of thermal radiation from the fire on unprotected structural steel (CSB, 2006). As was stated above, radiant heat applied to structure steel lowers its yield strength, thus making it "weaker" and not able to withstand the expected stress imposed. In this incident the collapse of plant from structure steel failure increased the magnitude of the incident. Figure 2 shows how a bare steel column and a fireproofed column fared in the fire.

Figure 2. Difference between bare and fireproofed columns (CSB, 2006)

Considering Formosa Point Comfort, some parts of structural steel had been fire proofed but others had not. It is unclear why this had occurred, though it may be reasonable to question if there was a fundamental understanding of the risk of fire relative to the location of the structural members. Without adequate assessment by competent people, correct decisions, in this instance on fire proofing, were not be made.

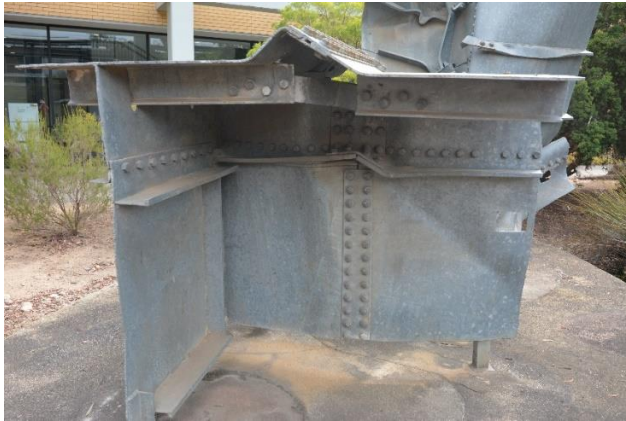
Figure 4. Shows a similar buckle that developed after the kentledges were loaded

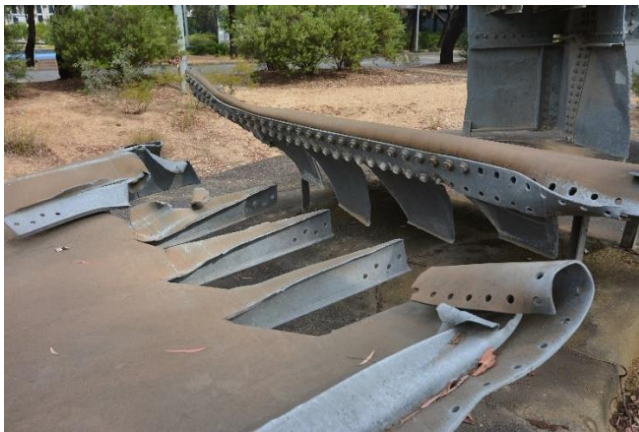
Figure 5. Shows the failure point on the flange where they had started to remove some bolts to release the stress causing the buckling. This was the failure point on the span that collapsed.

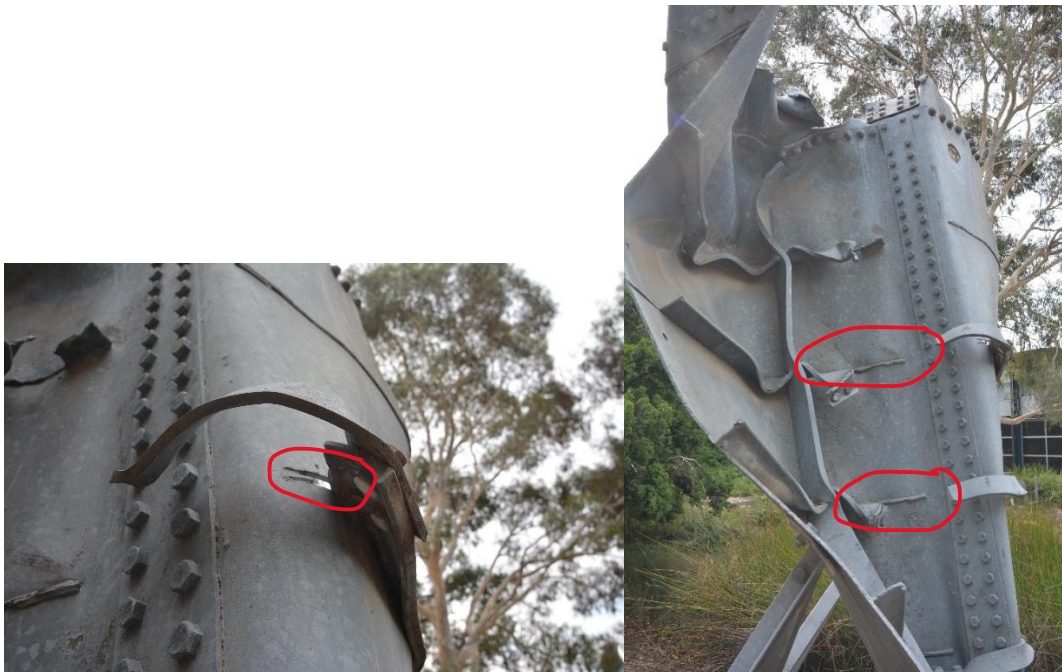
Figure 6. Section of the inner web of the box girder, shows where the steel was torn, mainly in the heat affected zones around welds.

The West Gate Bridge suffered from a lack of understanding of the forces not only during construction but also during operation. Cable-stayed steel box girder bridges were relatively new at this time, and there were a number of failures around the world. The errors made in this instance stem back to the engineers not being able to prove something was unsafe, when they should have turned their efforts to proving it was safe.

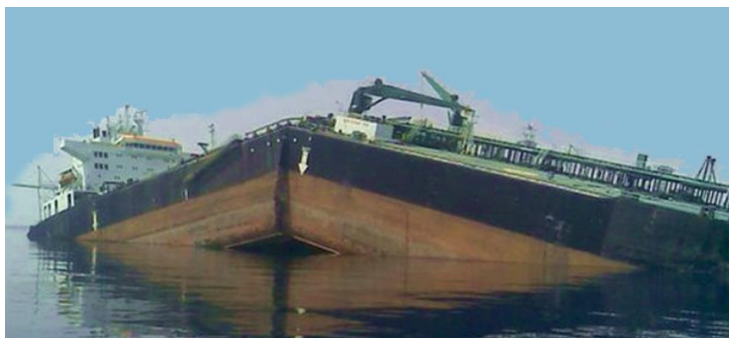
Sea tankers are constructed of steel plates, with internal ribs for structural stability. When a tanker is loaded or unloaded, the plates and structure are placed under a changing stress situation. Loading or unloading of a tanker, including ballasting, needs to be undertaken in a certain order to prevent hogging of the vessel. This is when a ship curves up in the centre and sags at each end and can result in a physical breaking of the hull. The hogging is usually a result of excess stress occurring in the structure and can be caused by uneven loads. For example, a ship should be unloaded from the tanks closed to the bow and then work back, this will result in the bow rising from the water. If the tanks in the middle of ship are unloaded first, these tanks will be more buoyant and try to rise in the water, but with the weight remaining the same in the bow and at the stern (with the engine weight) the centre is forced up with either end pulling down. This follows the principle of Euler-Bernoulli beam theory. Refer to Figure 7 showing a tanker with a broken back from hogging.

Figure 7. Tanker with broken back from hogging (Munro, 2017)

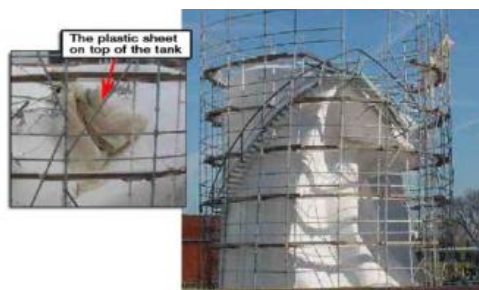
In a similar manner to sea tankers, there is an assumption that because the vessel is constructed from steel, it must be strong. This assumption has been proved wrong time and again as we see items as simple as a plastic bag over a vent or a blocked flame arrestor on an atmospheric tank result in the sucking in of the tank when a slight vacuum is applied. Most atmospheric storage tanks may be able to withstand a positive pressure of around 2kPa, but can only withstand a vacuum of approximately 0.6 kPa (Kletz, 1999). This equates to a water column of approximately 6cm only. The application of a small amount of stress on the tank can result in its catastrophic failure. Refer Figure 8 showing a tank that has been sucked in.

Emptying of a vertical tank

Figure 8. Vertical storage tank sucked in (QAQC Construction, 2019)
