Investigation into a Microbiologically Induced Corrosion (MIC) failure of an onshore pipeline

Keith Birkitt CEng MWeldI FIMMM, Principal Materials Engineer
Aneta Nemcova PhD MIMMM, Materials Scientist
Ian Chapman CEng MIMechE, Mechanical Engineering Inspector

16th, 17th, 18th November 2021

Hazards31

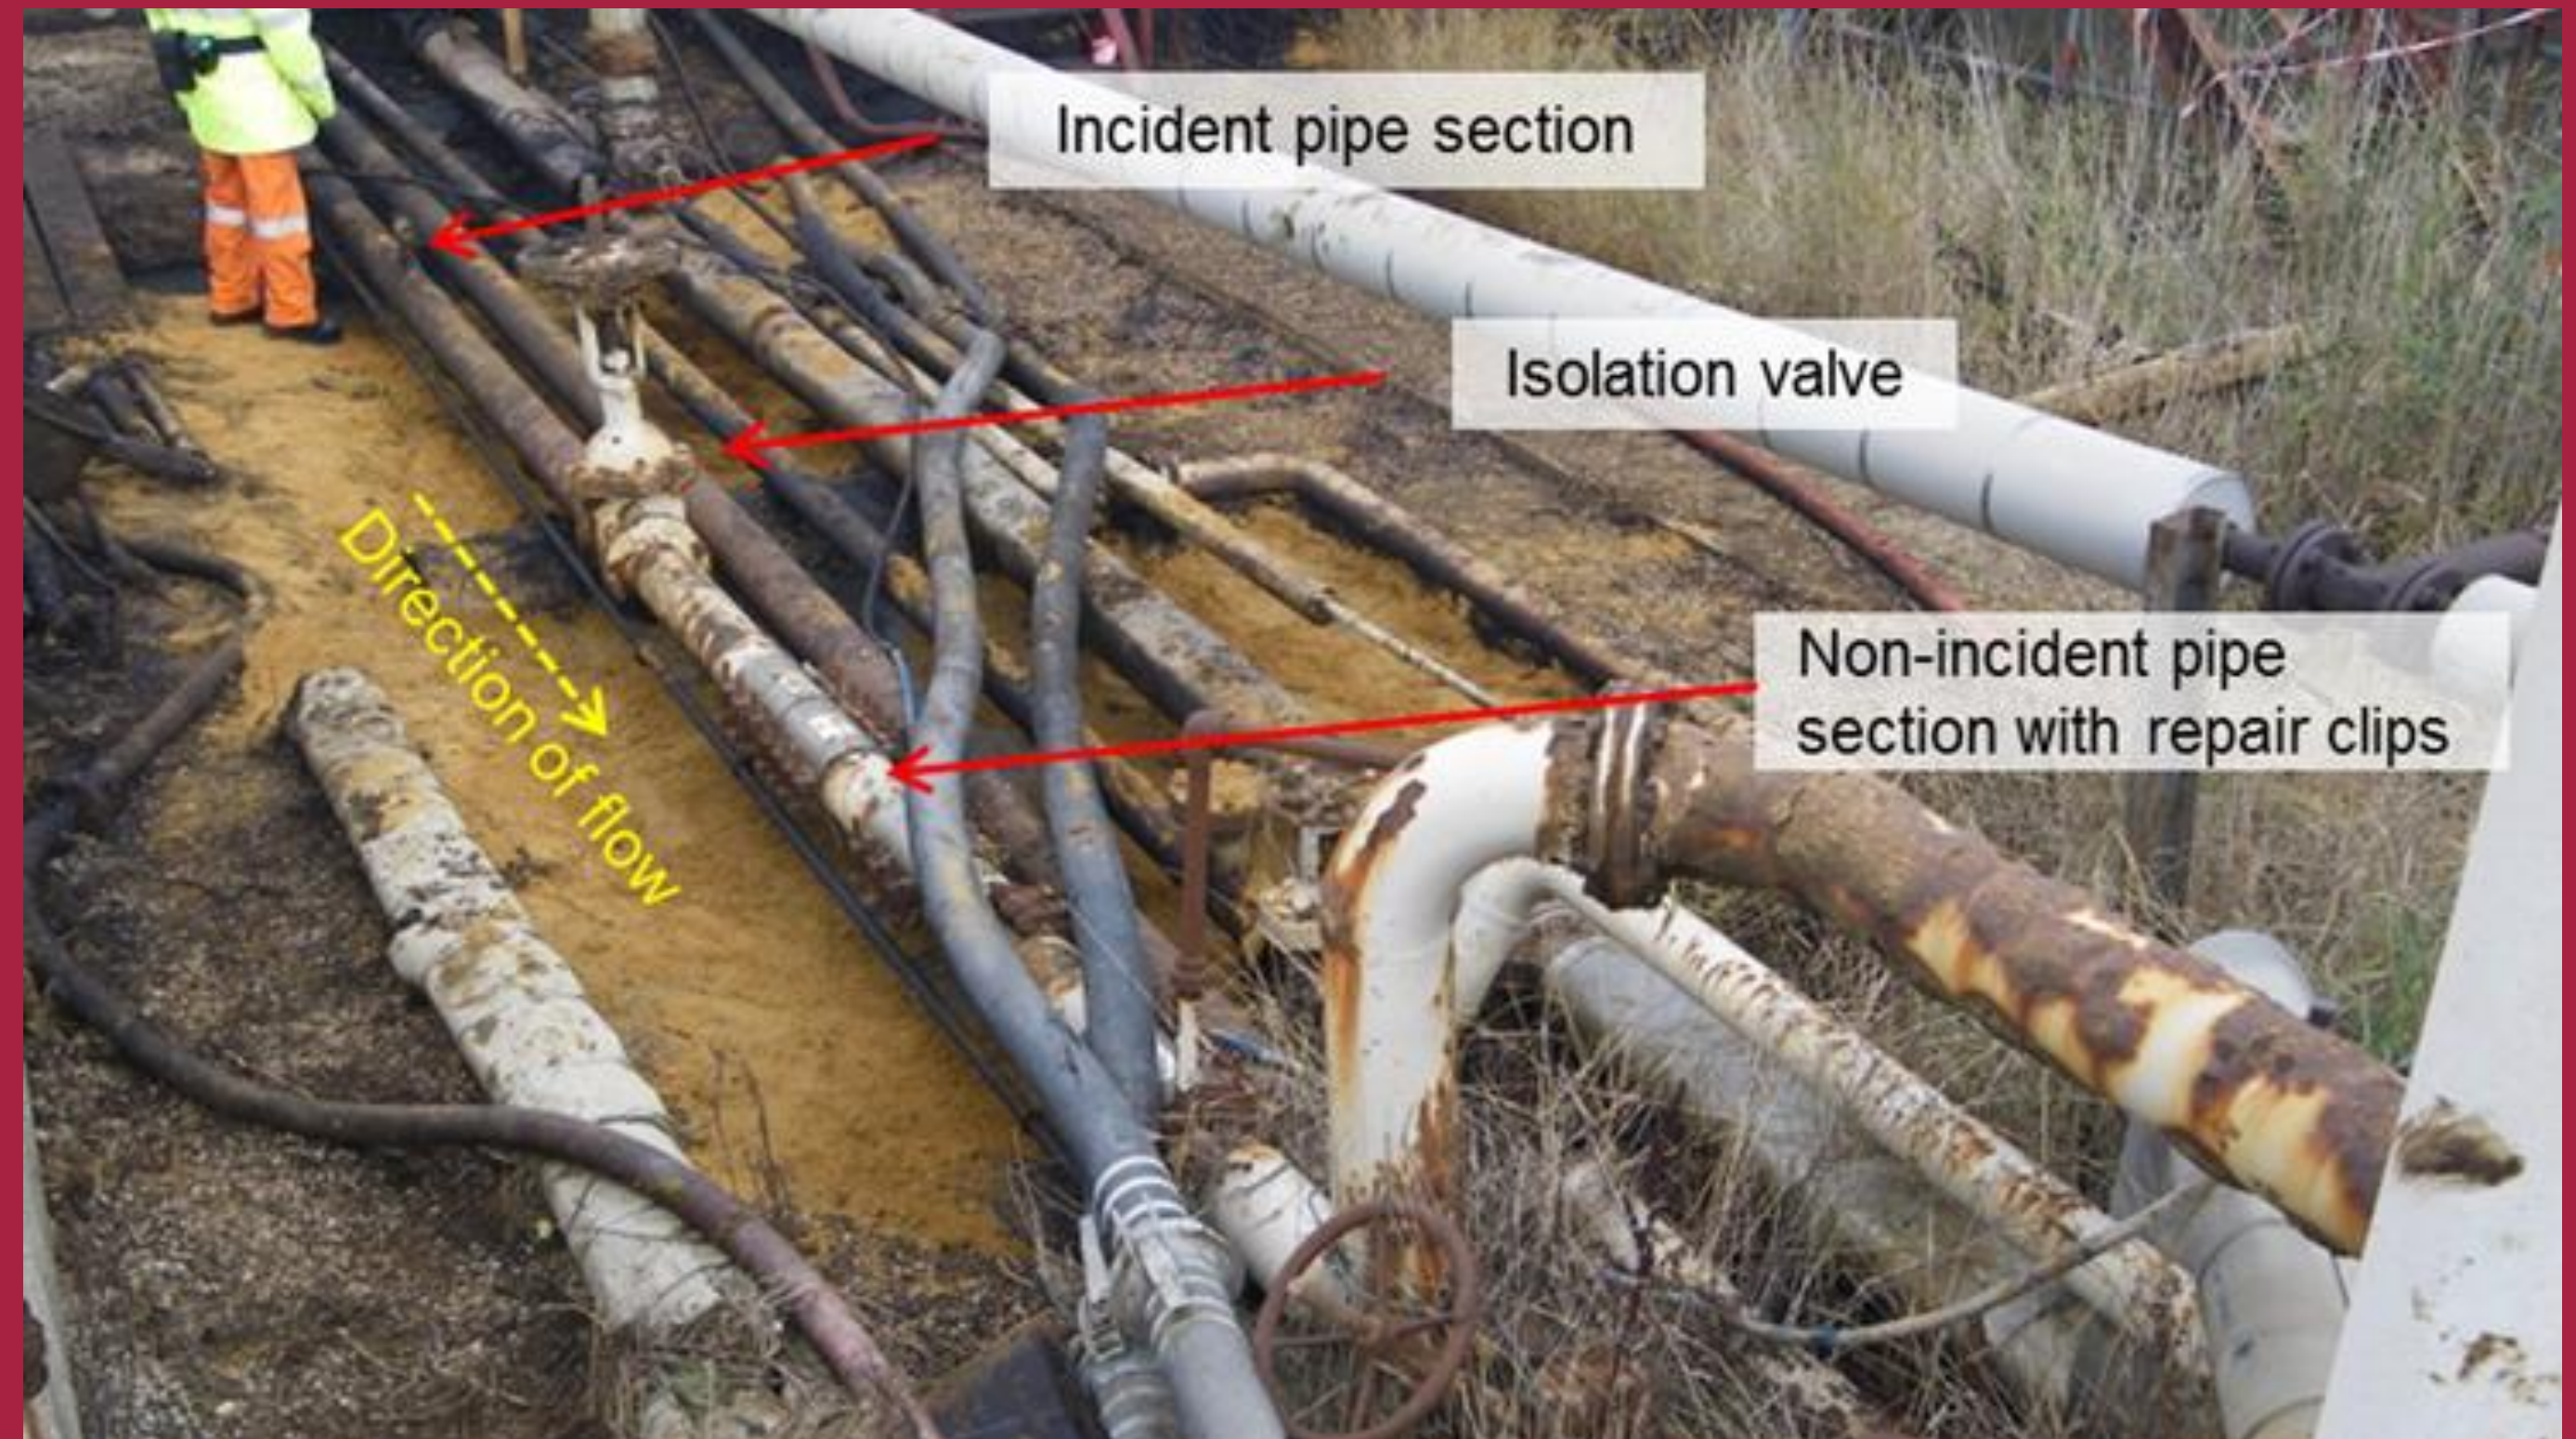
- Loss of containment of 450 m³ liquid hydrocarbon and water mixture
- 6 inch (150 mm) diameter pipeline
- Pipework normally dormant, however temporary re-routing of pipe flow required

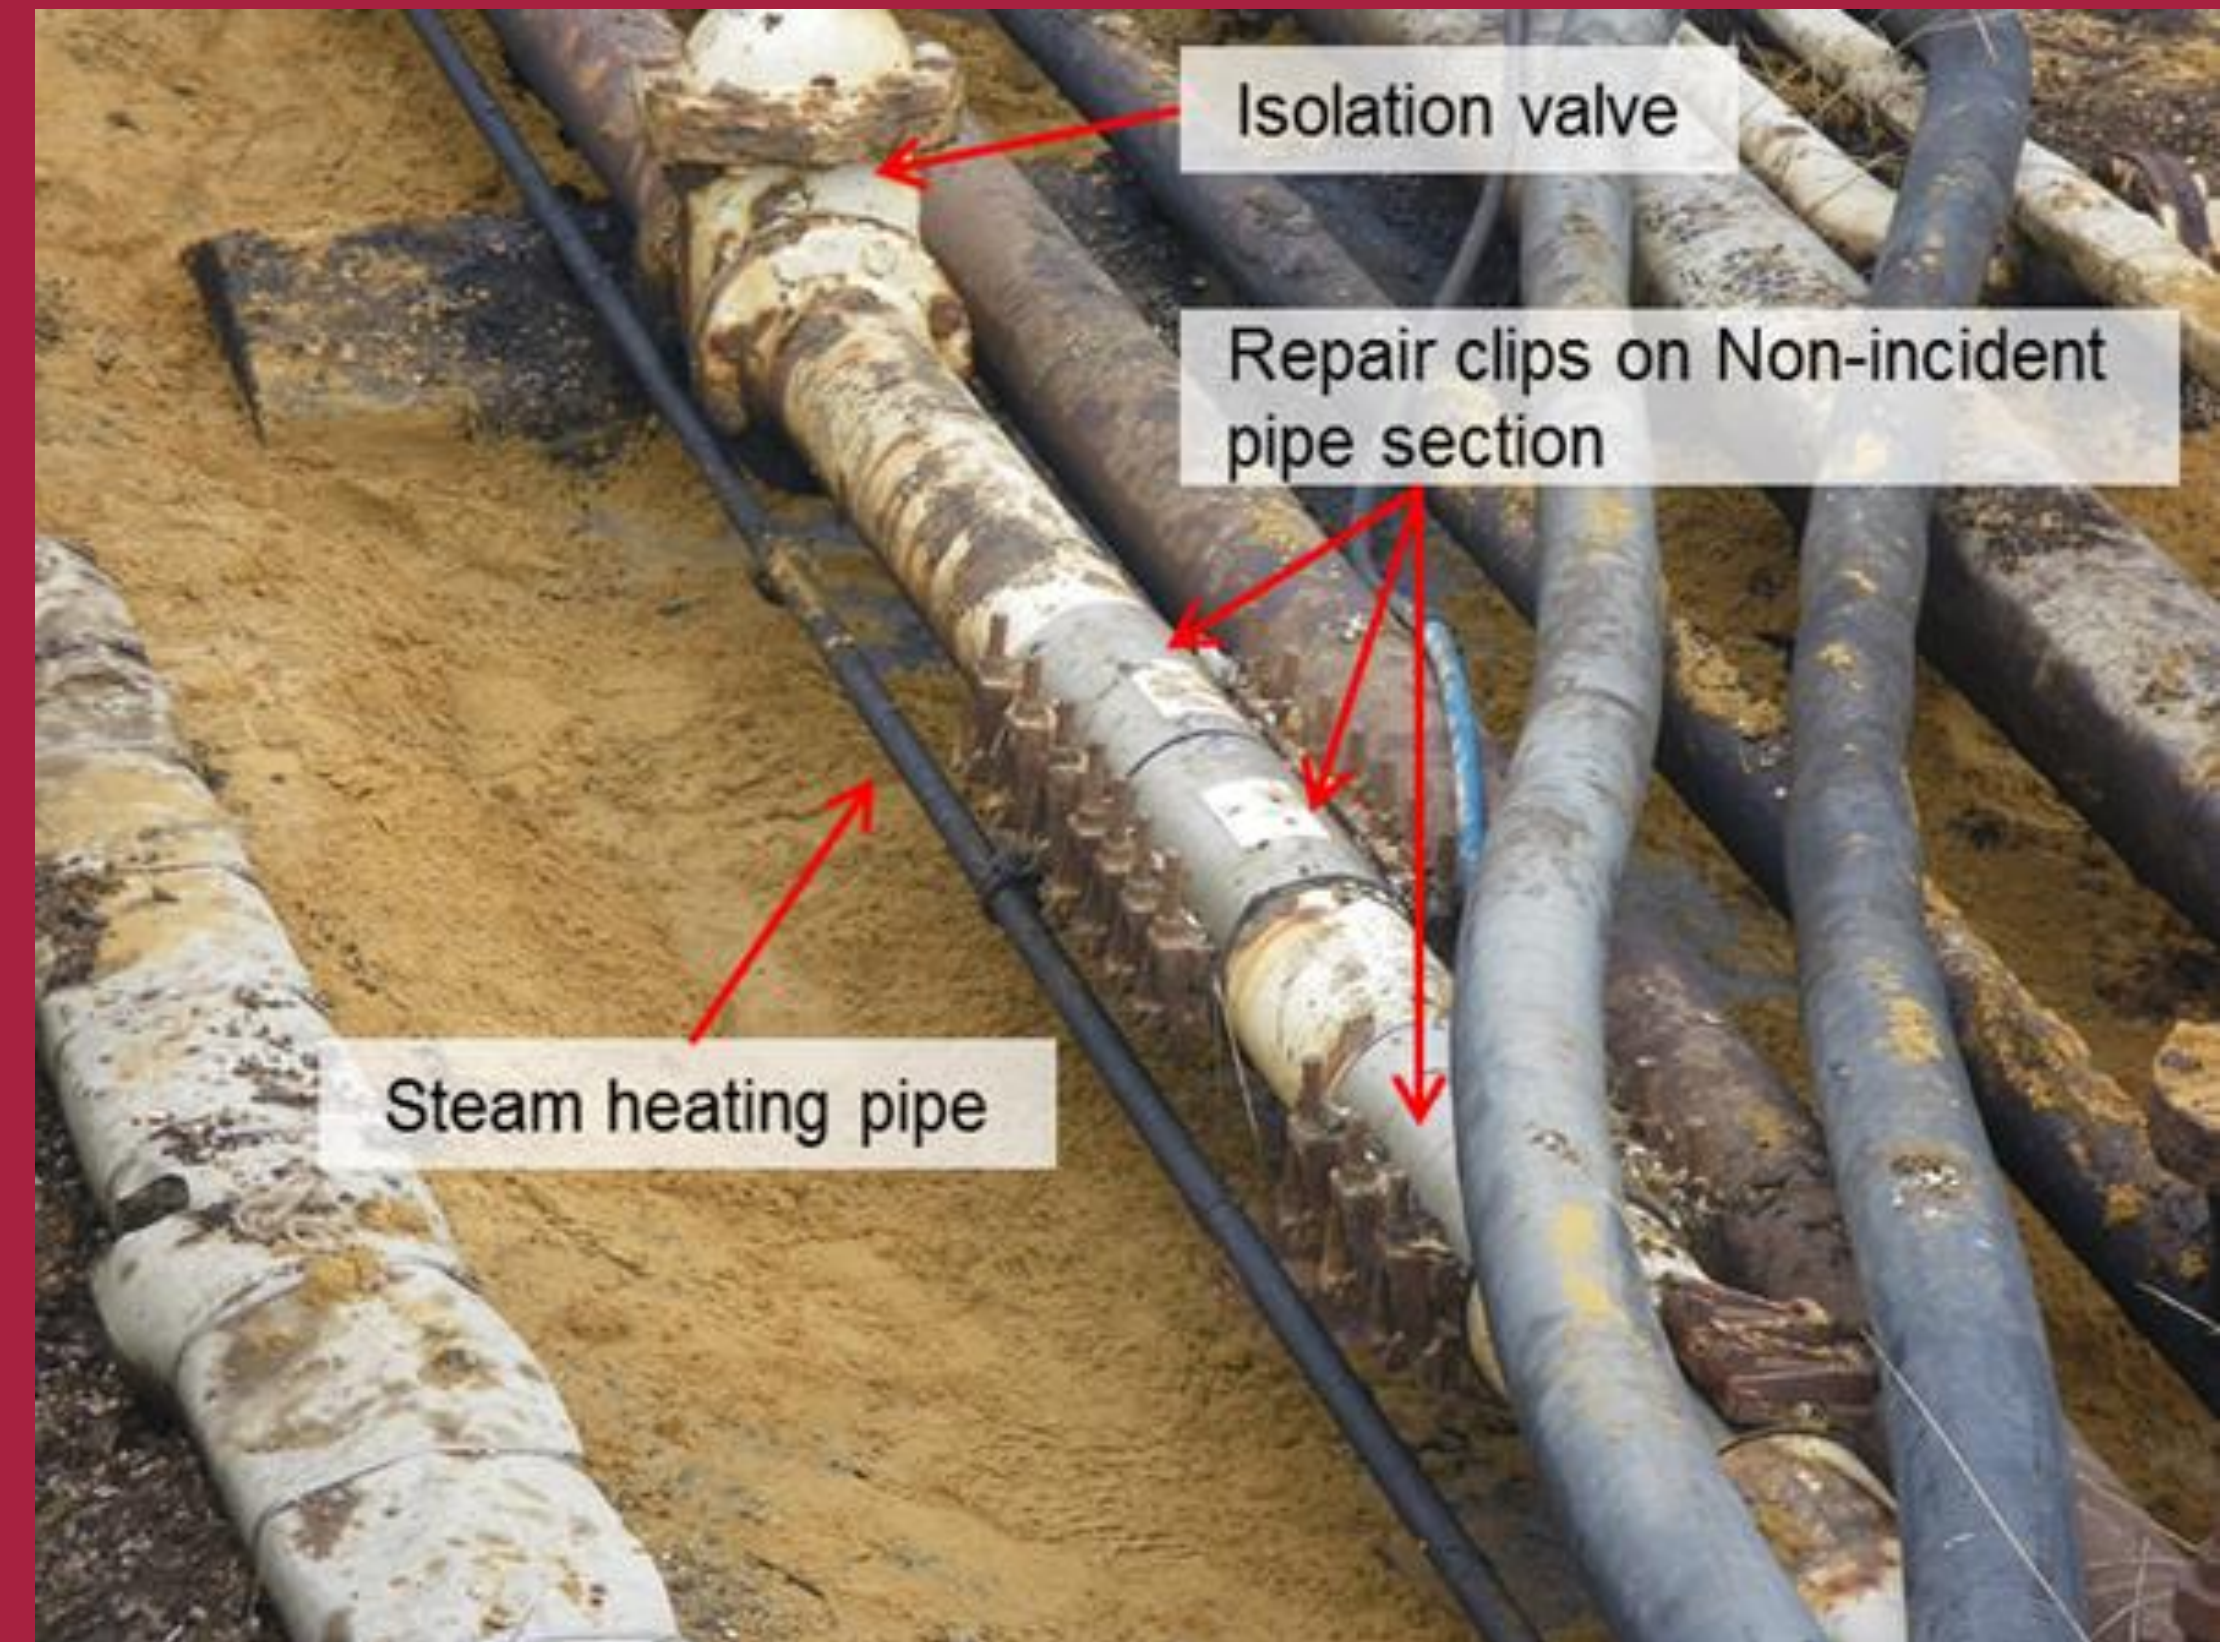
- Evidence of a steam heating pipe
- Six repair clips
- Wall thickness 5mm in non-corroded areas (originally 7 mm)
- Evidence of previous painting
- External corrosion and spalling
- Perforations at 6 o'clock position

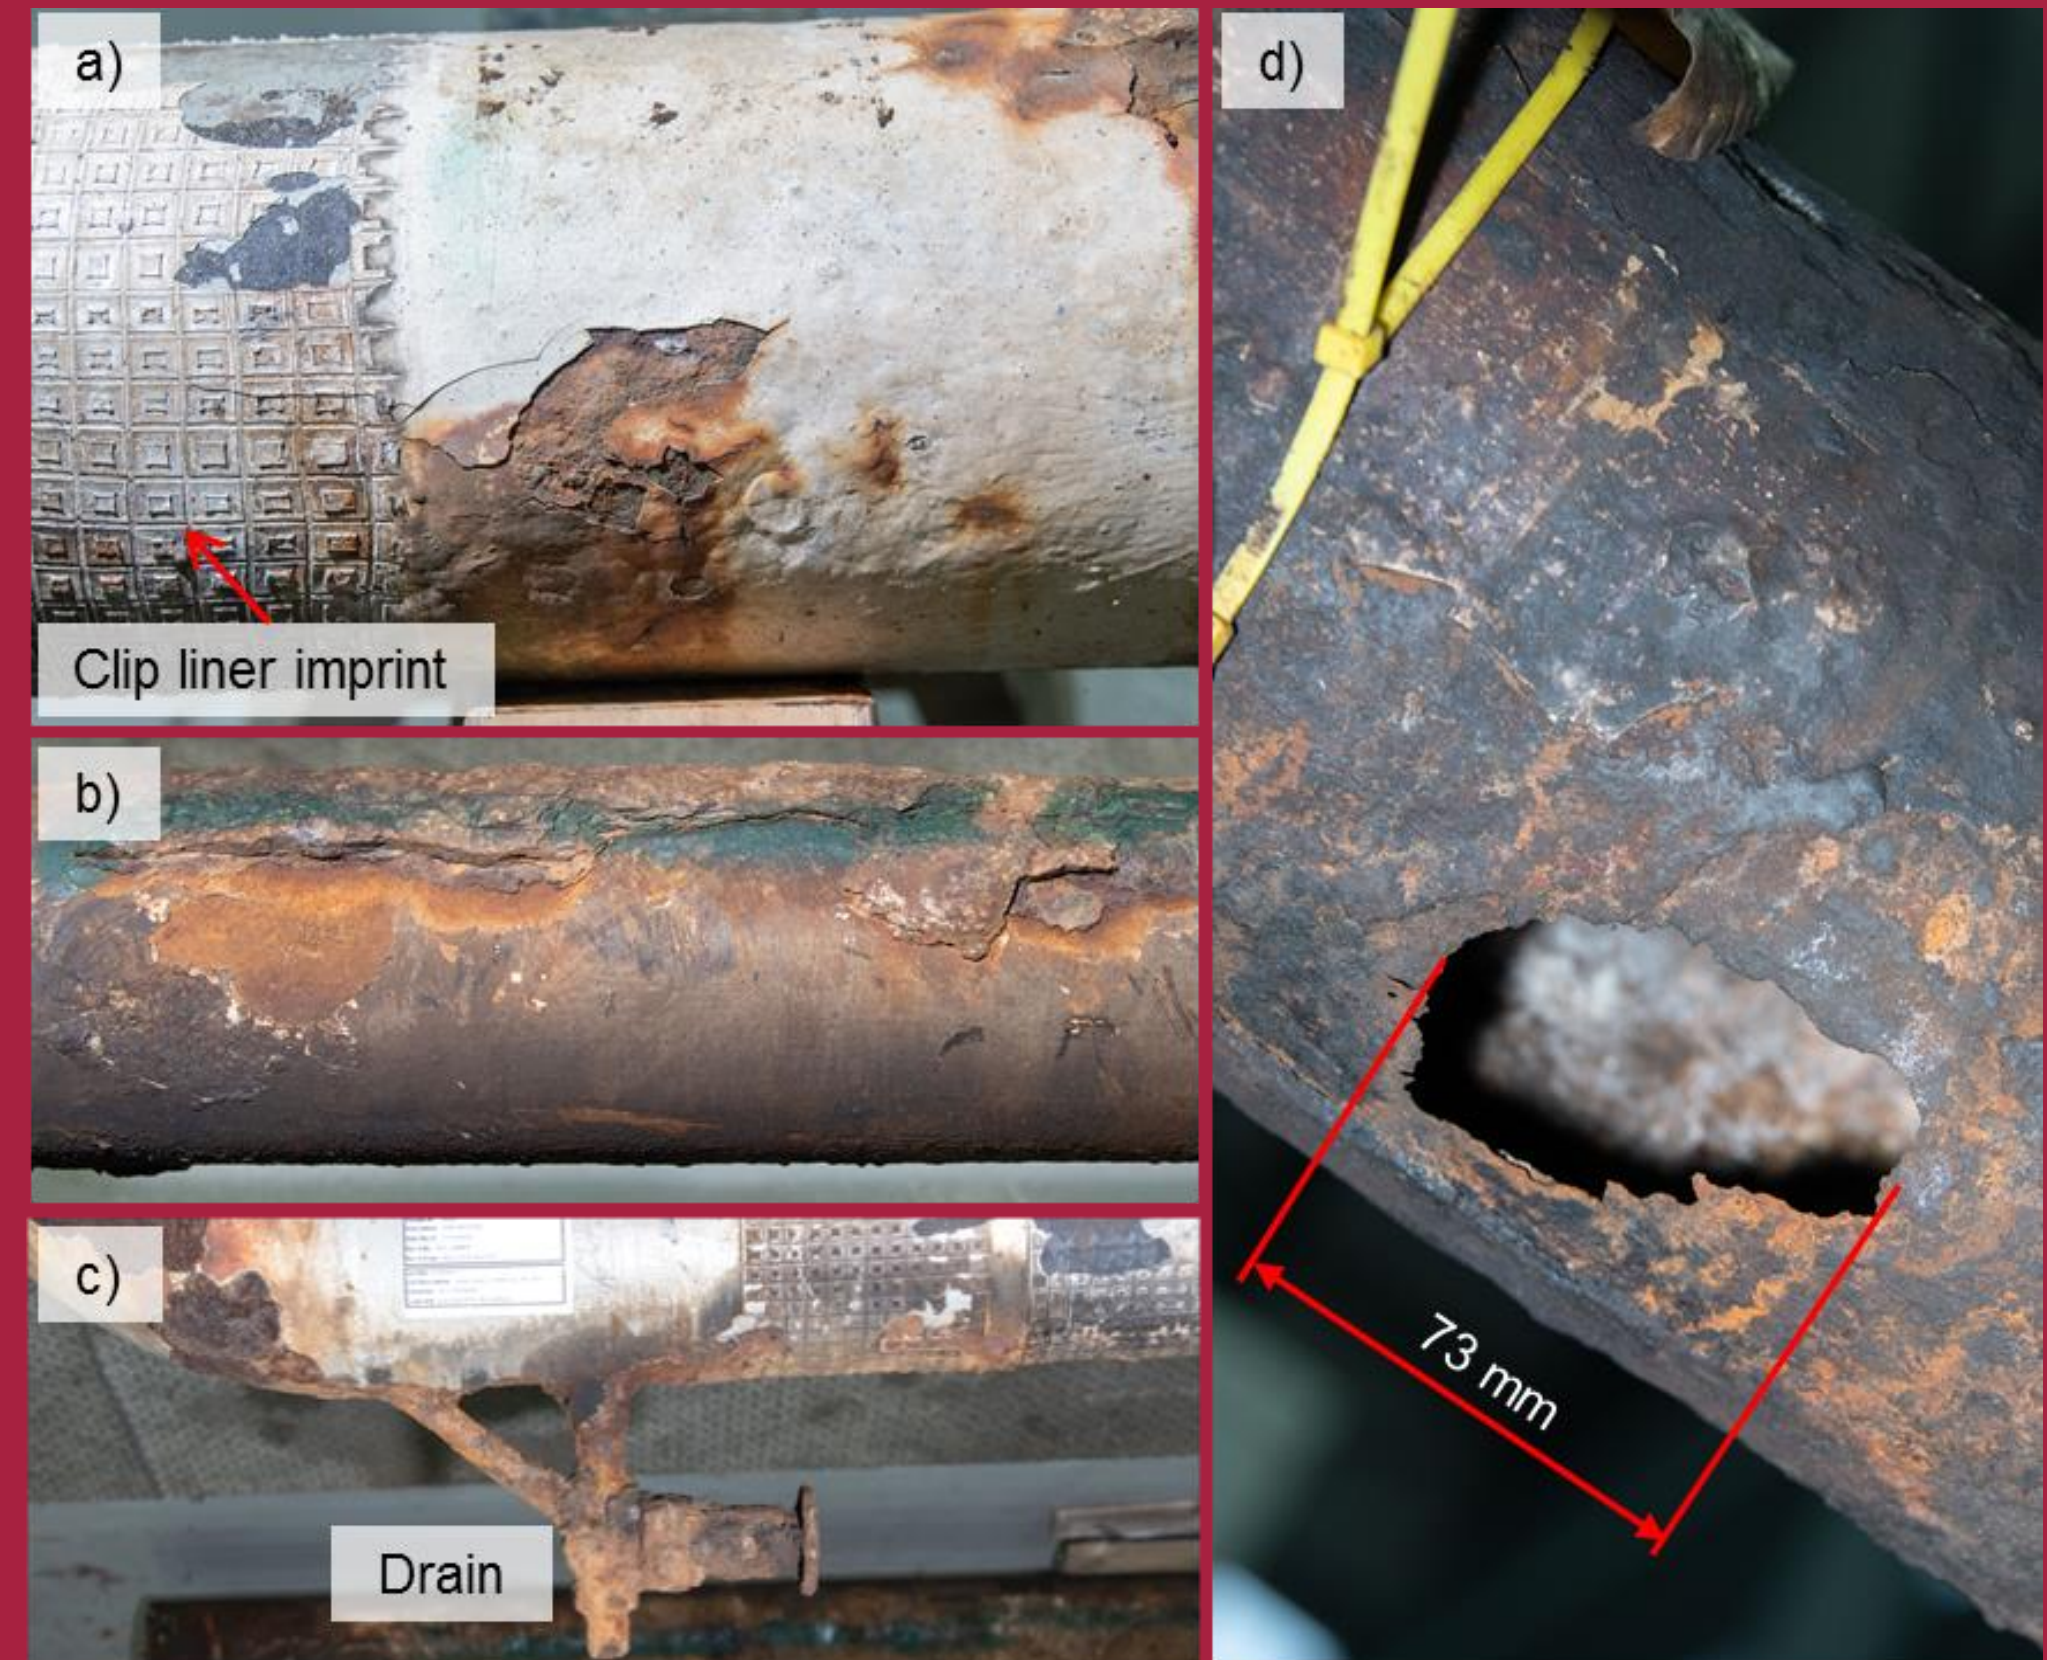
- a. Paint on non-incident pipe
 - b. Incident pipe external corrosion
 - c. Drain on non-incident pipe
 - d. Defect associated with loss of containment
- Defects under the clips were close to joining up

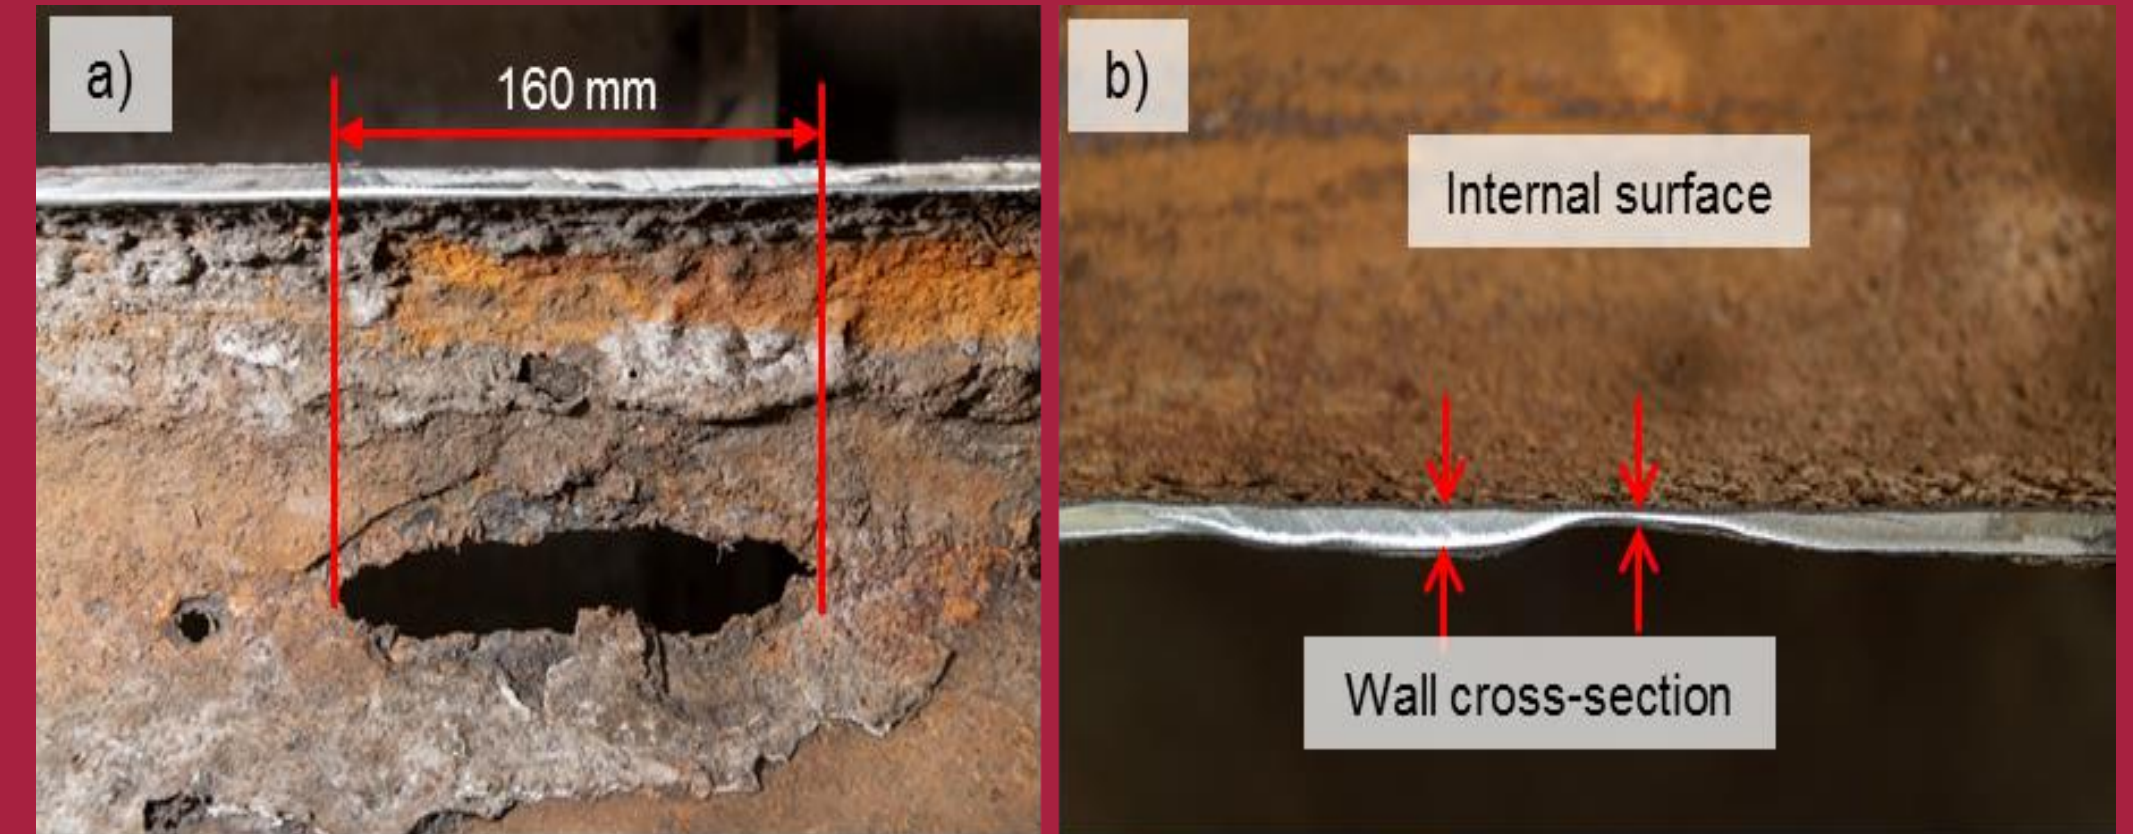
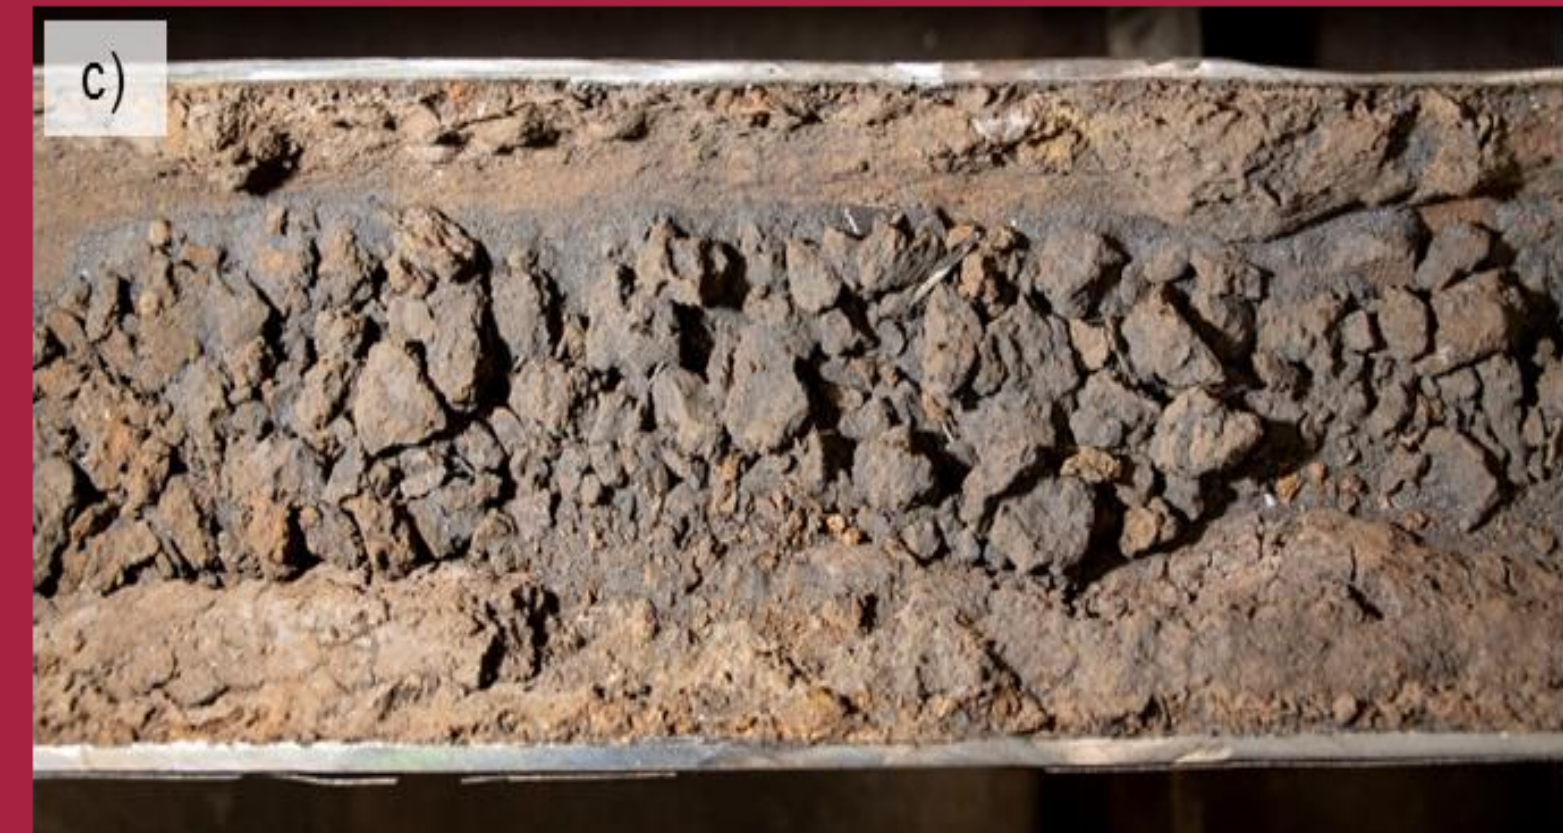
- Pipes cut longitudinally at 3 and 9 o'clock position:
- Significant internal deposit of solid debris and corrosion product
- Internal and external corrosion evident

- ICP OES revealed analysis consistent with API 5L grade B steel
- XRD of deposits revealed SiO_2 (silica) and FeCO_3 (siderite) – i.e. sand and corrosion products of iron

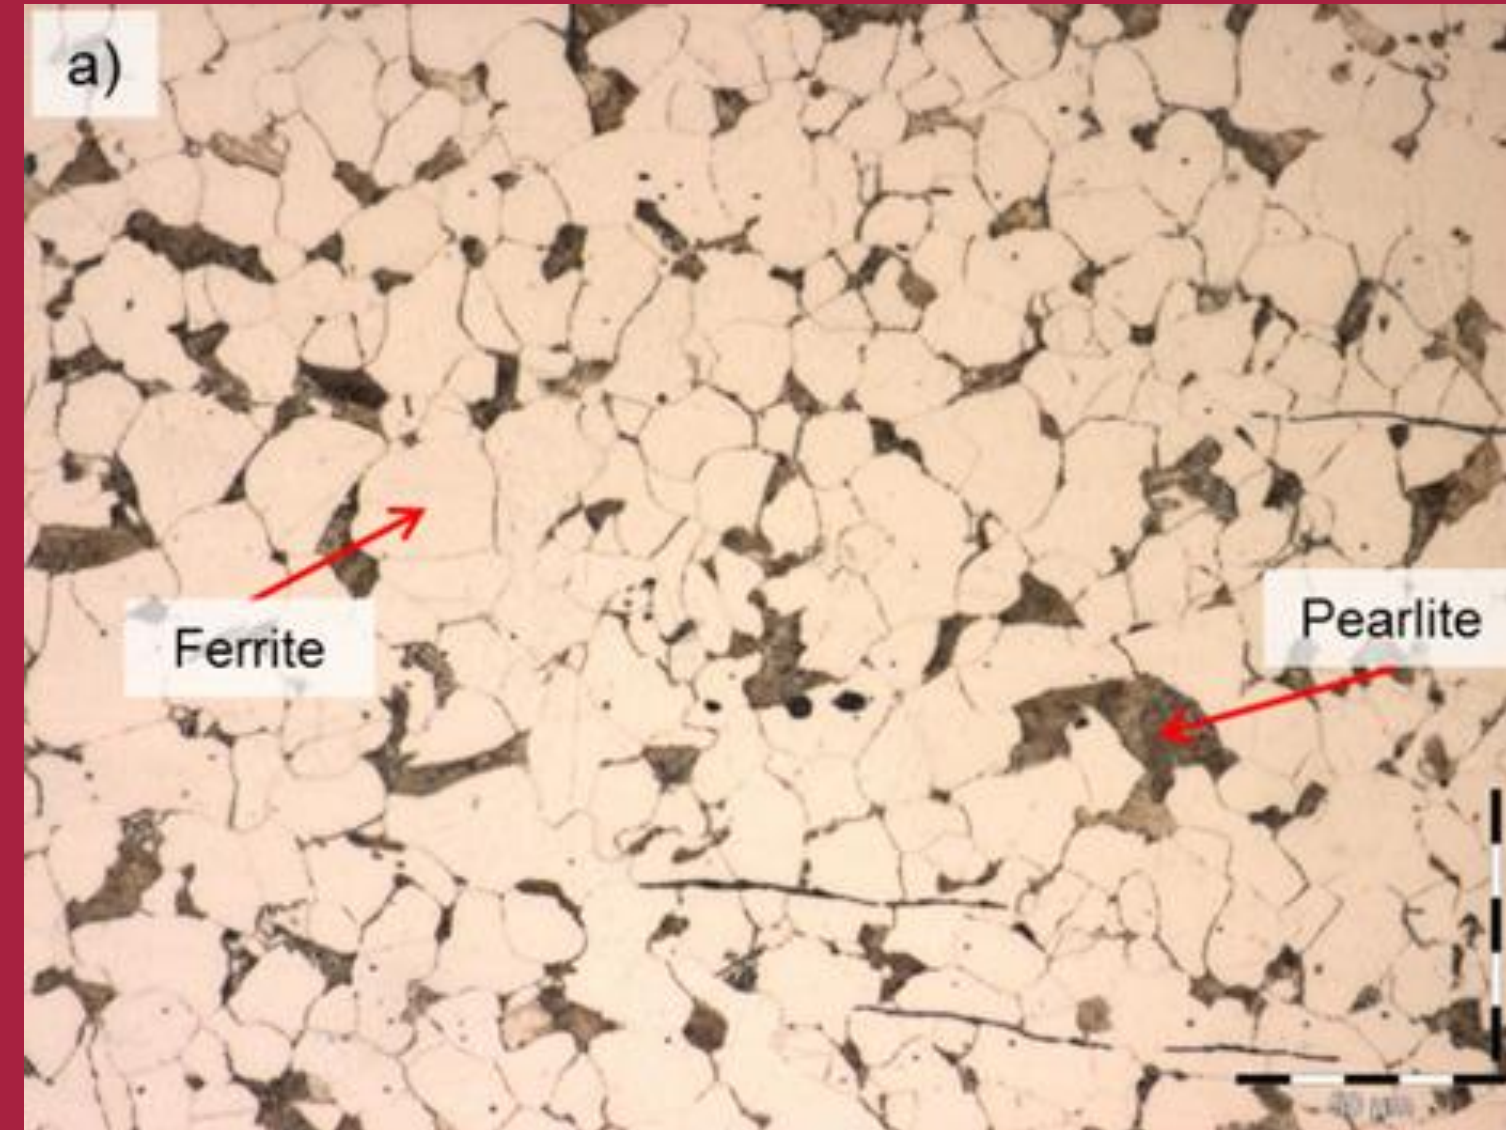
Incident pipe

- Ferrite/pearlite microstructure consistent with the chemical analysis
- Hardness of 136 HV10 (incident pipe) and 130 HV10 (non incident pipe)
- Equivalent ultimate tensile strengths (UTS) of 430 MPa and 415 MPa
- Metallography and UTS consistent with API 5L grade B

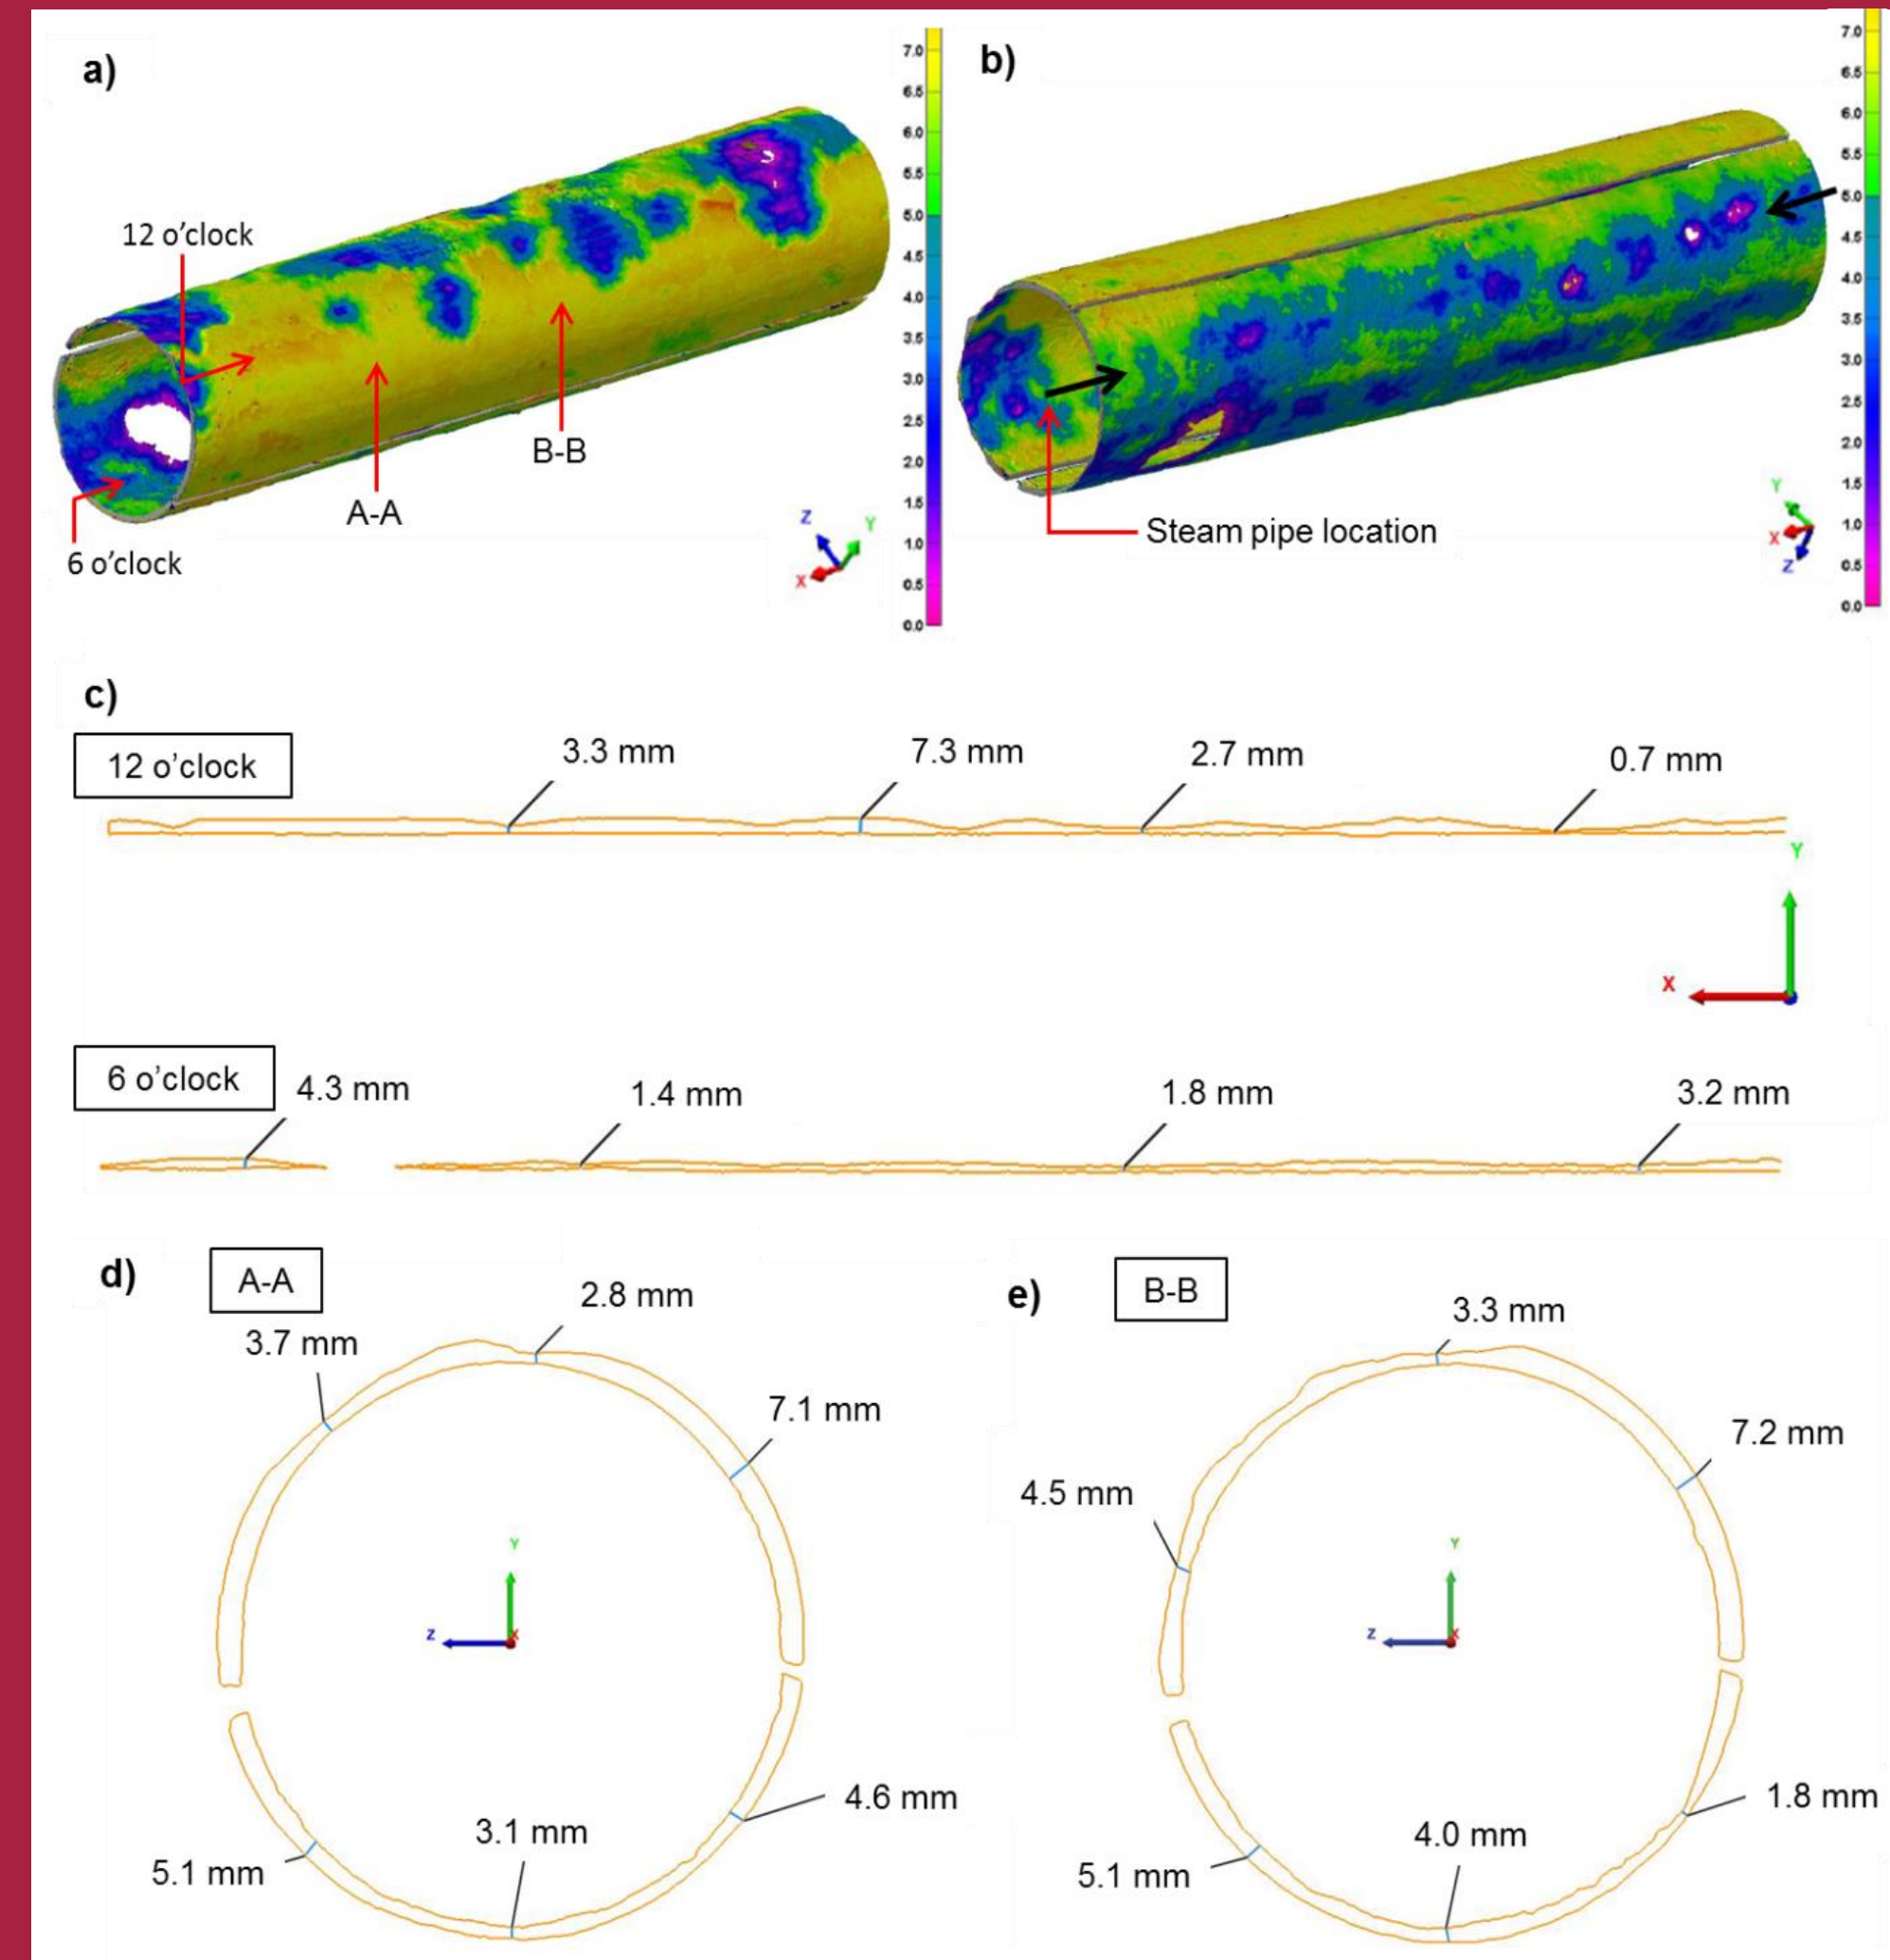
- Pipe scan images, a) and b) rotated anti-clockwise through 90 °
- 1m lengths of incident pipe
- Hole at 6 to 8 o'clock
- Steam pipe at 4 o'clock
