Investigation into a Microbiologically Induced Corrosion (MIC) failure of an onshore pipeline

Keith Birkitt CEng MWeldI FIMMM, Principal Materials Engineer
Aneta Nemcova PhD MIMMM, Materials Scientist
Ian Chapman CEng MIMechE, Mechanical Engineering Inspector

16th, 17th, 18th November 2021

Hazards31

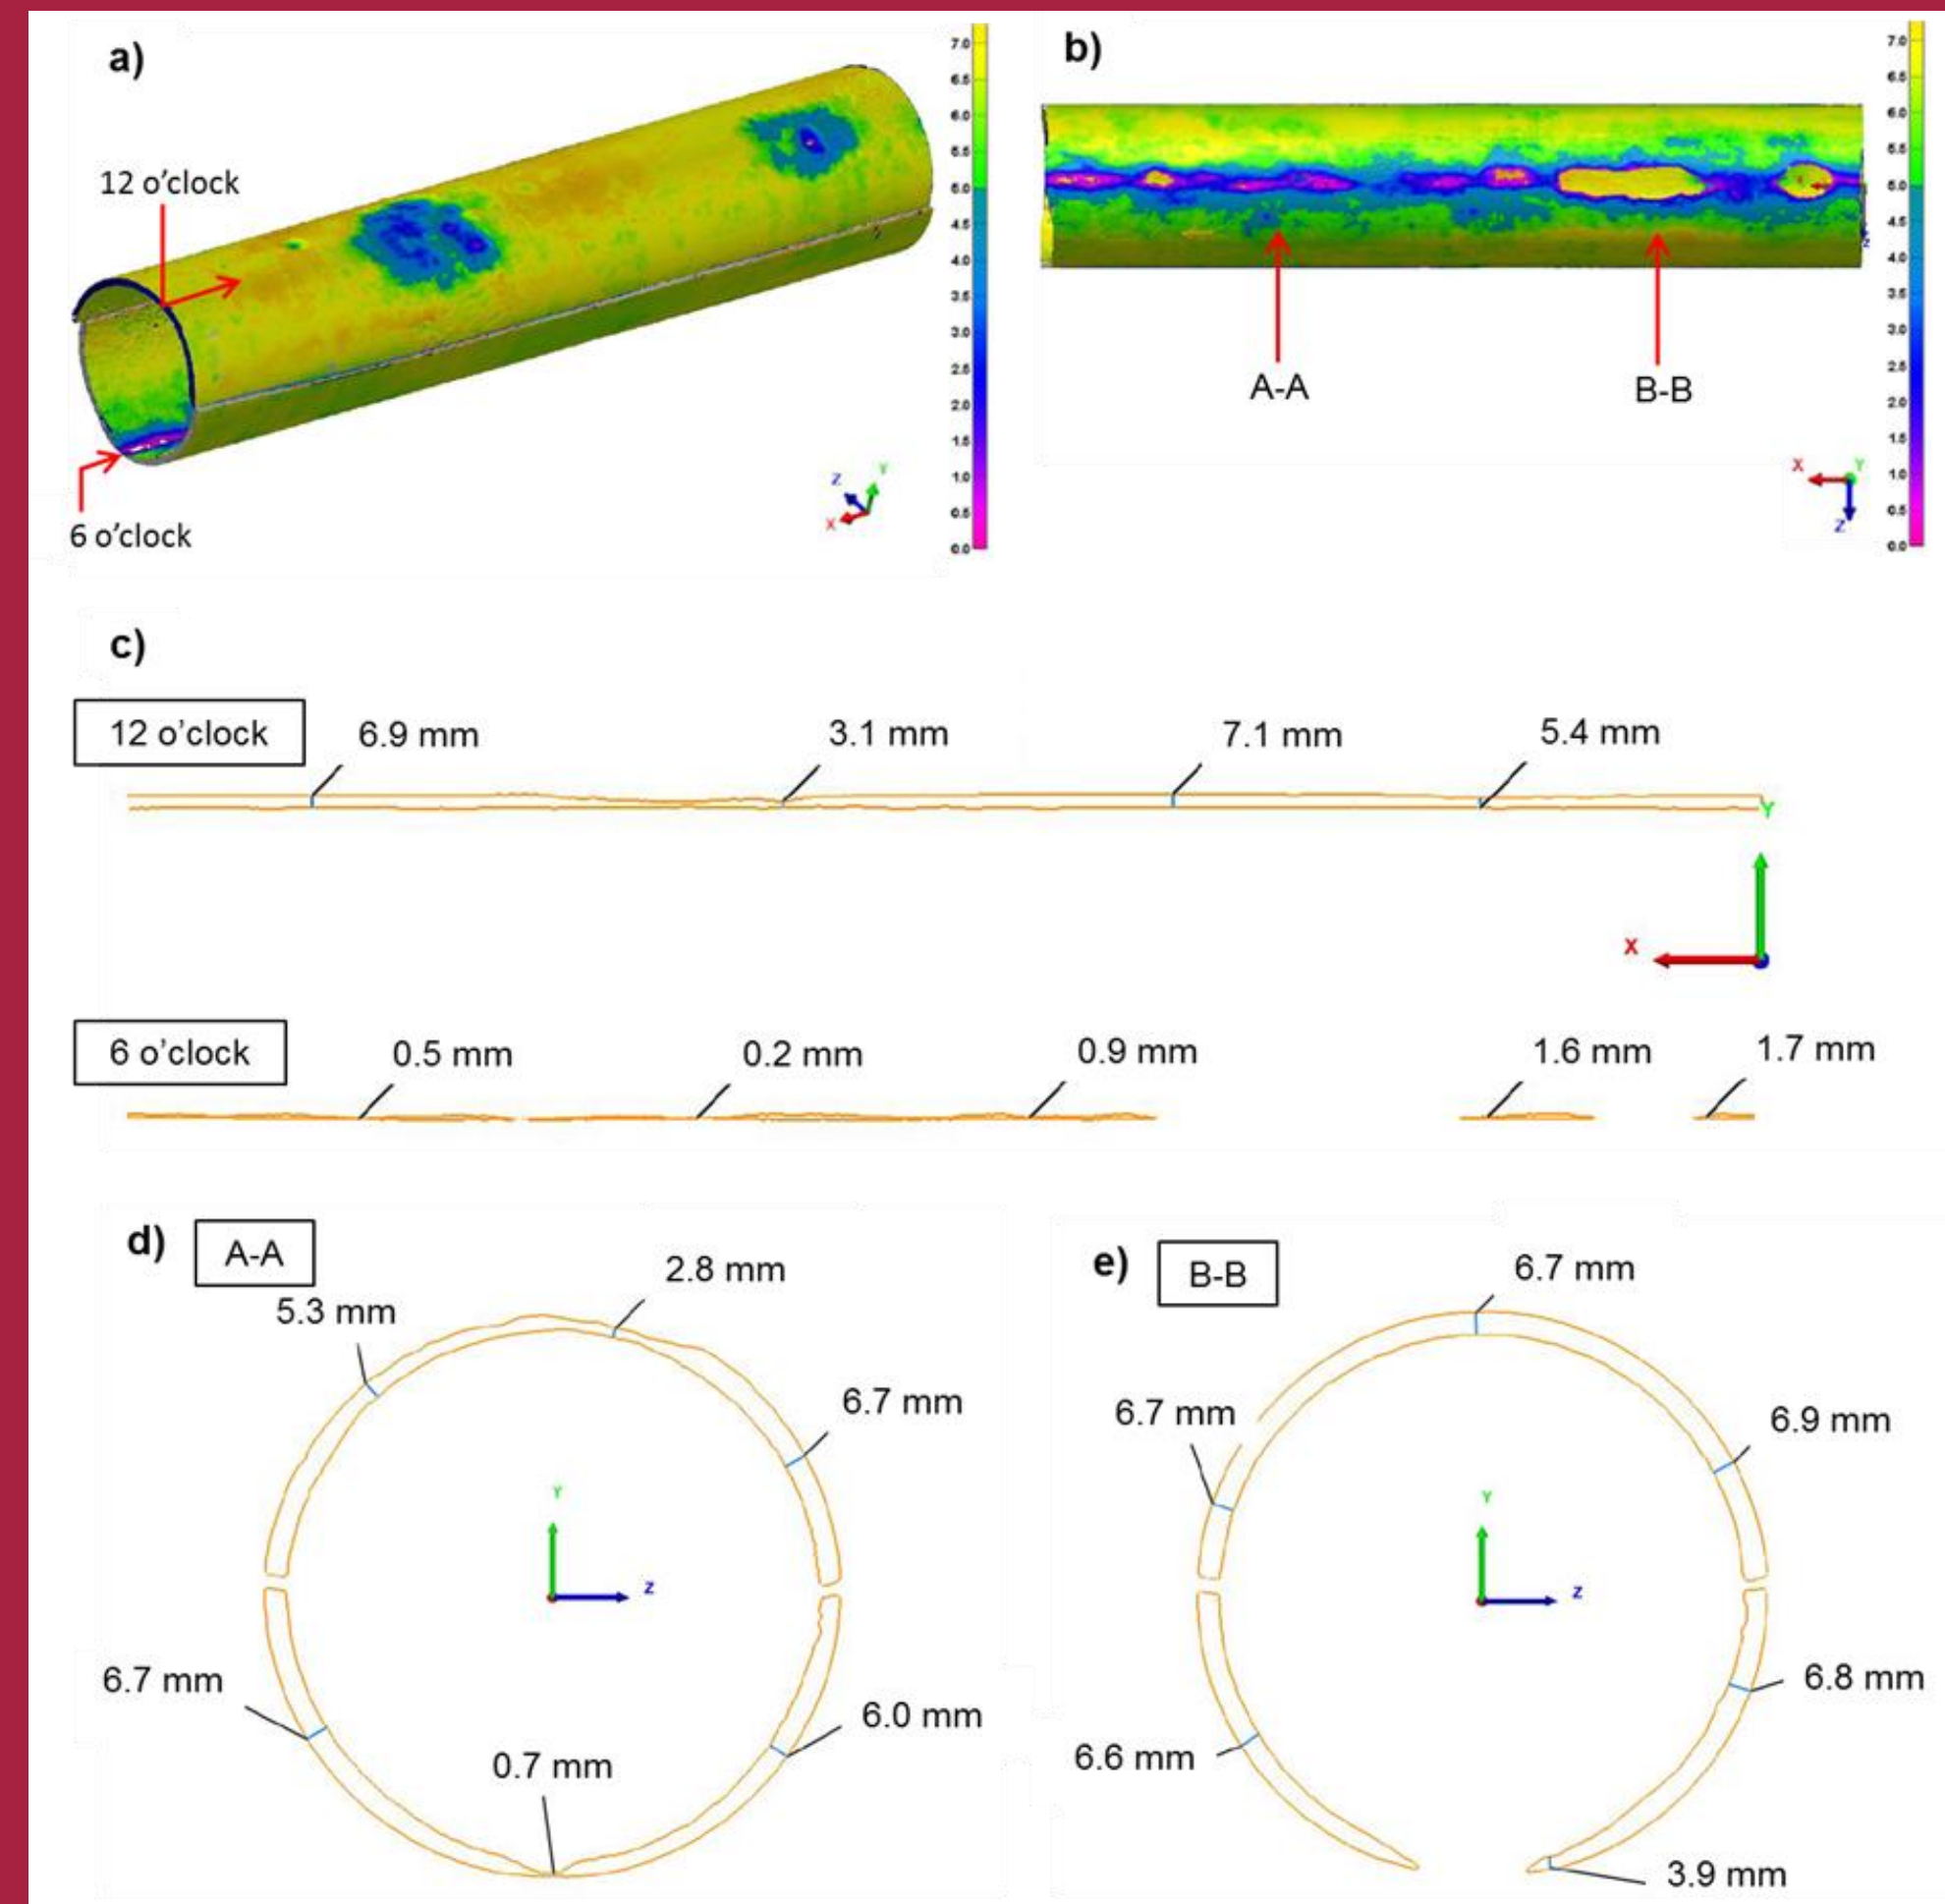
- Pipe scan images, a) and b) rotated anti-clockwise through 90°
- 1m lengths of non-incident pipe
- Holes pits and groove at 6 o'clock
