The Flixborough disaster

Report of the Court of Inquiry

**Formal Investigation into Accident on 1st June
1974 at the Nypro Factory at Flixborough**

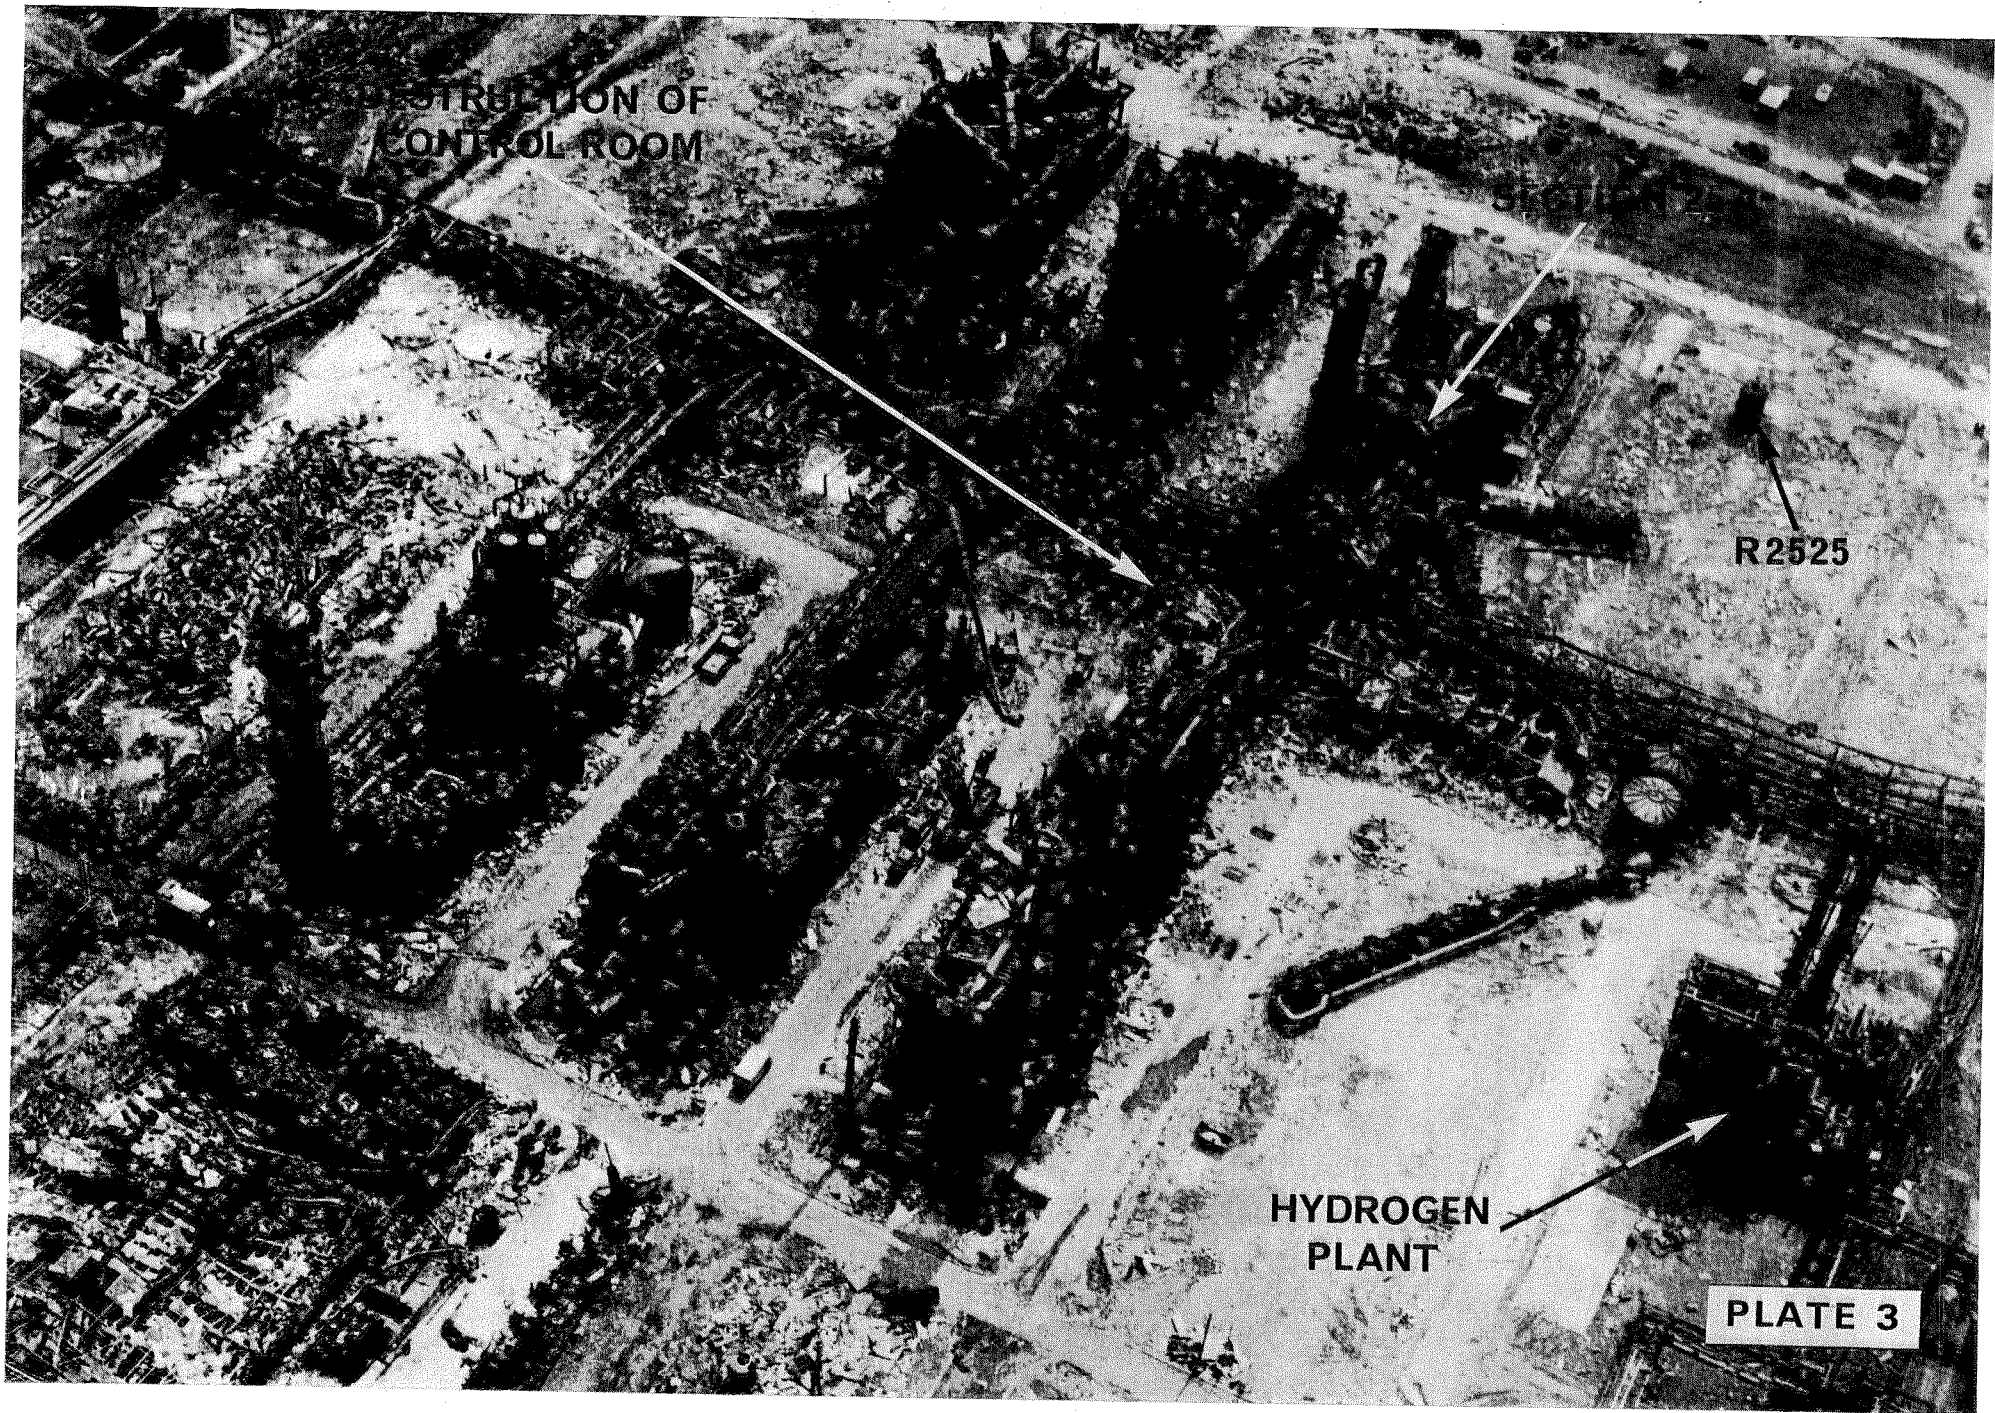
PLATE 3

Plate 3 (facing page) Works after the explosion, seen from the north.

DESTRUCTION OF
CONTROL ROOM

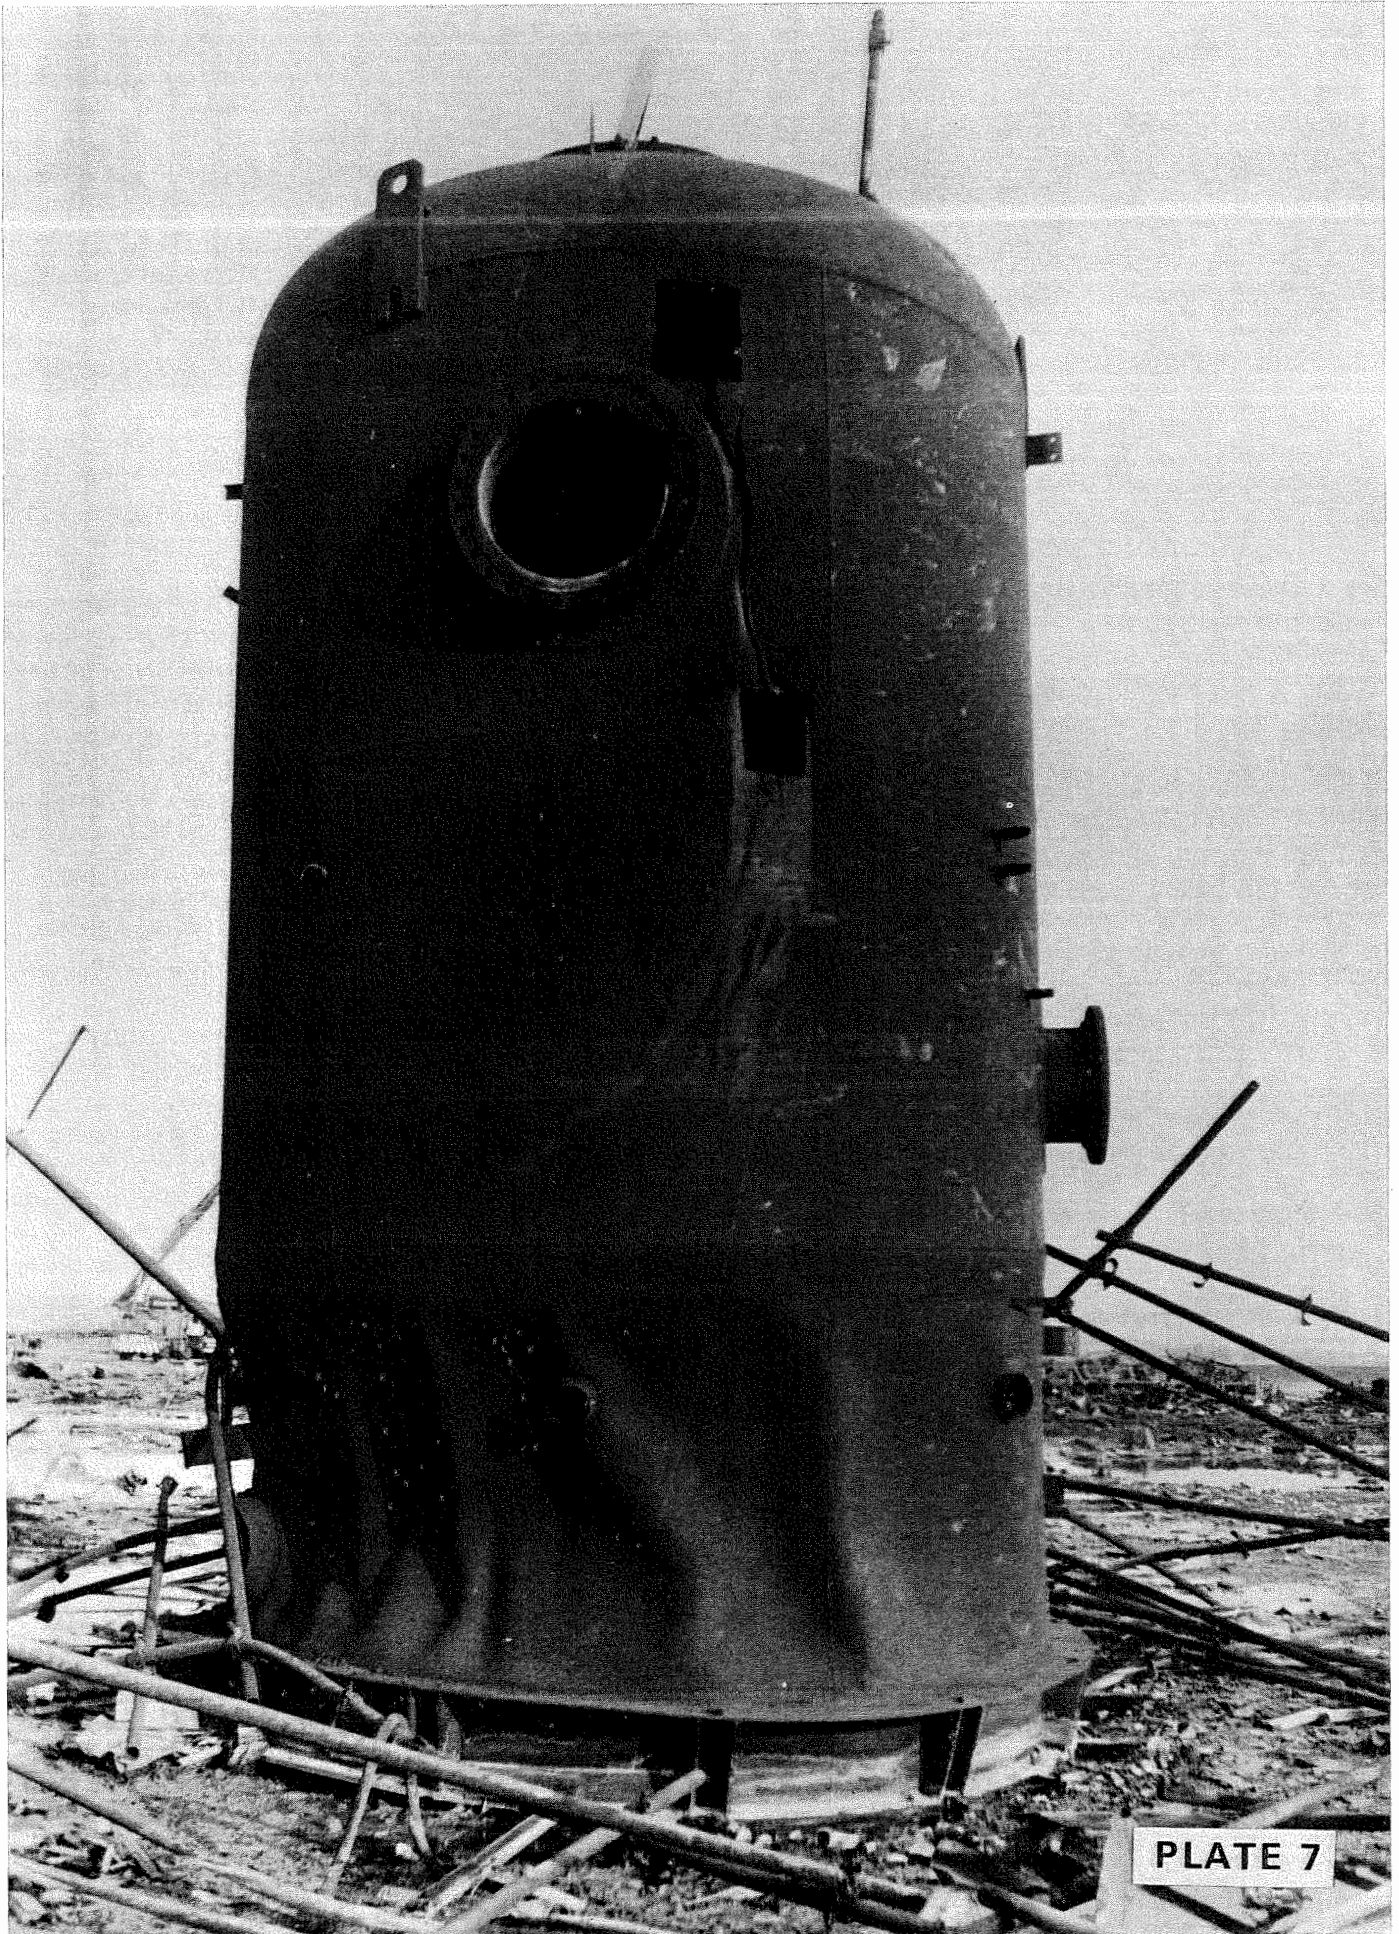
53 In the evening of 27th March, cyclohexane was discovered to be leaking from Reactor No. 5 (R2525) which like the other reactors, was constructed of $\frac{1}{8}$ inch mild steel plate with $\frac{1}{8}$ inch stainless steel bonded to it. On investigation a vertical crack was found in the mild steel outer layer of the reactor shell (Plate 7) and cyclohexane was emerging over a small part of this crack thus indicating that the inner stainless steel layer was also defective. The Chief Superintendent on duty telephoned the Plant Manager for Area 2 and it was agreed between them that the plant should be shut down, depressurised and cooled when a full inspection might take place.

54 The following morning, the 28th March, the Plant Manager inspected the crack, and found that it extended for some 6 feet. This was clearly a serious state of affairs and the same morning a meeting was held to decide what should be done. It was attended by Mr Beckers the General Works Manager,

Plate 7 Reactor 5 showing crack which led to its removal and replacement by the by-pass in March 1974. The square holes are where metal has been removed for examination (crack opened by fire).

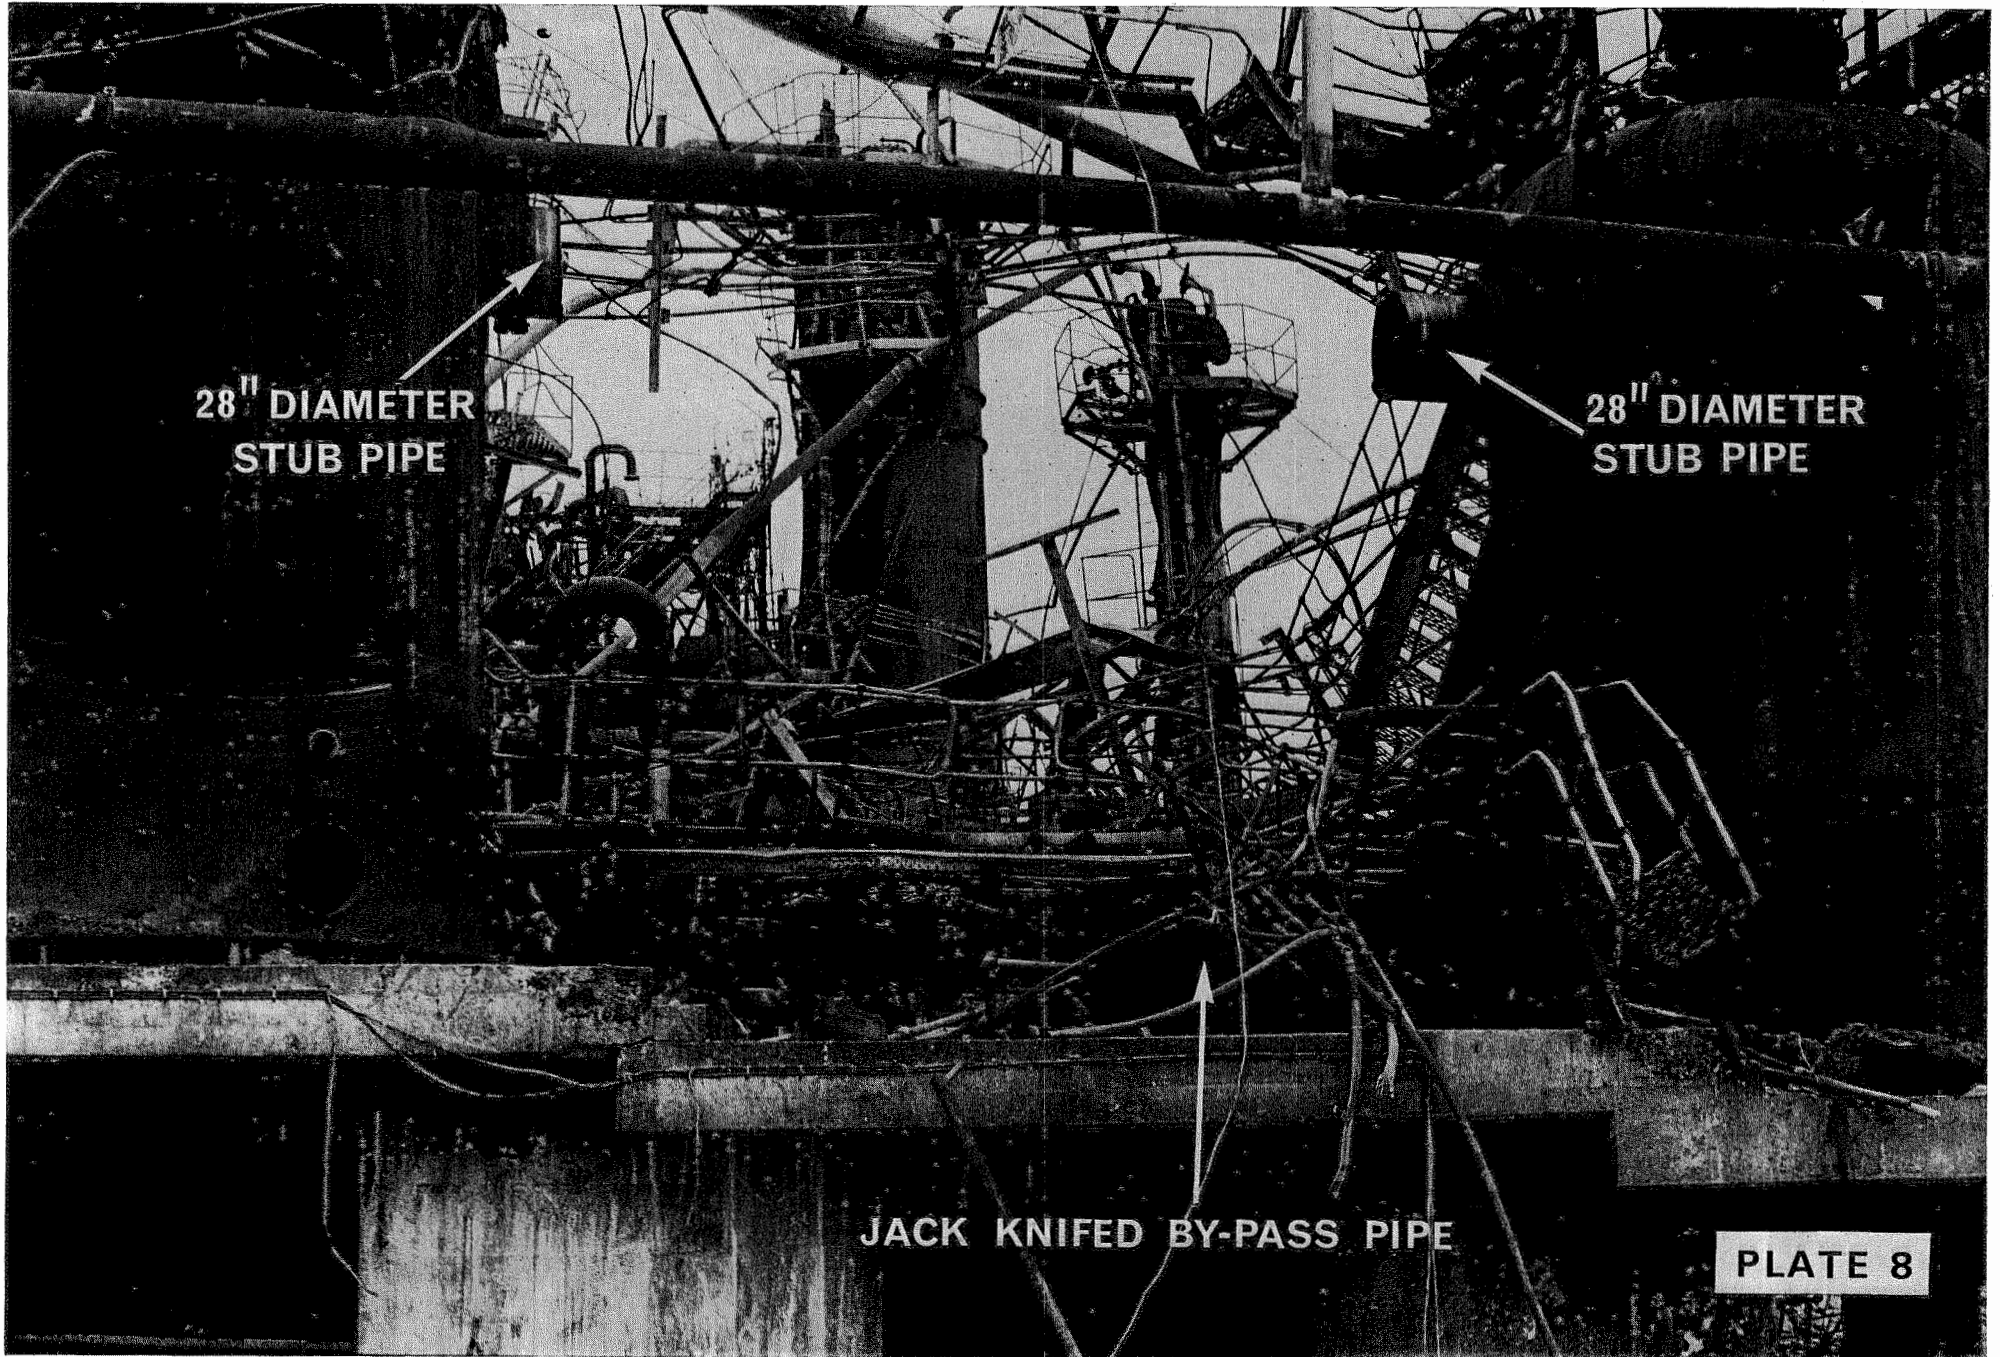
PLATE 8

Plate 8 Reactors 4 and 6 soon after the explosion.

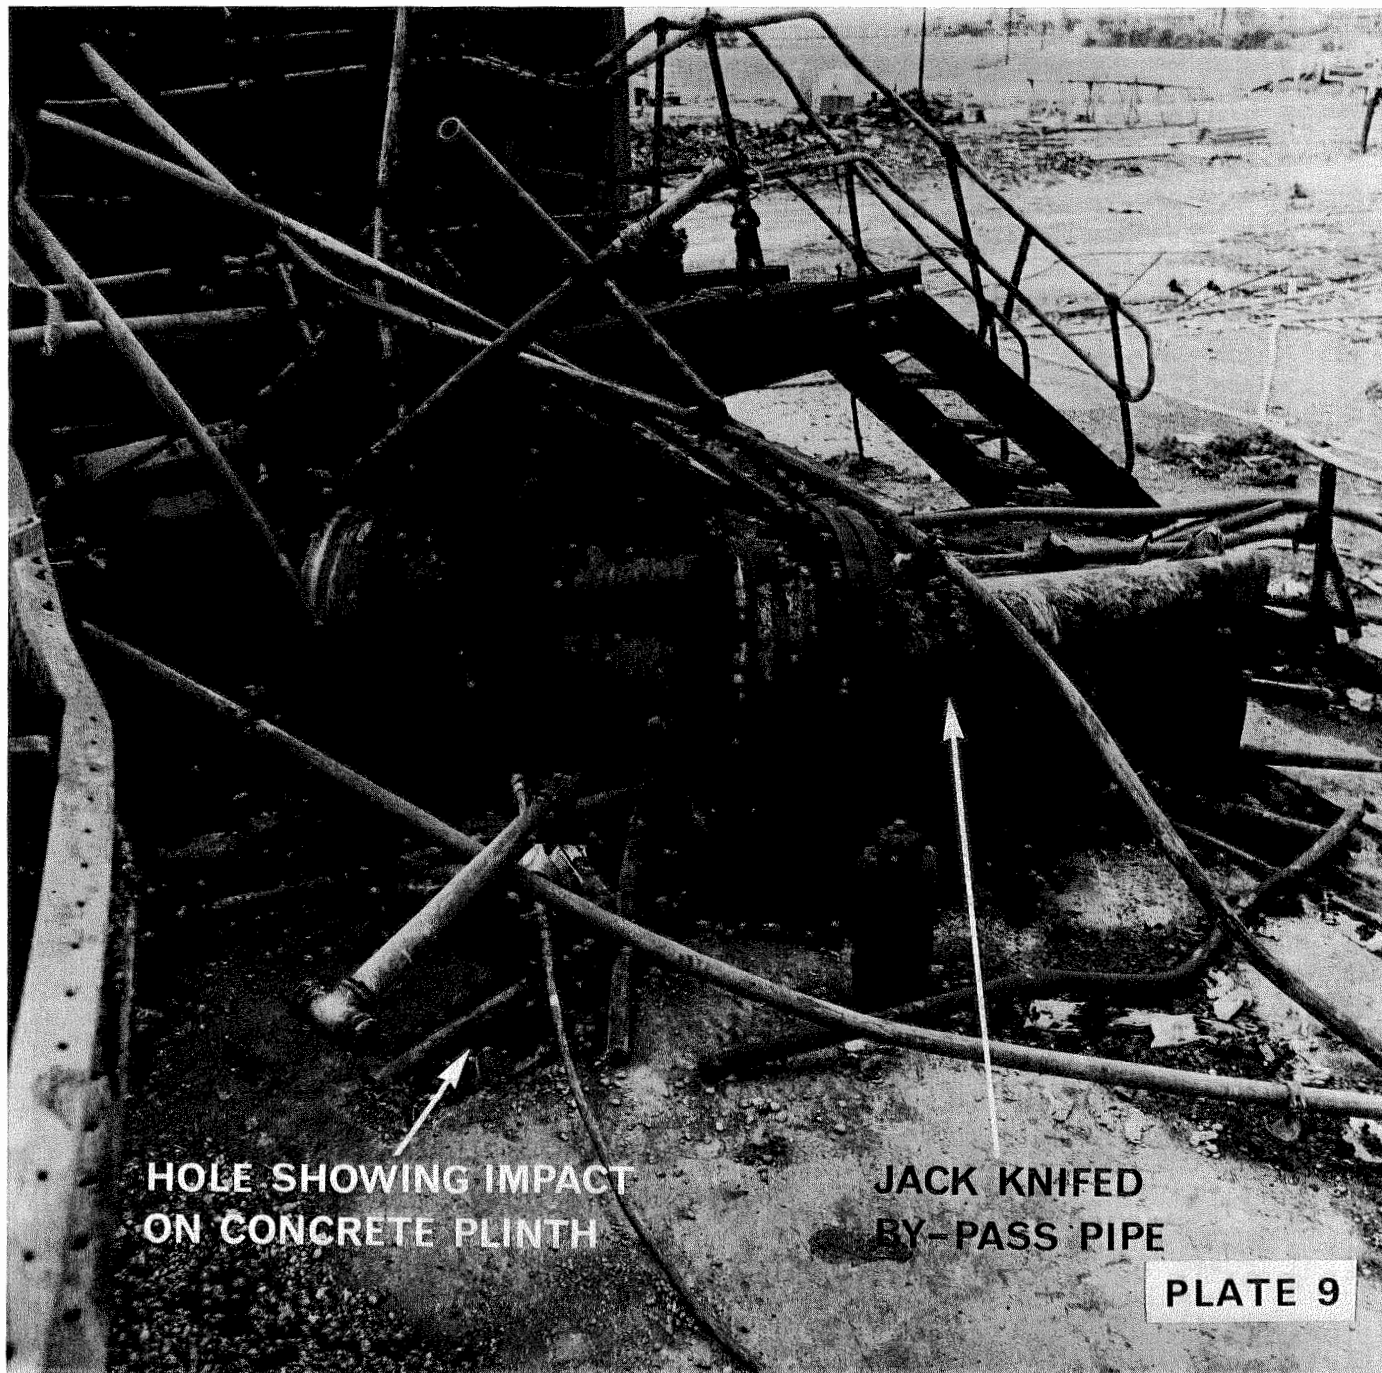
PLATE 9

**HOLE SHOWING IMPACT
ON CONCRETE PLINTH**

**JACK KNIFED
BY-PASS PIPE**

Plate 9 The jack-knifed 20 inch pipe with attached flanges and 28 inch stub pipes.

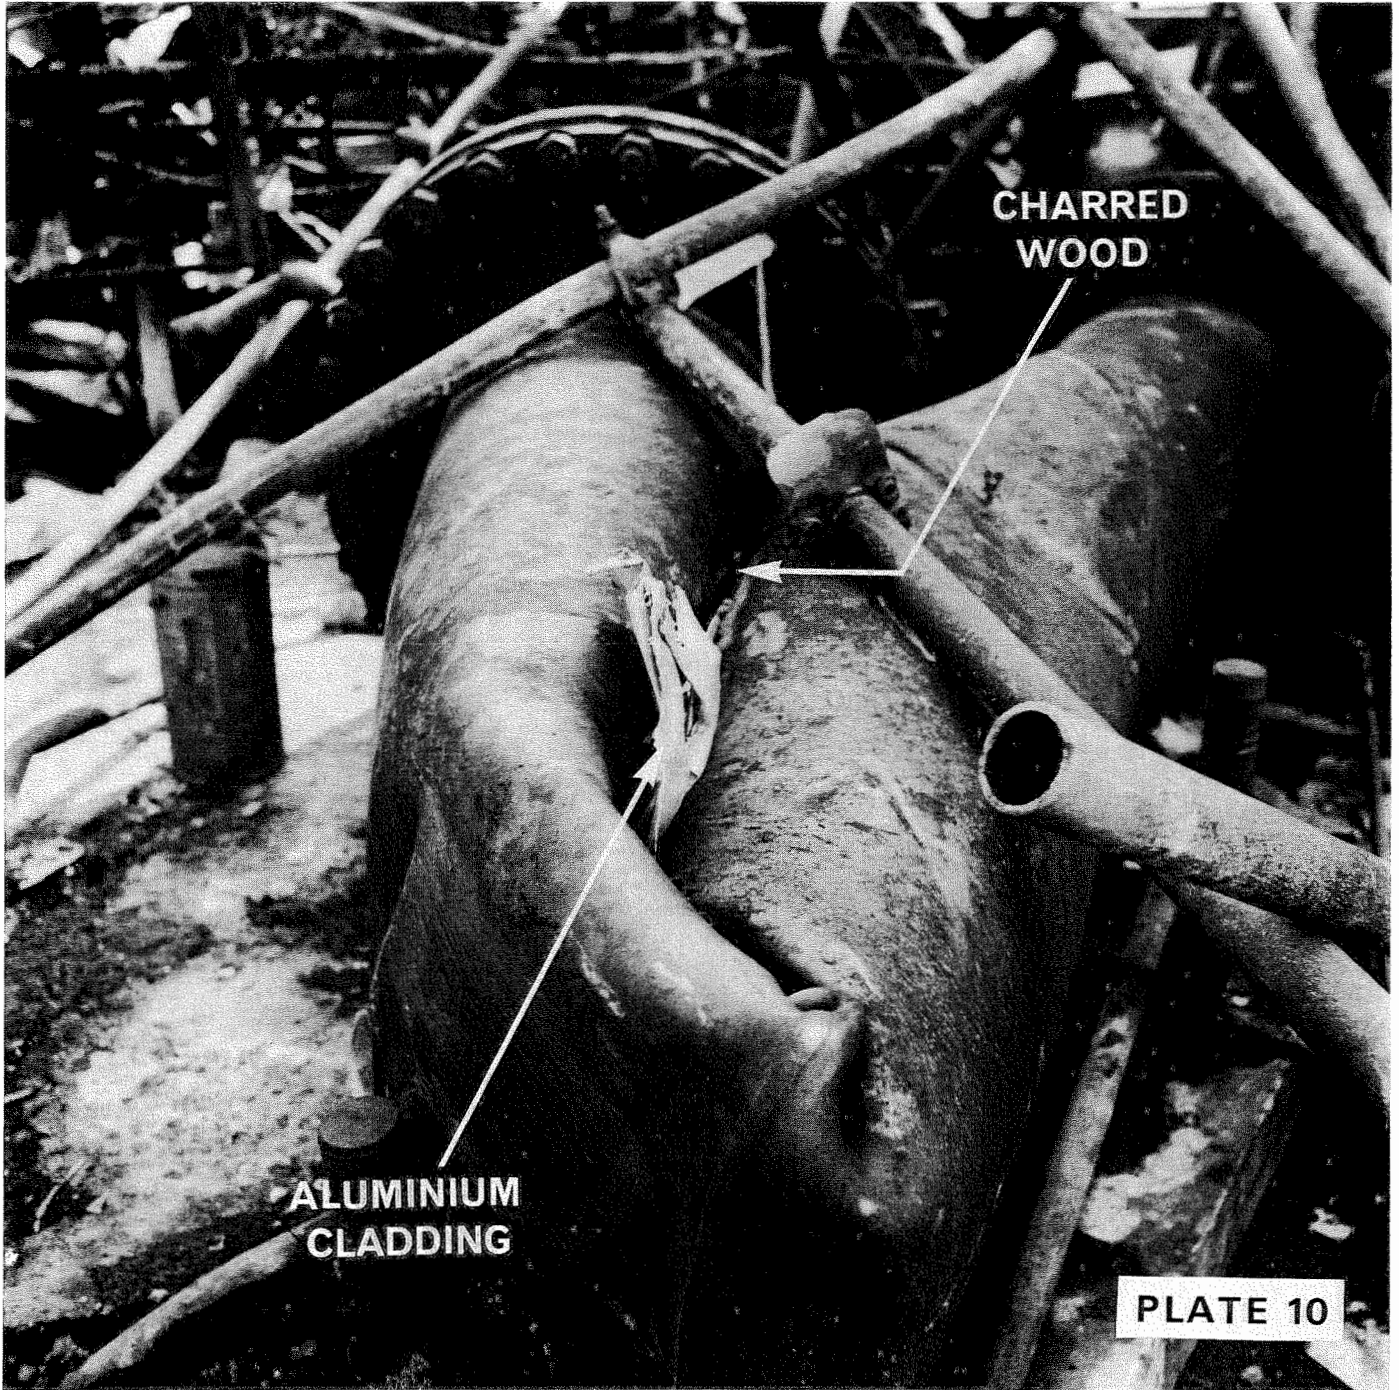
Plate 10 The jack-knifed 20 inch pipe showing trapped aluminium cladding and charred wood.

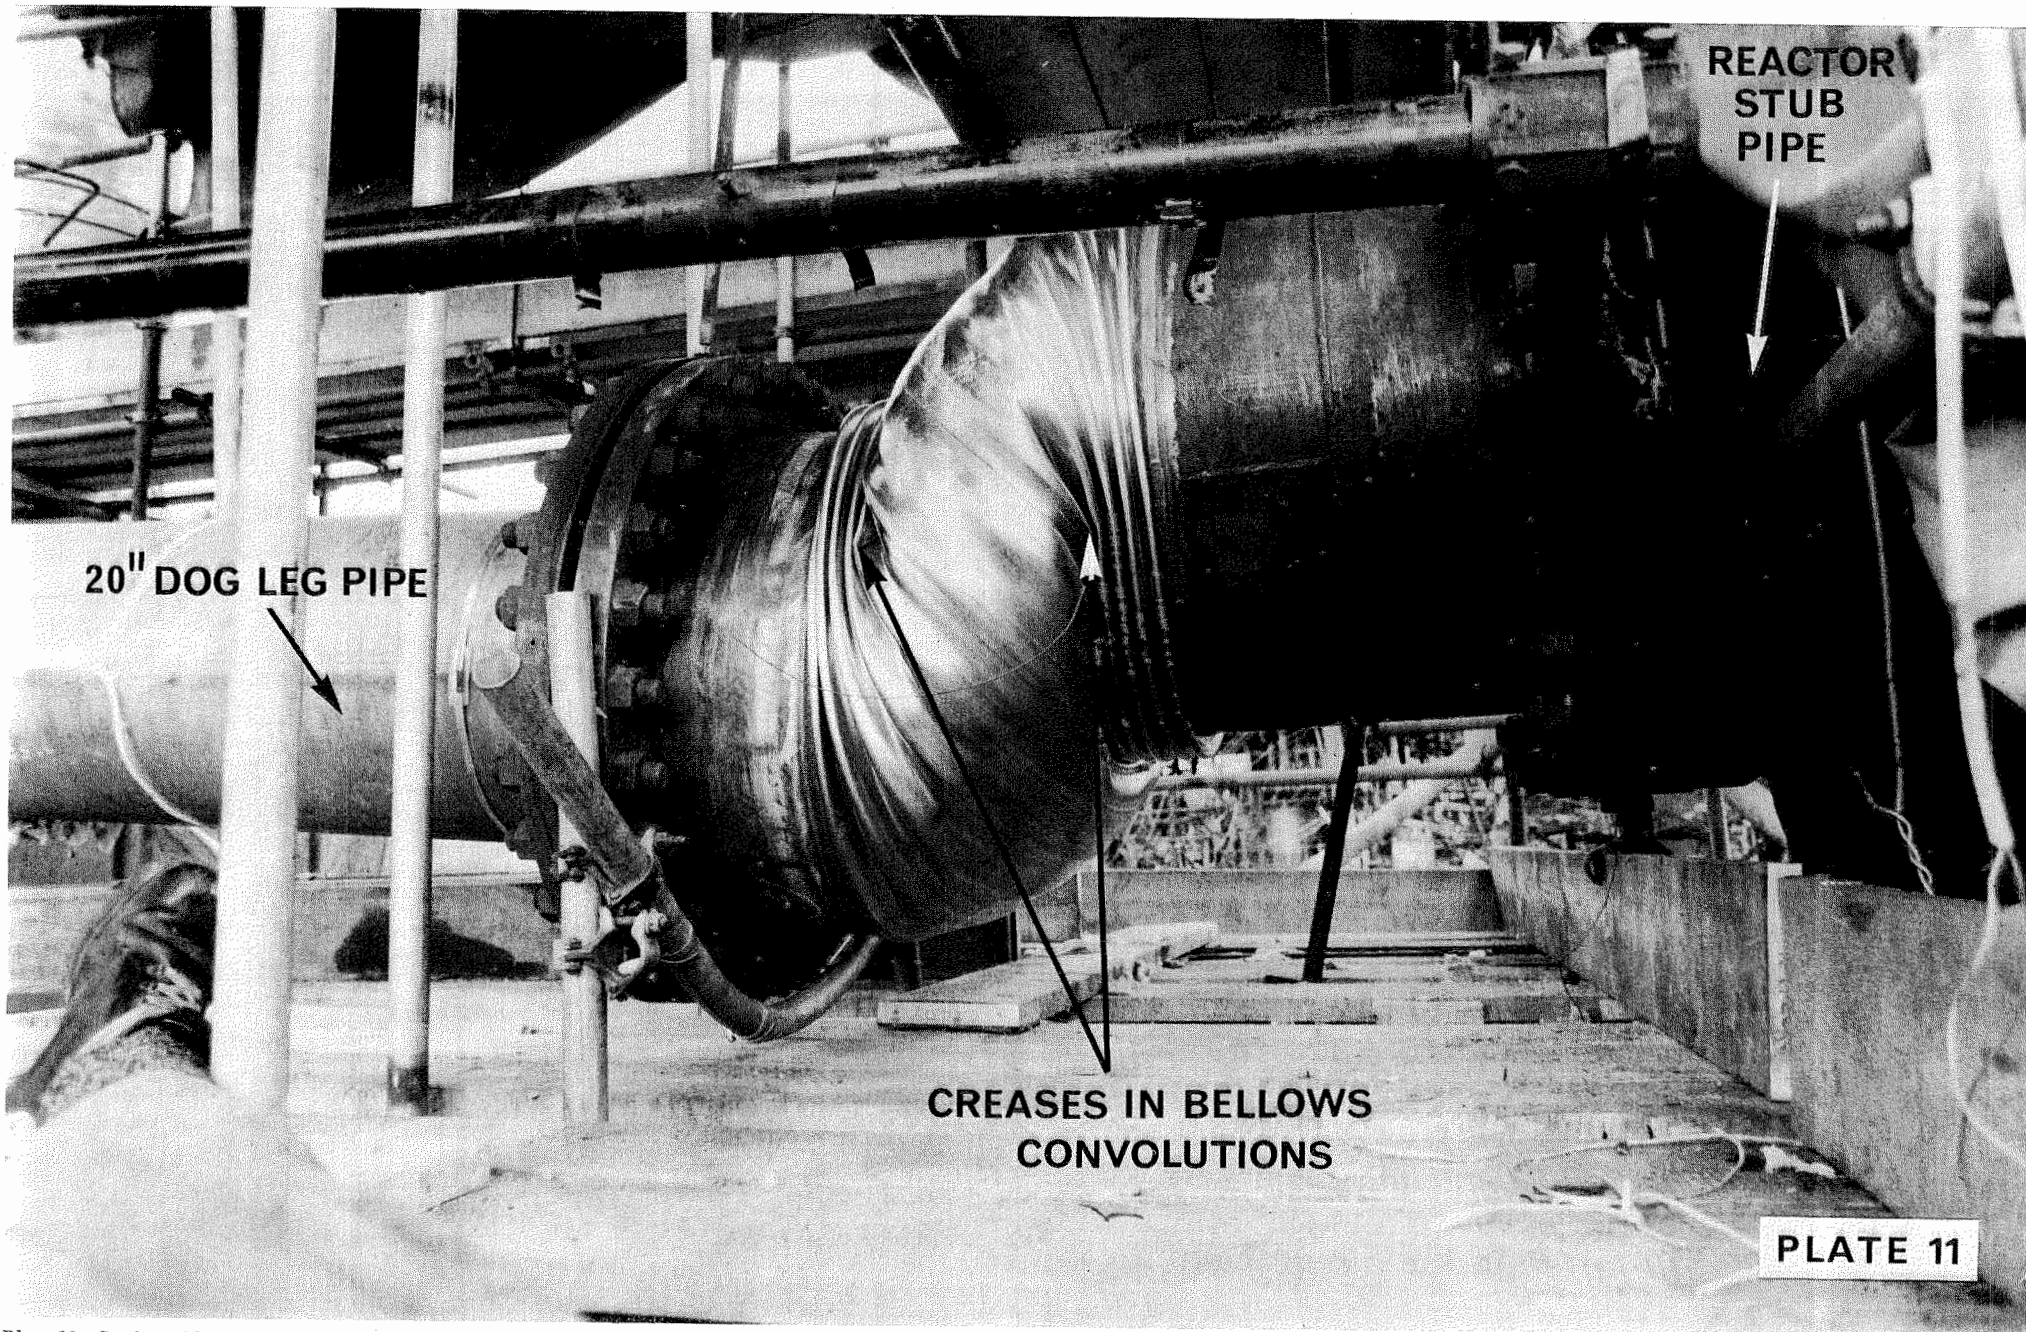
Plate 11 Squirmed lower bellows in the SMRE simulation test.

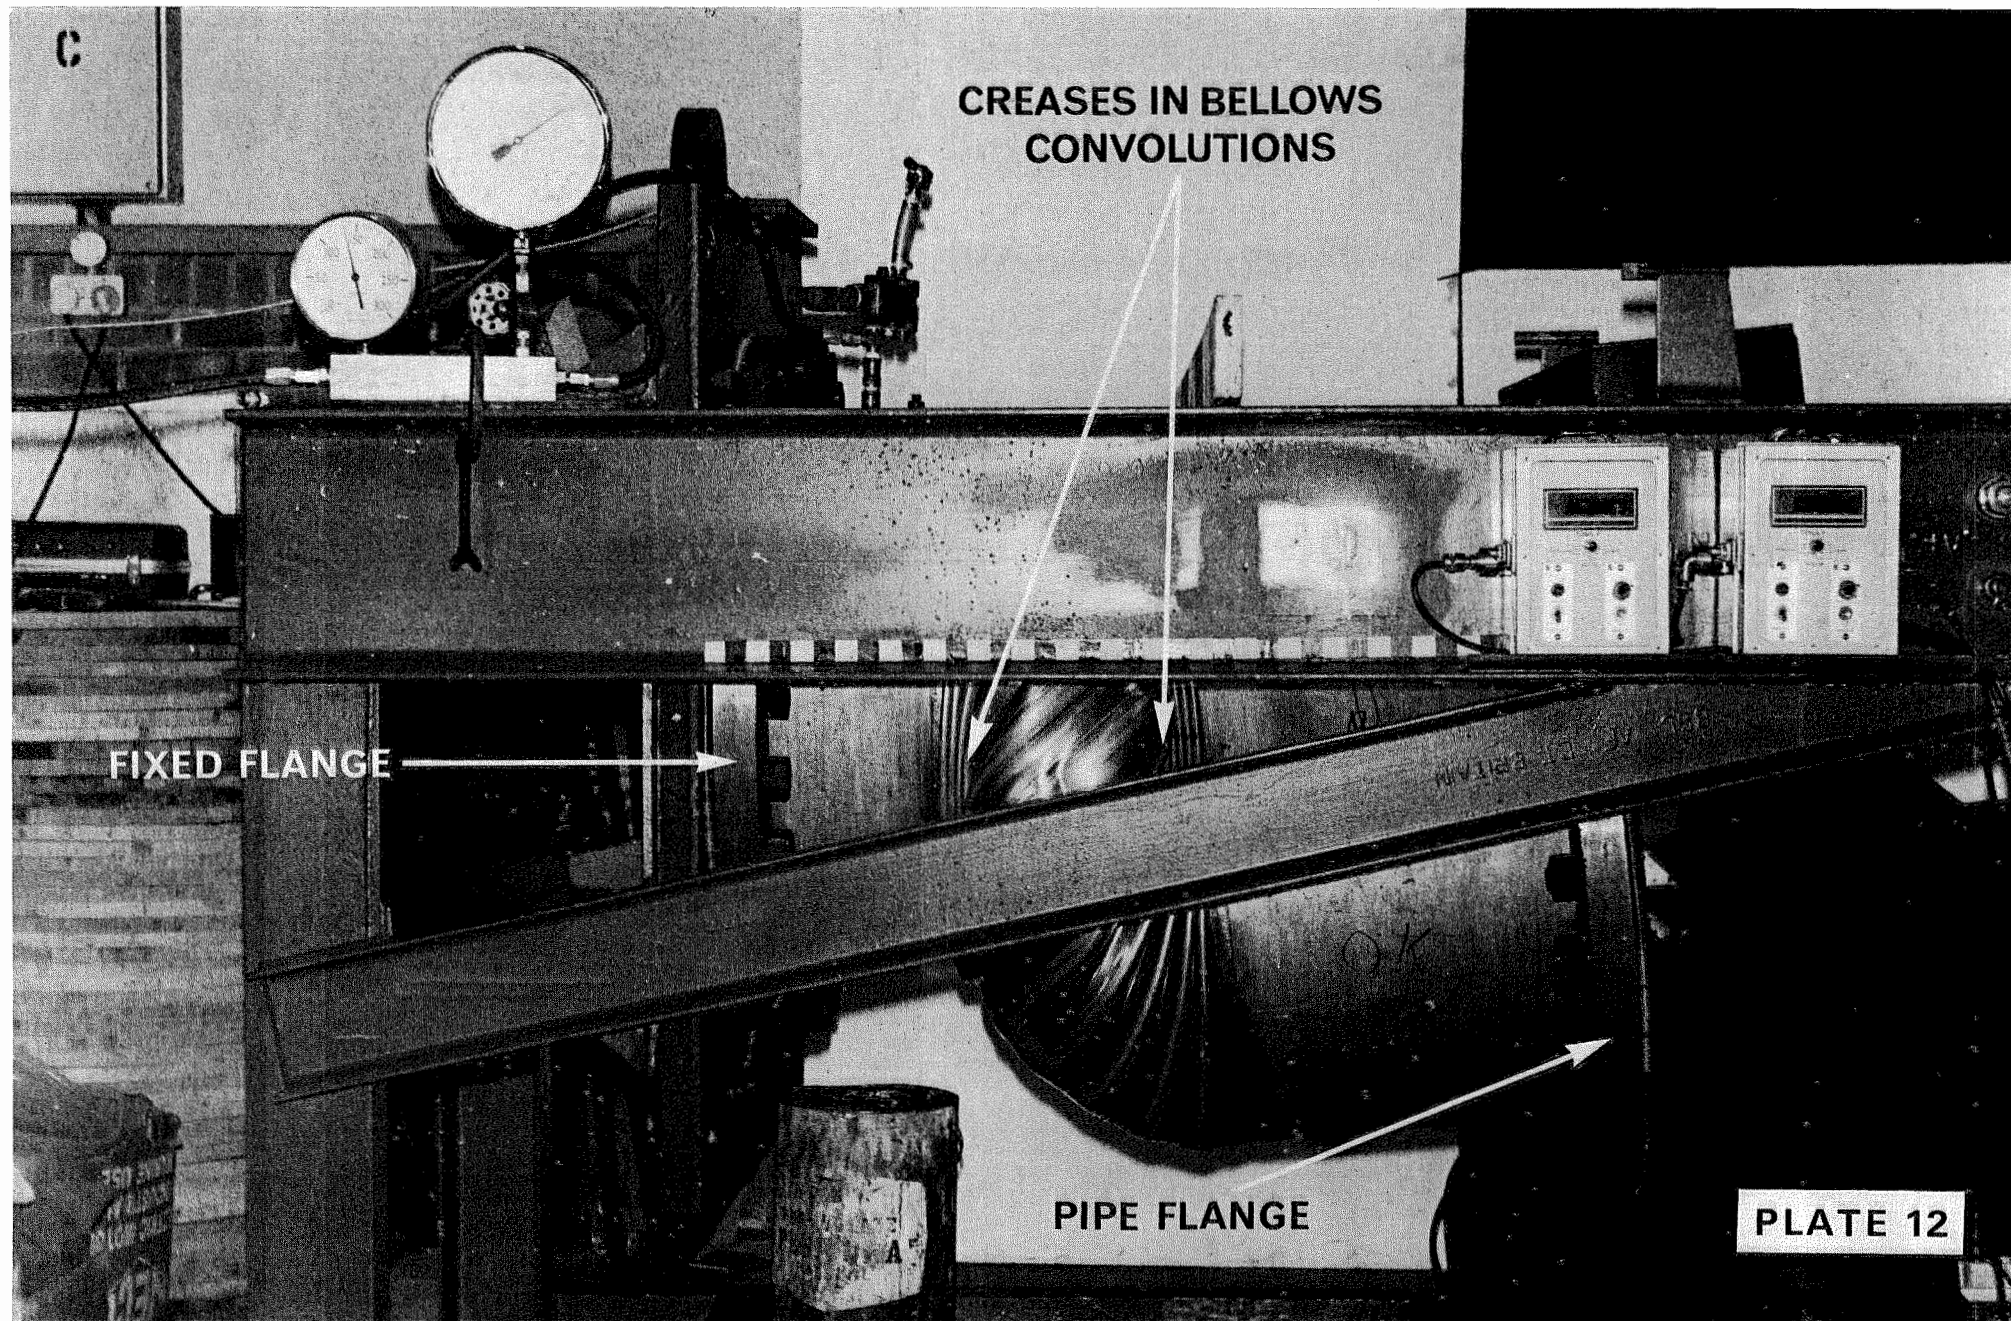
Plate 12 Squirmed bellows in the Nottingham rig. Note the similarity to Plate 11. (See also Fig. 7.)

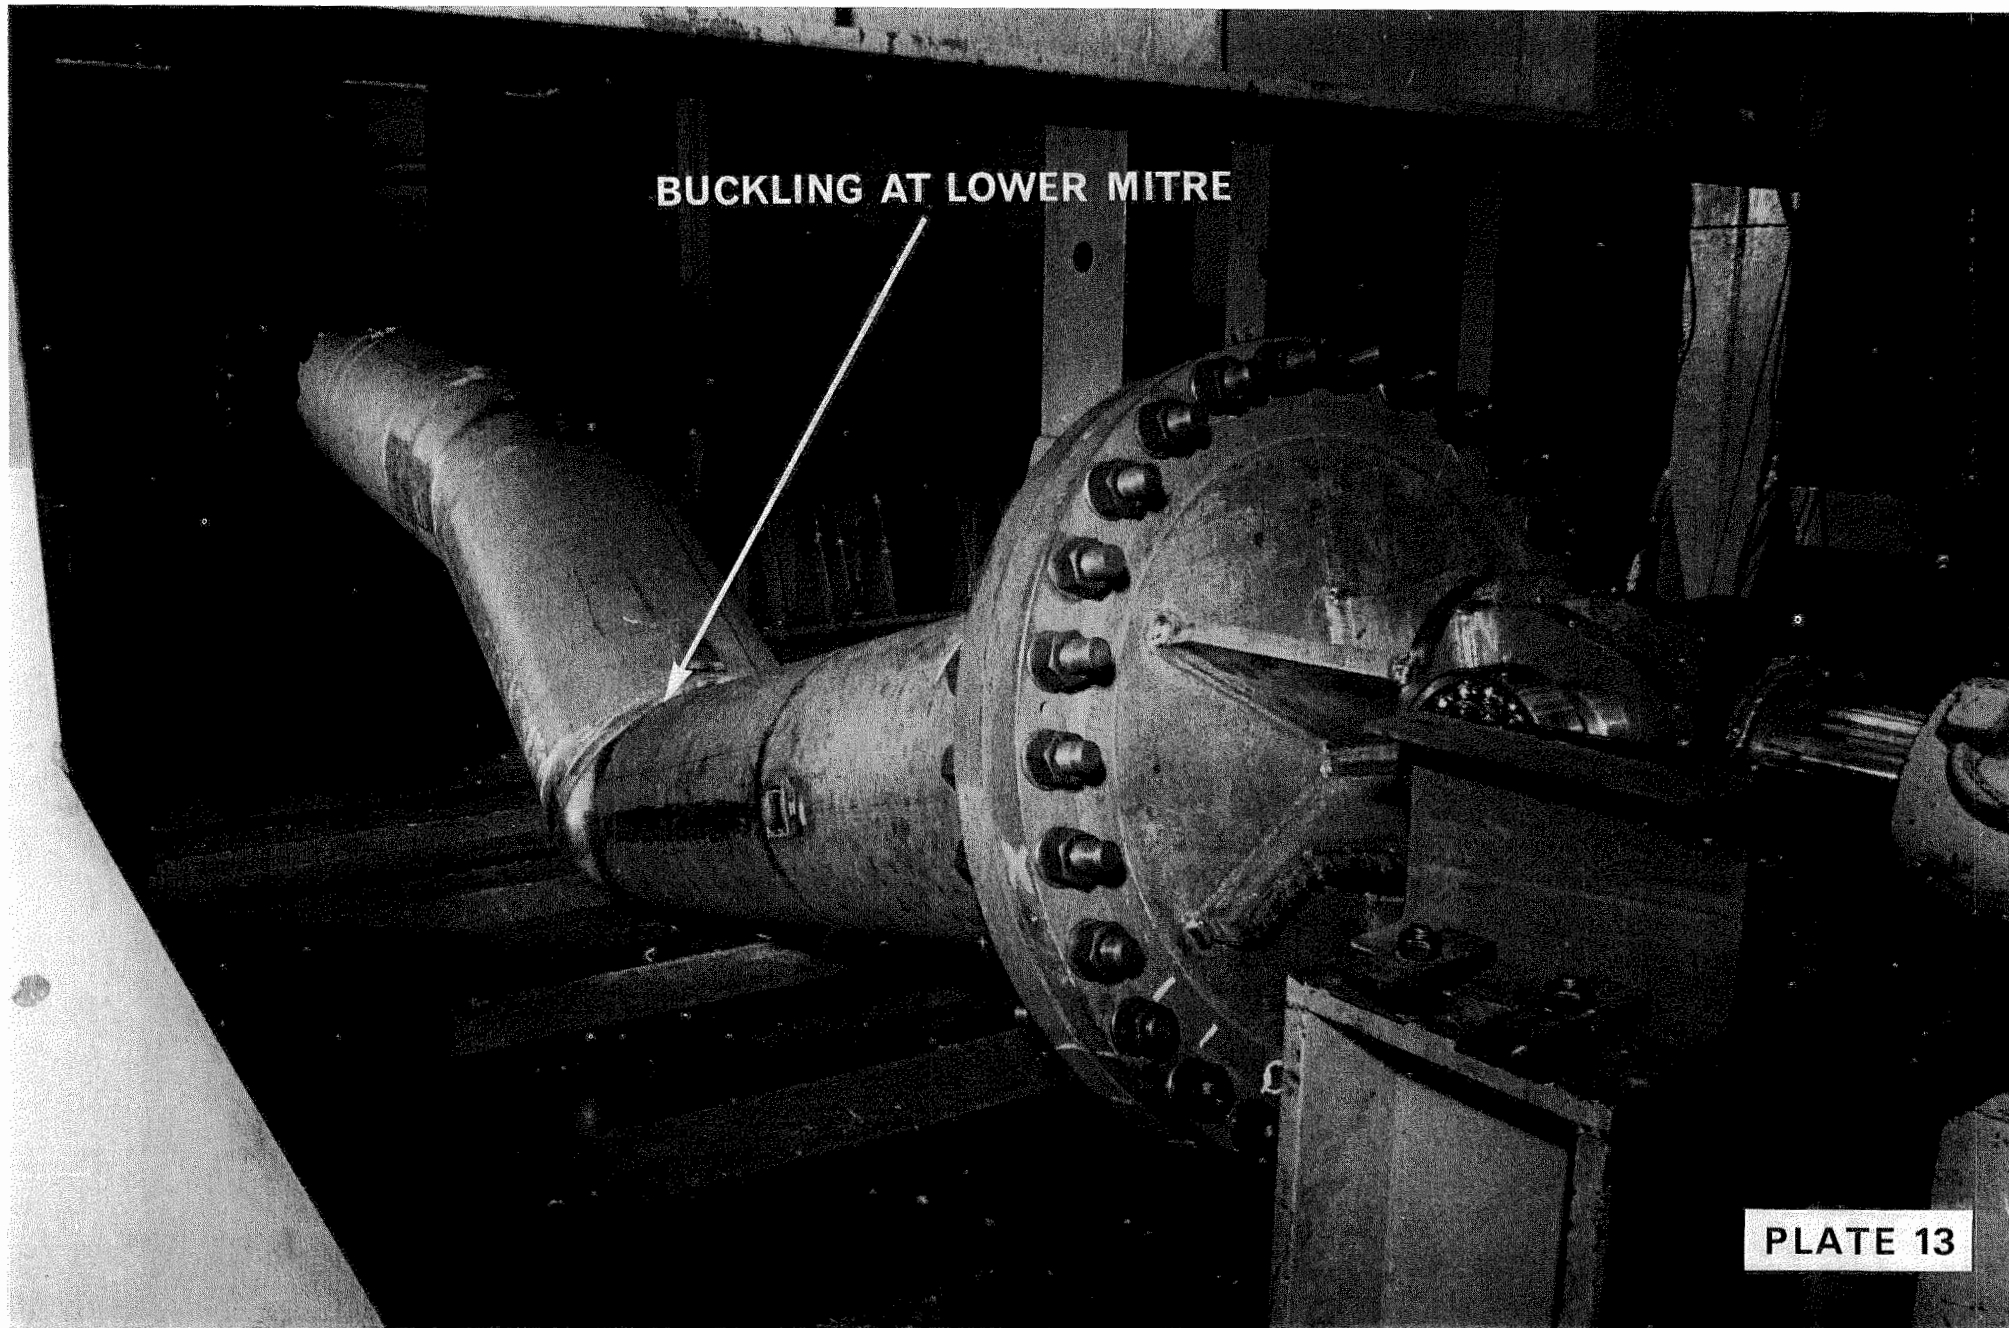
PLATE 13

Plate 13 Buckled pipe at Bretby. Compare with Plates 9 and 10 in which the jack-knifing is complete.

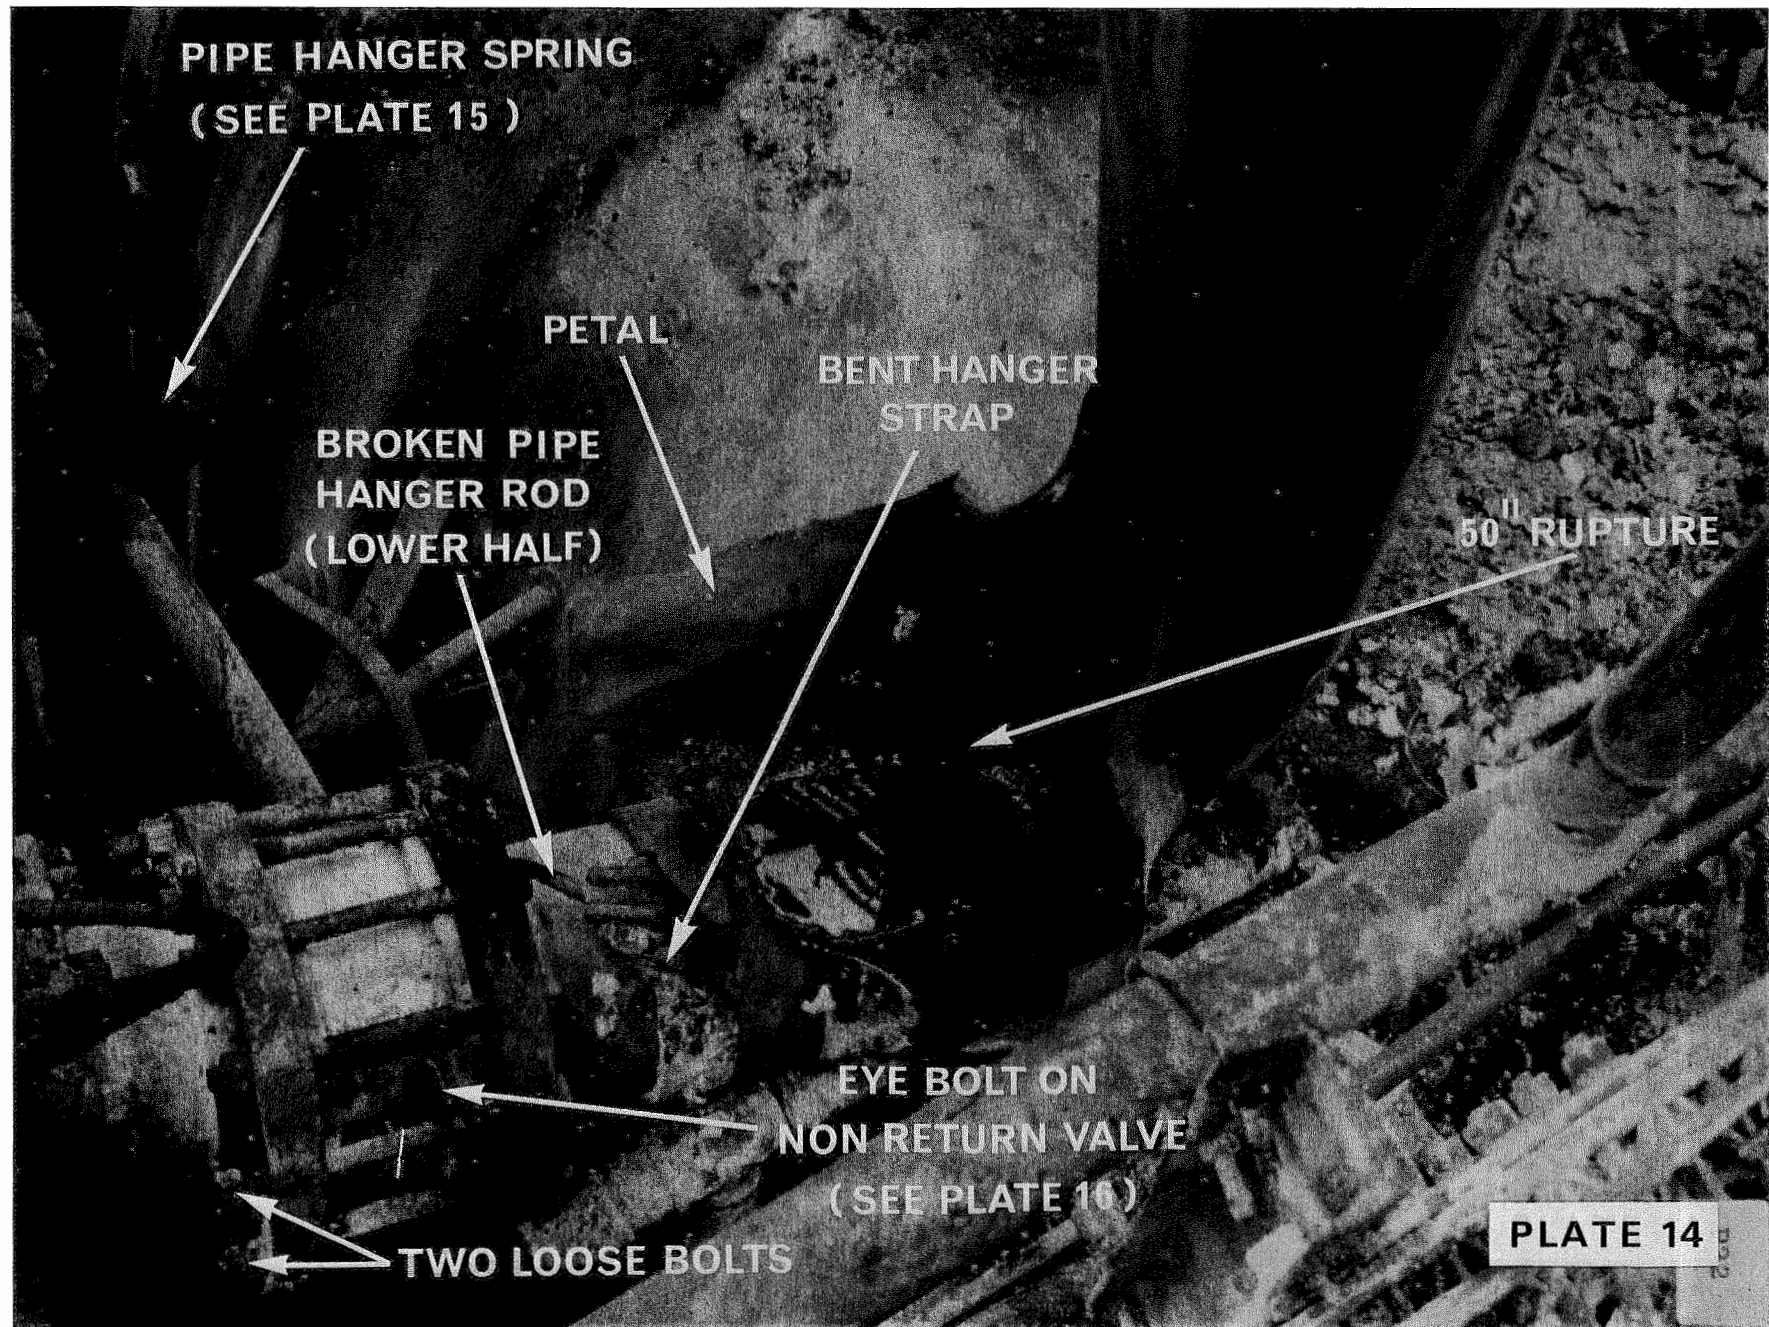
Plate 14 The 50 inch rupture on the 8 inch pipe.
