The Flixborough disaster

Report of the Court of Inquiry

**Formal Investigation into Accident on 1st June
1974 at the Nypro Factory at Flixborough**

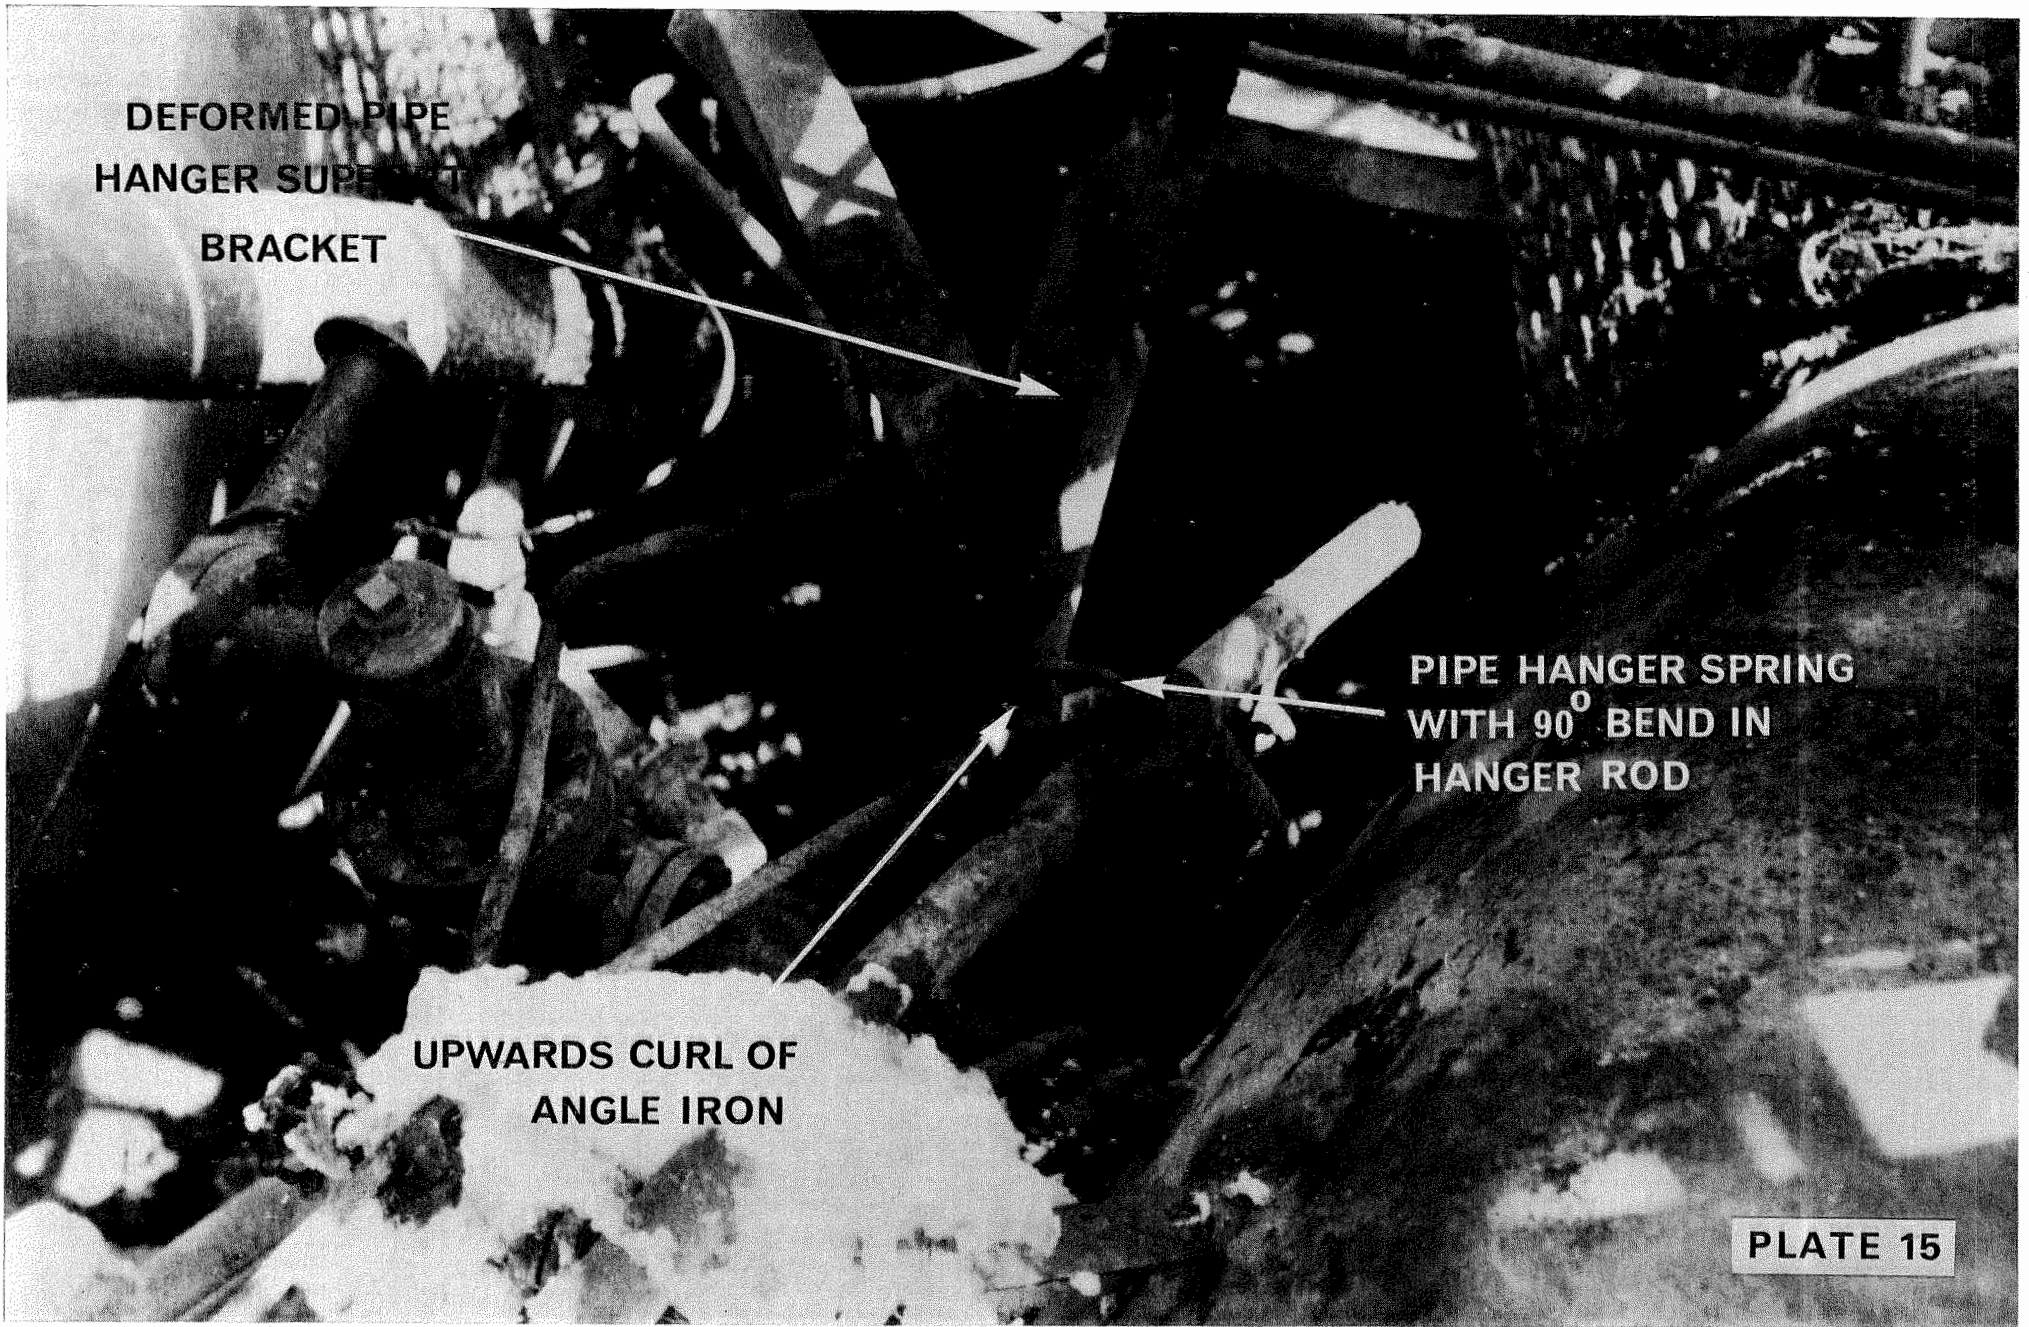
Plate 15 Broken and bent pipe hanger rod, and spring.

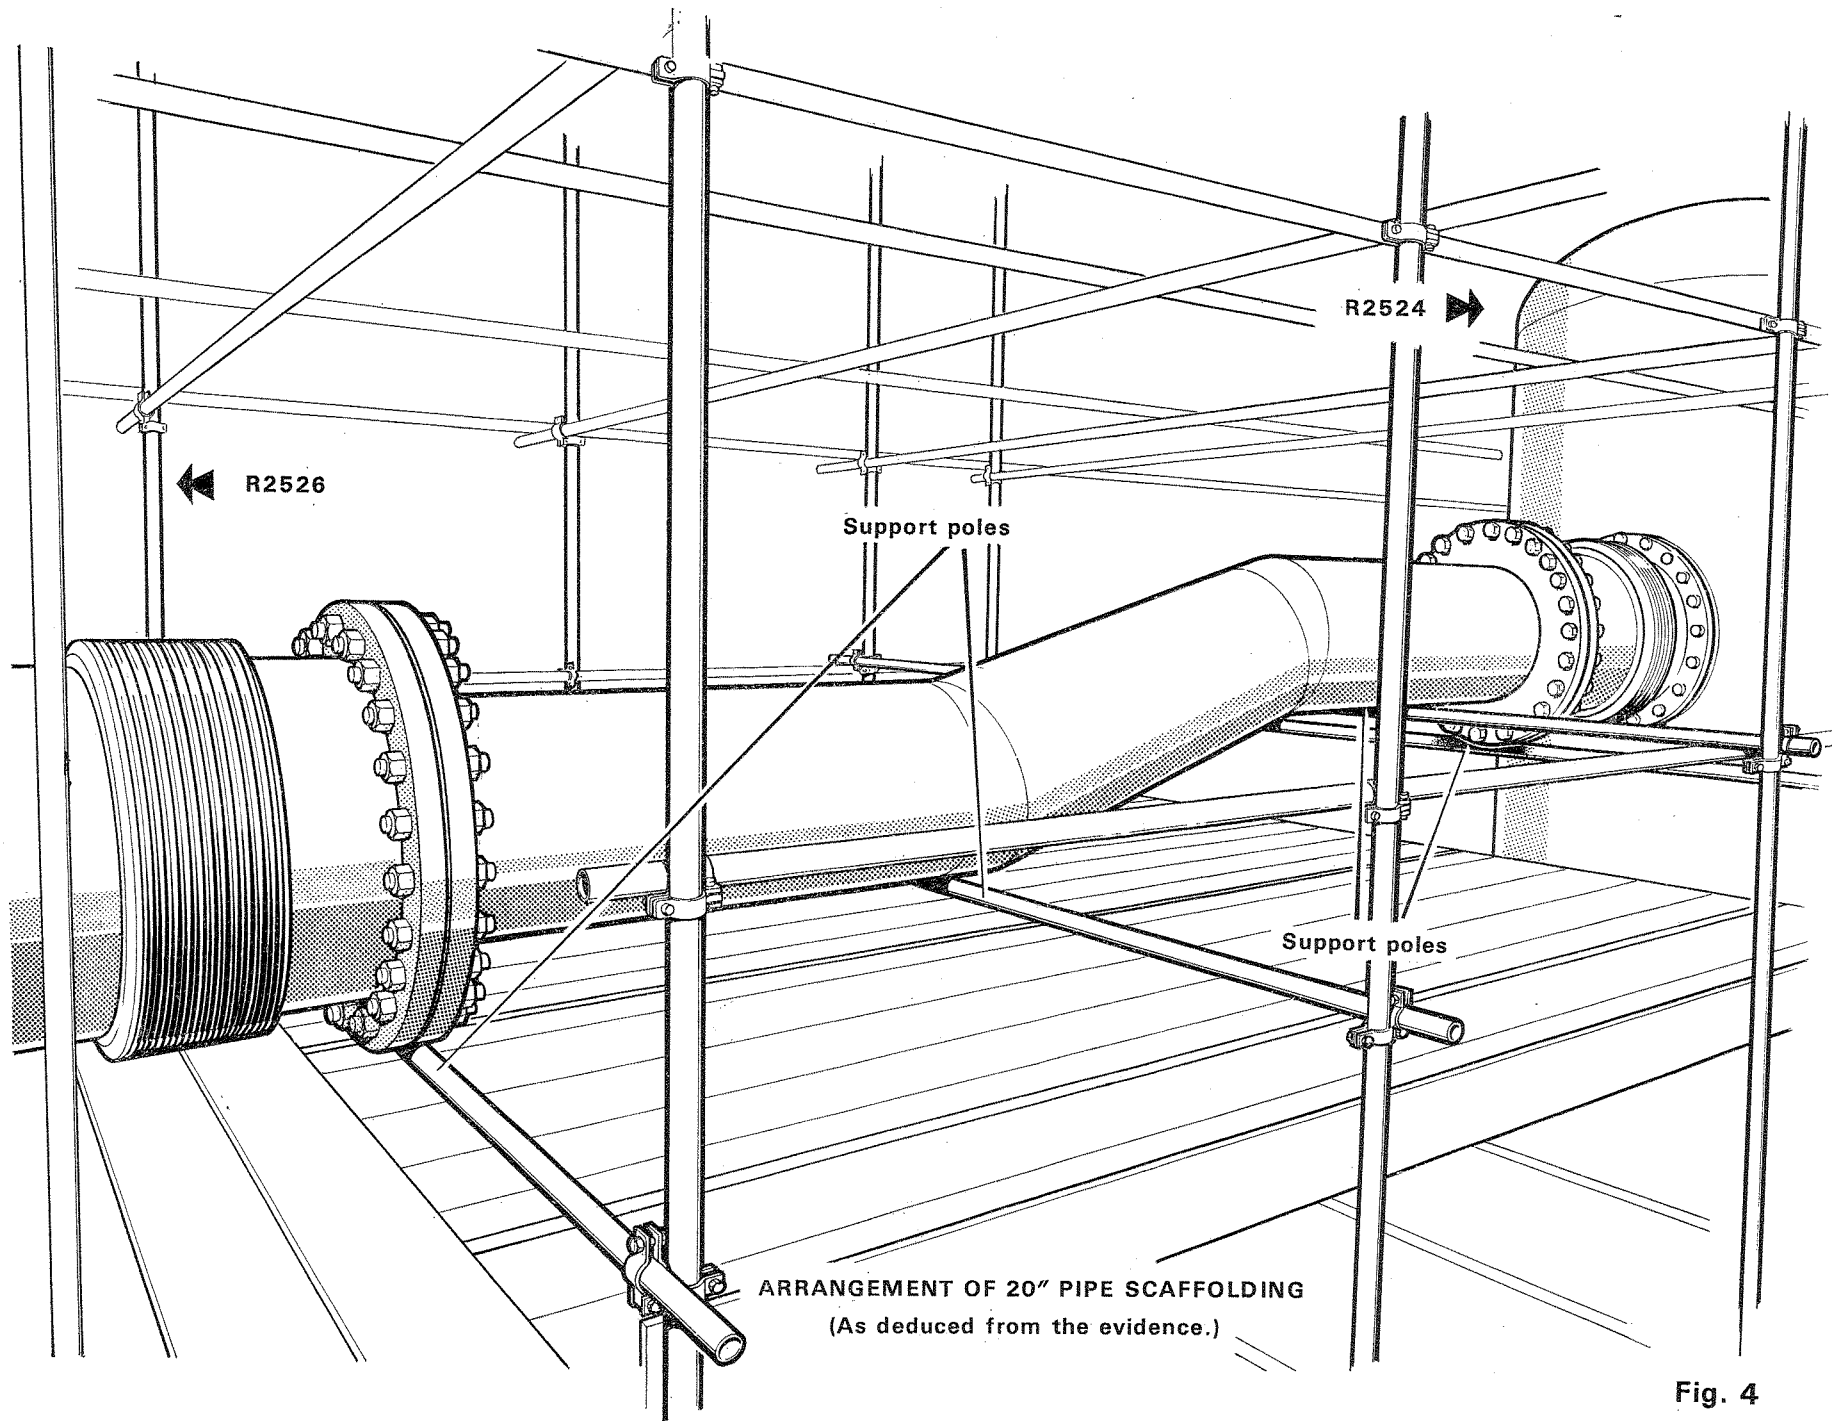
Fig. 4

62 It having been ascertained that the pipe as a pipe would both take the flow and would stand the internal pressures involved, the assembly, shown diagrammatically in Fig. 4, was devised. The existing 28 inch pipes with inset bellows — which had previously connected Reactors 4 to 5 and 5 to 6 — were instead connected by a dog-leg pipe which thus replaced Reactor 5. This dog-leg pipe consisted of three lengths of 20 inch pipe welded together, with flanges at each end bolted to the existing flanges on the stub pipes. The new flanges thus formed bridging pieces between the existing 28 inch pipes and the new 20 inch pipe. No-one appreciated that the pressurised assembly would be subject to a turning moment imposing lateral (shear) forces on the bellows for which they are not designed. Nor did anyone appreciate that the hydraulic thrust on the bellows (some 38 tonnes at working pressure) would tend to make the pipe buckle at the mitre joints. No calculations were done to ascertain whether the bellows or pipe would withstand these strains; no reference was made to the relevant British Standard or any other accepted standard; no reference was made to the designer's guide issued by the manufacturers of the bellows; no drawing of the pipe was made, other than in chalk on the workshop floor; no pressure testing either of the pipe or the complete assembly was made before it was fitted.

The approximate position of the four poles supporting the assembly is shown in Fig. 4. No poles or other means were used either to hold the pipe down or to prevent lateral movement. The four poles that were used (as shown on Fig. 4) were intended merely to afford support during assembly to ensure that the bellows were not strained under the weight of the assembly itself. For this purpose they were probably adequate. They were wholly inadequate as supports for the assembly during working conditions. This is not surprising for no thought appears to have been given to the question of desirability of support under such conditions, save by Mr Blackman who at the "design" stage provided Mr Culpin (his assistant) with a sketch for supports bolted to the pipe flanges and firmly attached to the reactor plinth. This support was not, however, provided and Mr Blackman did not take any steps to insist upon its installation.

(a) An assembly was installed which had been the subject of no design calculations, which did not comply either with the British Standard or with the bellows manufacturer's recommendations; which was subject to a turning moment under pressure; which was wholly unrestrained in an upward direction and wholly inadequately restrained in a downward direction. As a result the bellows were subjected to shear forces for which they were not designed and the 20 inch pipe was under high and unknown stresses resulting from the end loads of 38 tonnes.
