Creeping Change: Liquid Accumulation in a Flare System at a Gas Terminal

Roger Berriman, Senior Process Safety Engineer, CSL, Woodland House, Woodland Park, Hessle, HU13 0FA, UK

Keywords: Flare, Condensate, Management of Change, Pre-startup safety review.

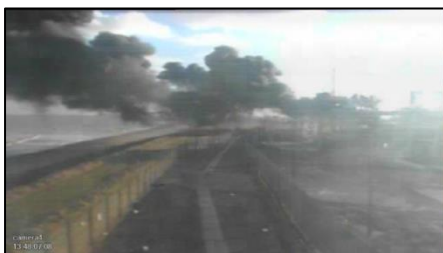
An abnormally large flare was observed at Easington Terminal on 17th January 2018 at 13:48. The 20 metre large flame was accompanied by thick black smoke and a pool fire contained within the on site ground flare sterile area (see Figure 2). The site alarm was sounded and all 102 personnel mustered.

Figure 2: CCTV image from the large flare event on the 17th January 2018.

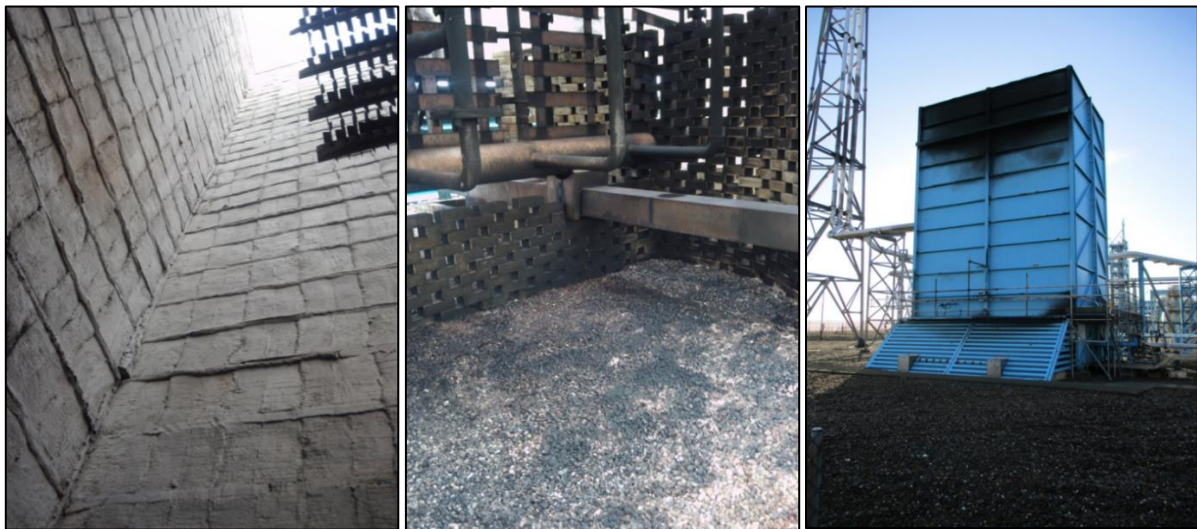
The event caused minor damage (i.e. scorched pipework) within the flare stack and left a soot film on the outer surface of the vertical flare ‘box’ (see Figure 3). No injuries were sustained to personnel during the event. The smoke from the flare could be observed offsite although the prevailing wind was from the West, taking the smoke cloud out to the North Sea.

Figure 3: Inspection photographs of the ground flare following the event. Internal fire bricks (left), pipework and scorched gravel (pool fire residue) (middle) and soot deposits on external structure surface of the ground flare (right).

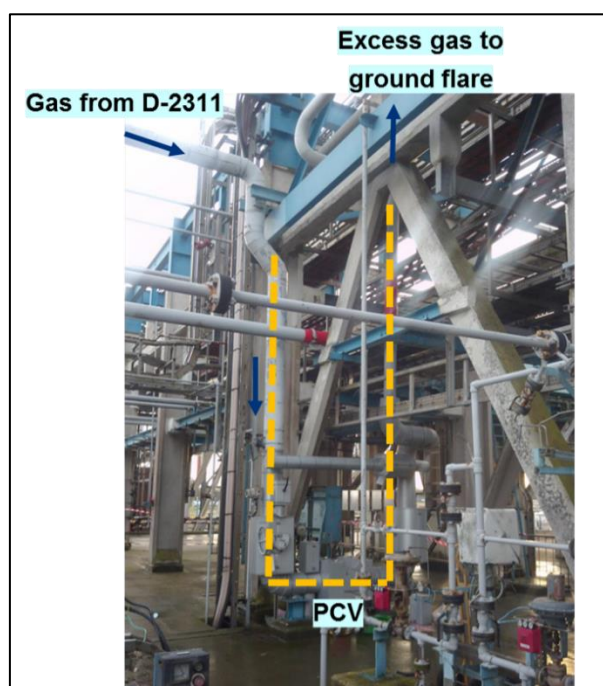
- Low points in vapour pipework from the hot flash system to ground flare. The 6" vapour line from D-2311 dropped down to grade level and into back pressure controller PCV-23351 before heading back up to the pipe rack level (approx. 10 metres elevation). Condensed liquids accumulating in the main 16" header flowed back towards low point at PCV-23351. See Figure 6.

Figure 6: Overhead vapour line from the hot flash system. Dashed line represents low point or 'pocket' in the line for liquid accumulation. The vent header pipework to the ground flare is inclined back towards the PCV causing accumulated liquids to drain back to the low point.

In changing the operation of the continuous operation flash gas condenser (E-2307) to run in batch mode and removal of the route to the flash gas system and onto the ground flare instead, the potential for liquid condensation in the system outlet vent header was not initially recognised. The operations and maintenance teams at Easington terminal had not expected liquids to accumulate downstream of D-2311 which therefore resulted in condensation and accumulation of liquid in the low level 'pocket' (see Figure 6) at PCV-23351 and the vent header to the ground flare.

flare from the flash gas/hot flash area of site. The orientation of the remaining section of the 16" line (which runs approximately 100 metres from West to East across site) has resulted in a natural fall in level back towards the hot flash system allowing liquids to build up at a low point (PCV-23351).

- Re-range and relocate the pressure transmitter in the hot flash system, recalibrate flow transmitters and ensure flow control valves fail safe (i.e. closed) in the event an error occurs with a flow transmitter, recalibration of level transmitters on the knock out drum (D-2301) and cleaning of level bridals, recalibration of back pressure controller (PCV-23351).
- Provide hot flash cooler (E-2307) fan running indication and temperature indication on the DCS for the control room operator to monitor.
- Provide operating instruction to ensure hot flash system lines are drained and free of liquids prior to start-up.
- Relocate back pressure controller (PCV-23351) from grade to vent header gantry to remove low point 'pockets' in the vent line through to ground flare.

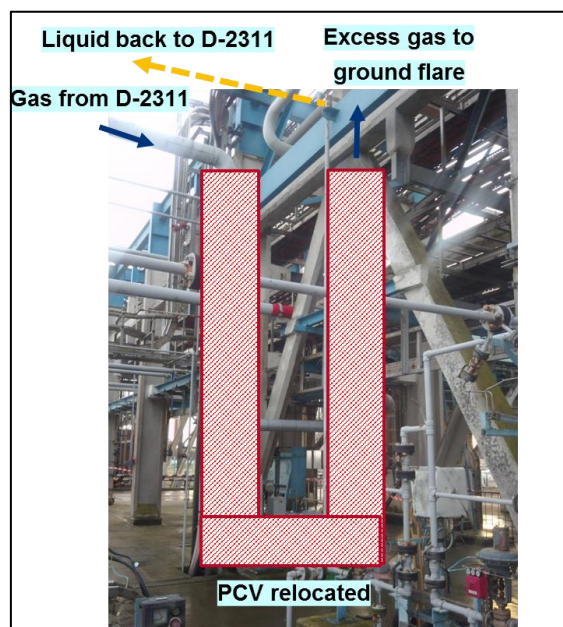
Figure 7: Overhead vapour line (with 'pocket' removed) from the hot flash system following proposed site upgrade project. Dashed line represents condensed liquids draining back from the vent header to the hot flash condensate stabilisation system knock-out drum (D-2311).

A further enhancement project at the site will enable processing of gas from the Tolmount gas field to start in 2020 (see Figure 1 for location of the Tolmount field in the Southern North Sea). Figure 7 shows the proposed modification that will remove the existing 'pocket' from the gas vent line to ground flare that has been incorporated into the detailed design for the wider site upgrade project.
