When the Holes Align

Anowi, Nnamdi (*Engineering Manager, Nigeria - Shell Companies in Nigeria*) & Alaka Olanrewaju (*Senior Process Engineer*)

This paper reviews the effect of human and behavioral actions on one of the watertight Process Safety Management method in the Energy Industry, with reference to Fossil Energy (hydrocarbons). The case studies analyzed are based on breaches to the three elements of Asset Integrity Methodology of managing Process Safety, which has Integrity Leadership at its core.

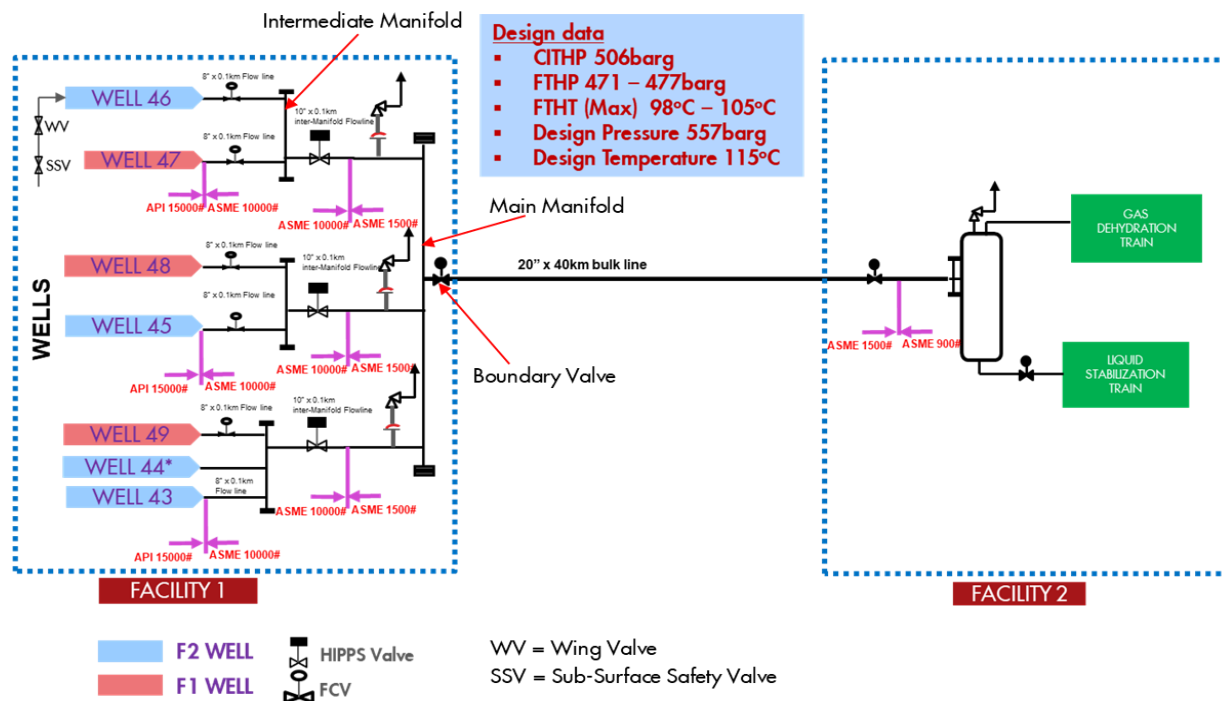
Figure 2.1: Schematic of Case Study 1

On 29th March during routine well equalization activity at a remote gas well manifold, the relief valve (RV) on the line connecting the 3rd intermediate manifold to the main manifold lifted at 129barg (below set point of 150barg). A Root Cause Analysis (RCA) into the failure and joint assessment confirmed that a similar event occurred 9 days earlier (on 20th March), with circa 3750 standard cubic feet (scf) of gas (87kg) discharged to the cold vent from the 3 RVs on the lines connecting the individual intermediate manifolds to the main manifold.

- No pressure excursions outside the operating envelope. Examination of RV (during recalibration) confirmed damage to spring.
- Historical trending on Distributed Control System (DCS) revealed unusual pressure spike on the intermediate manifold on the 20th March (153+barg).

- Pressure spike above 150barg on the 20th of March ruptured all 3 BDs on the intermediate manifold flowlines.
- PDIAs (Pressure Differential Alarm) across the BDs were found to be isolated from process (during a previous maintenance activity) and therefore did not register alarms in the DCS when BDs ruptured. – **Failure 1 (Technical Integrity)**

- The manifold operations continued between 20th to 27th March with ruptured BDs.
- Valve closure time of Wing Valve (WV) and Sub-Surface Safety Valve (SSV) for wells is 40 - 60secs while the boundary valve on the bulk line closes in 20 secs. This resulted in rapid pressure equalization across FCV, over-pressurization of the low-pressure section of the manifold (#1500 section), rupture of BD and lifting of RVs. – **Failure 2 (Design Integrity)**

- Process dynamics is faster than the valve dynamics hence pressure excursions beyond the High Integrity Pressure Protection System (HIPPS).
- Piping lengths upstream of FCV is longer than the piping length downstream of FCV, hence settle out of inventory across FCV on ESD/OSD results in the rapid over-pressurization of the downstream low-pressure section. – **Failure 3 (Design Integrity)**

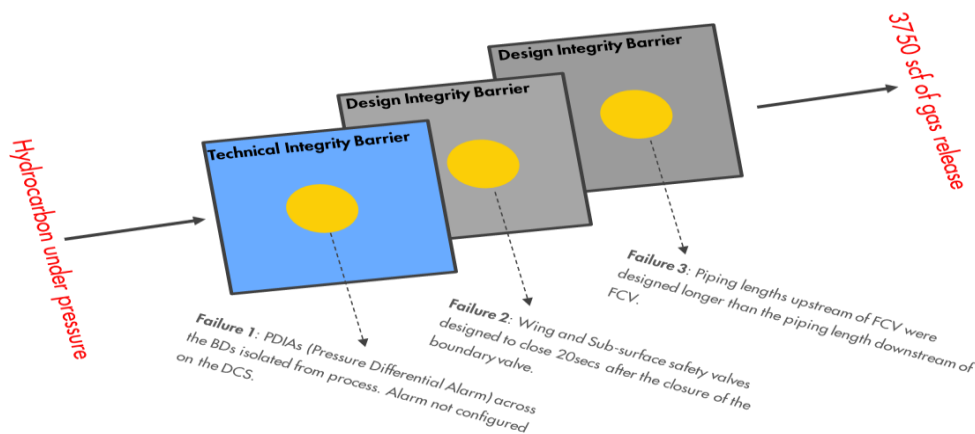
Figure 2.2: Failed Barriers for Case Study 1

This case study identified breaches to two elements of the Asset Integrity Management System. However, the focus in this analysis is on design integrity (Figure 2.2). An important part of facility design should be the impact of piping dimensions and automated shutdown/isolation valve response times on the behavior of the process. Furthermore, dynamics behavior should be confirmed using simulators, prior to commissioning and startup. The lack of appreciation of how changes in process dynamics affect the operation of the facility, comes down to human error in design.

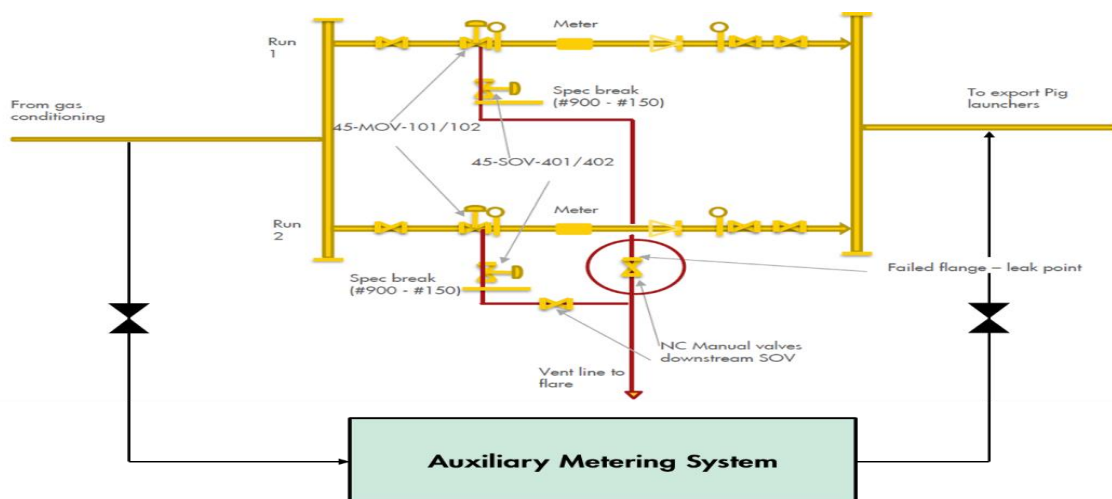
Figure 2.3: Schematic of Case Study 2

At about 10:35hrs, an operator observed a leak from a 2" vent line flange on the standby meter Run-1 of a gas metering system. Flow was then diverted from metering system (Runs 1 and 2) to auxiliary metering system, followed by depressurization of the line to stop the leak.

- The 1" solenoid valve (45-SOV-401) connected into the cavity of the 24" MOV (45-MOV-101) failed open (failed solenoid coil). However, the 2" (manual) vent valve to flare downstream 45-SOV-401 was in closed position, leading to over-pressurization and hence failure of the 150# gasket on the line.

- The 24" manual valve upstream 45-MOV-101 was passing in closed position. – **Failure 1 (Technical Integrity)**
- As per Standard Operating Procedure (SOP), 45-MOV-101 should be in closed position when Run-1 is on standby. However, 45-MOV-101 was faulty and stuck in open position. Furthermore, Asset was yet to initiate corrective maintenance for the Safety Critical valves prior to incident. – **Failure 2 (Operating Integrity)**

- Piping and instrumentation diagram (P & ID) indicated 2" manual (vent) valve downstream 45-SOV-401 as normally closed (NC) instead of normally open (NO), as per design guide (to guarantee open path to flare). – **Failure 3 (Design Integrity)**

- Further checks on the “Approved for Construction” drawing indicated the 2” vent valve as NO. However, post construction update of As-built indicated 2” vent valve as NC, with no approved Change Management. – **Failure 4 (Design Integrity)**
- Leak detection system (45-SOV-401 and 45-PIA-401) is not configured on the DCS graphics. Although found in the Asset Register, no maintenance plan was in place. 45-PIA-401 is configured only as a pressure transmitter (display only on site). – **Failure 5 (Design Integrity)**

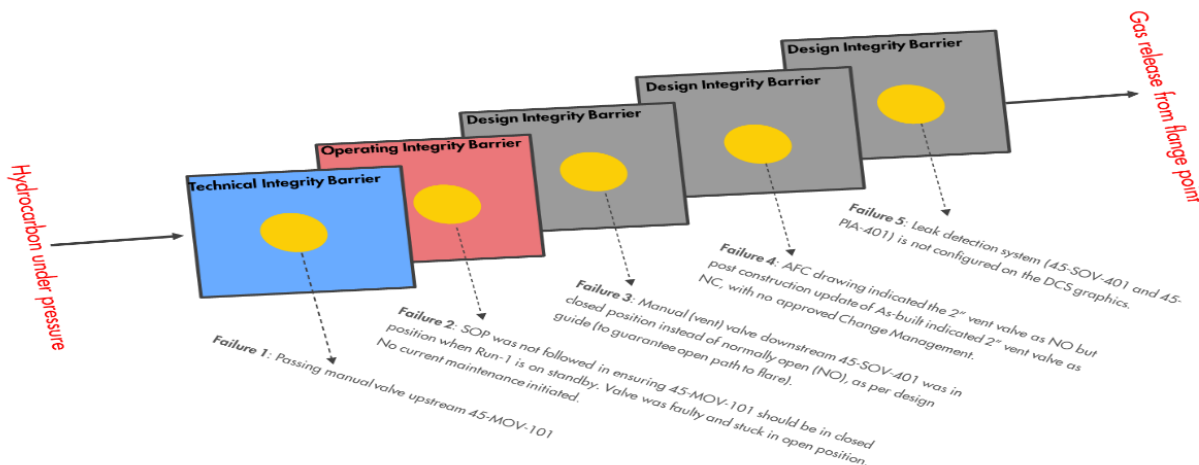
Figure 2.4: Failed Barriers for Case Study 2

However, focus of this case study is on the breach to Operating Integrity (figure 2.4). There is a high likelihood that if the operators had walked the line after noticing the failure of the solenoid valve and the passing 24” ball valve, they could have observed the 2” (manual) vent valve to flare in closed position. Operating integrity centers primarily on compliance with procedures and standards, which in this case was breached. Furthermore, connection of 45-PIA-401 to the DCS could have warned operators of the trapped high-pressure gas in Run-1, which would have prevented startup of production until the valves are fixed. There was apparently no demonstration of end-to-end appreciation of the cumulative risk of multiple failed barriers by the operators.

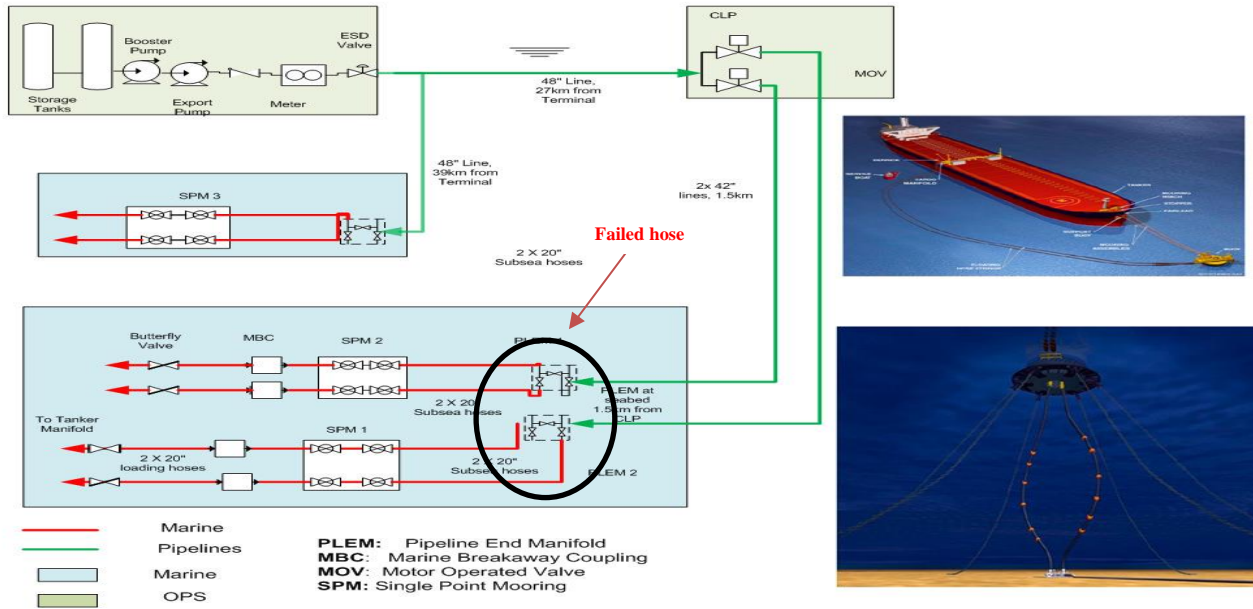
Figure 2.5: Schematic of Case Study 3

At about 05:00am on Friday 22-Dec-17, a “ship-shore” loading difference of 4,774 barrels was observed during the loading operations at a crude terminal. The control room contacted the ship operators to reconfirm the figure. The Ship Captain (Pilot) was consequently informed to stop the loading due to a suspected leak. The loading was stopped at 05:10am. An oil sheen area of approximately 187 barrels was noticed in the marine environment.

- Hose proof test pressure was 22.5 barg as against typical operating pressure of 15 barg
- Offtake pressure from the terminal was at average of 18barg, while the pressure at the subsea hose (delivery point) was 15.9barg – **Failure 1 (Operating Integrity)**

- Hose minimum burst pressure is 75 barg and design life is 5 years from installation date. Hose was installed on 1-Dec-10 and due for change-out 1-Dec-15. Changeout was originally scheduled for 10-Jul-16, and then extended twice without a change management approval. – **Failure 2 (Technical Integrity)**

- A tear of approximately 500mm x 80mm (although not deep) was observed on the first subsea hose attached to the string from the PLEM take off arm connection during April 2016 inspection. There was no evidence of close monitoring for further deterioration of the hose as the anomaly was not found in the corrective maintenance download from SAP. – **Failure 3 (Technical Integrity)**

- The leak occurred on 22-Dec-17 and Diver's inspection on 27-Dec-17 revealed a damaged section of the hose in question from the PLEM1 (which happens to be around the same section of deterioration identified during April 2016 inspection).

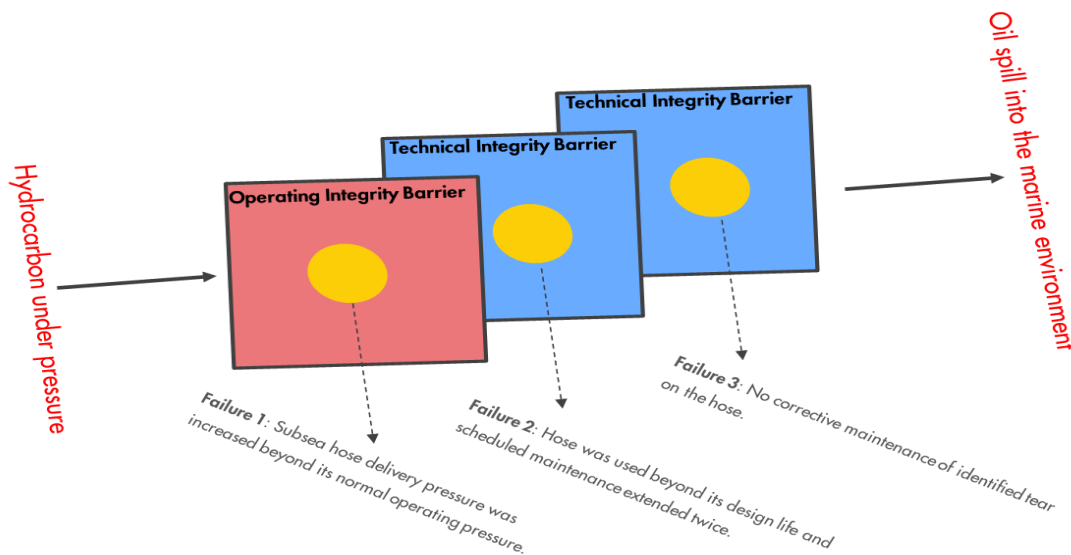
Figure 2.6: Failed Barriers for Case Study 3

However, focus of this case study is on the breach to Technical Integrity (Figure 2.6). Scheduled change out of hose was extended twice over a period of 2 years without a change approval, despite the observed failure from inspection. A performance standard was set for maintenance and replacement of the hose, but this was not followed through leading to the incident. The human and behavioural barrier in the maintenance chain failed in this incident.
