# Poly-butadiene formation in Olefins Debutanizer Condenser

Author: Ali Bazroun, Process Safety Engineer, Sabic

In one of Sabic olefins plant, the condenser of the debutanizer tower was fouling. This was evident through the pressure increase in the tower and the cooling water control valve reaching the maximum opening (69%) limited by the mechanical stopper. The condenser process service is butadiene, which has the tendency of polymerizing and formation of popcorn, which could plug relief piping or accumulate in the condenser until the vessel shell is over stressed causing loss of containment and leading to fire or explosion. The risk assessment team evaluated that the condition could result in multiple fatalities with a likelihood of  $10E-2$ . Dispersion modules were developed for the 2 failure modes identified, flange opening and mouth fish crack for fire and explosion to understand the risk. A new process line that bypasses the debutanizer tower and sends the material to the flare was constructed as interim solution to effectively mitigate the identified. The project execution was remarkable as it was completed in about a week. 15 tons of C4 was being flared per hour. This, h

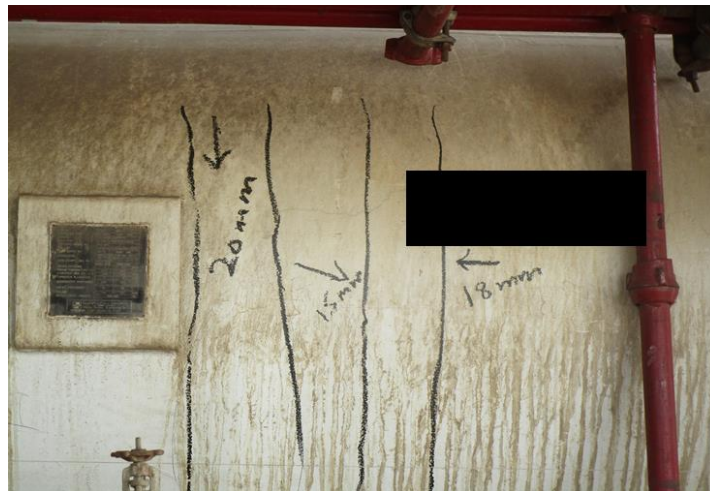
Exchanger channel cover leaked (water) due to shell deformation. Then operations observed that over a period of several weeks, the tower pressure is slowly increasing. Cooling water control valve reached the maximum opening (69%) limited by mechanical stopper. Survey was conducted and high delta pressure was found in the condenser which confirms the fouling. Risk assessment was conducted accordingly. The condenser shell side was bulged as shown in figure 6. Material obtained from pump strainer was tested and confirmed that the fouling is due to popcorn.

Figure 6. Evidence of bulged exchanger.

To ensure effective risk mitigation, a major plant modification was executed by constructing a new process line that bypasses the debutanizer tower and sends the material to the flare. The project execution was remarkable as it was completed in about a week. 15 tons of C4 was flared per hour. This, however, allowed the olefins unit to mitigate the risk effectively without any interruption of the production. The change was not done before in the local industry, and it reflected how effective measures can be taken to mitigate risk through strong leadership and excellent engineering. Interim mitigations, moreover, were in place until the modification was completed: for example, inhibitor injection in the exchanger to inhibit the popcorn formation as soon as possible, and an emergency procedure in case loss of containment. Without the effective mitigation, Sabcic operation team would have had to shutdown the olefins unit for over 2 months. This olefins unit feeds two poly ethylene that would shutdown consequently, causing significant losses over the mentioned period. New exchanger was manufactured and installed subsequently.

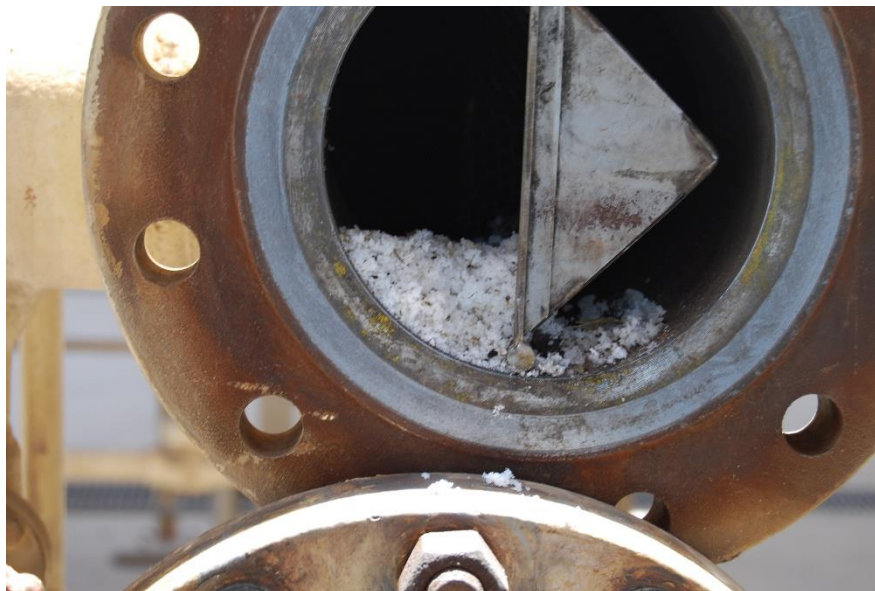
Figure 7. Popcorn found in the strainer

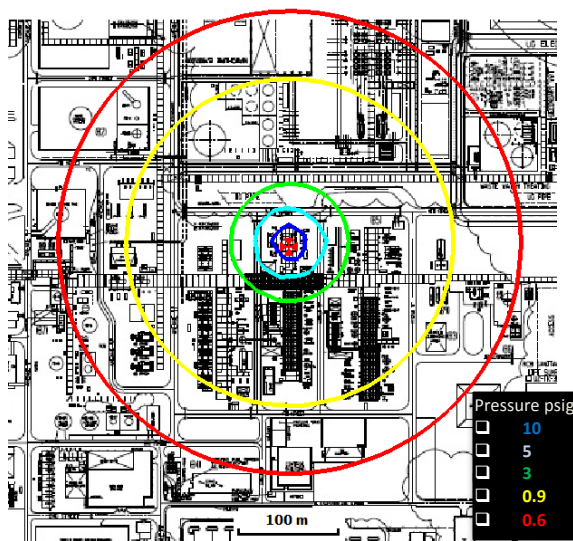
Scenario 1: Accumulation of popcorn material in PRV inlet nozzle plugs nozzle or PRV rendering the device inoperable, over pressure event occurs, PRV unable to function resulting in a loss of containment and possibly leading to fire or vapor cloud explosion.

- Failure Mode: flange opening of the biggest piping causing an opening equivalent to 20% of its area. The biggest piping is the process inlet with diameter of 10 inches. The bore size suspected is 2 inches
- Release rate: 32.6 kg/s
- Energy released due to blast: 2.8E9 J
- Event probability: 10E-2
- Risk evaluated: An explosion can cause multiple fatalities with a likelihood of with a probability of 10E-2, which is not acceptable according to Sabic risk tolerance criteria
- Figures below are illustration of the consequence analysis.

Figure 8: Blast contour for scenario 1

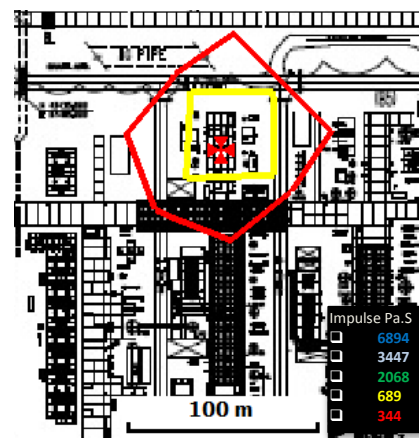
Figure 9: impulse contours for scenario 1

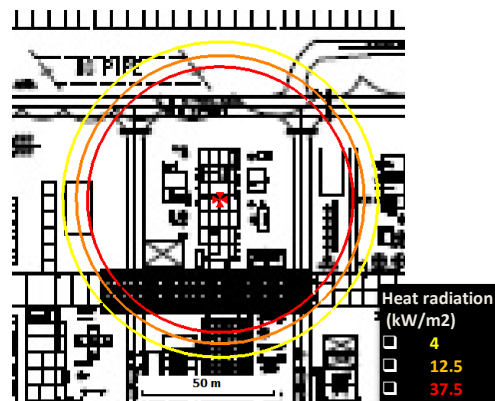
Figure 10: Jet fire radiation contour for scenario 1

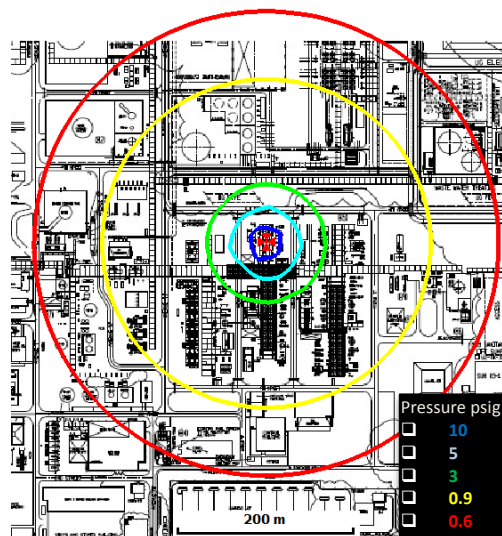
Scenario 2: Presence of popcorn polymer propagating in condenser developing local fouling at a weak point of the tube sheet or shell wall, rupture occurs resulting in loss of containment and possibly leading to fire or vapour cloud explosion.

- Failure Mode: mouth fish crack due to popcorn propagation exerting stress on the shell side. The crack would be more than 10” long
- Release rate: 408 kg/s
- Energy released due to blast: 4.2E9 J
- Event probability: 10E-3
- Risk evaluated: An explosion can cause multiple fatalities with a likelihood of with a probability of 10E-3
- Figures below are illustration of the consequence analysis.

Figure 11: Blast contour for scenario 2

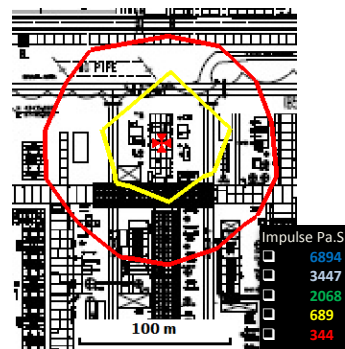
Figure 12: impulse contours for scenario 2

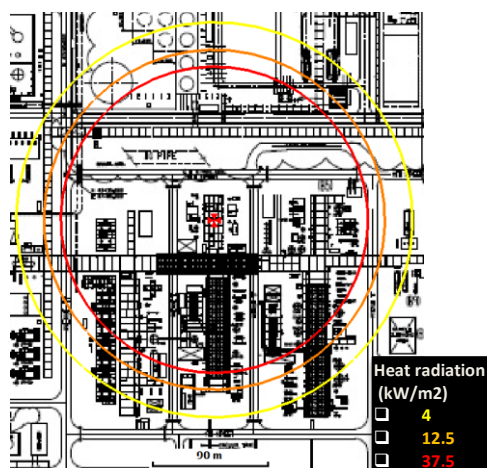
Figure 13: Jet fire radiation zone for scenario 2

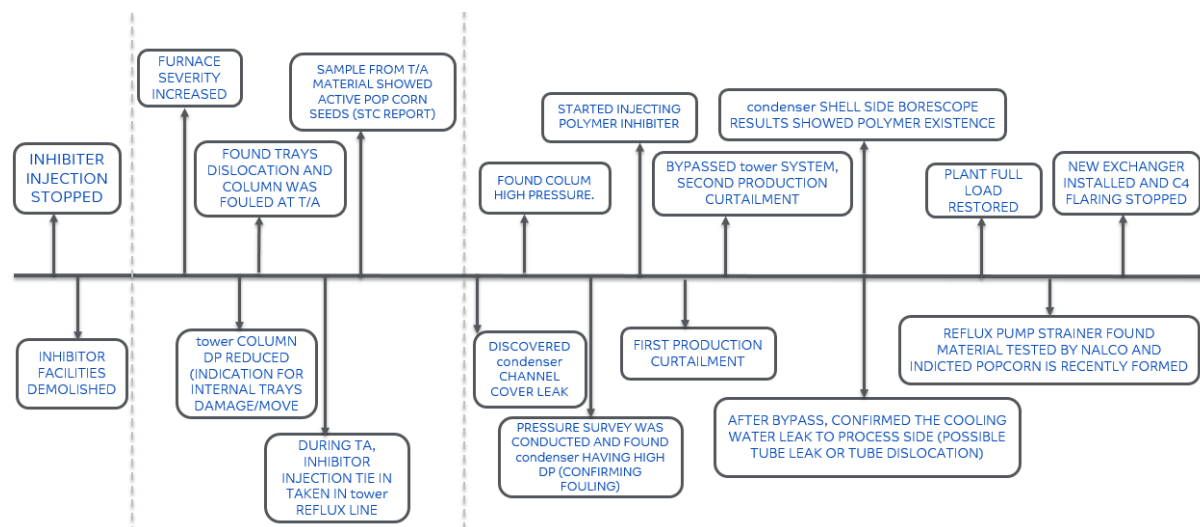
Figure 14. Incident timeline.

- Popcorn inhibitor injection was stopped at 2005 and facilities demolished at 2012. No safety assessment performed either during stoppage or through Management of change. In addition, at least two re-do hazop conducted that did not address inhibitor requirements

- 2006 condenser borescope inspection found the shell clean with yellow deposits on outside tube surface
- Since 2015, higher butadiene concentration exist due to higher propane furnaces conversion to cope with the additional feed allocated. Inhibitor tie in's re-constructed at 2017 turn around but actual inhibitor injection started at July 2018 after the realization of popcorn formation.
