Remembering the Philadelphia Gulf Refinery fire — 50 years on

Ewan Stewart

On behalf of the Queensland Joint Chemical Engineering Committee

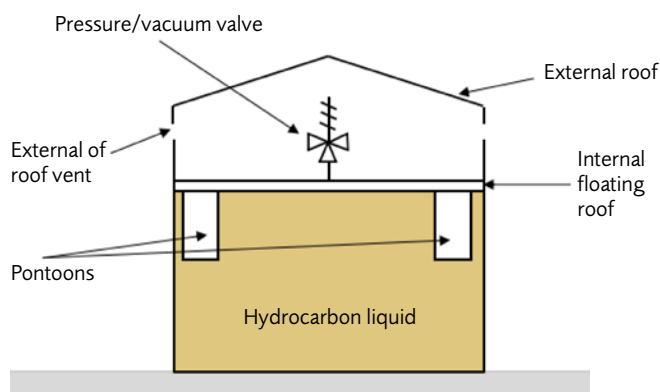
Figure 1 – Floating roof storage tank layout

To understand the origin of this incident, we first must understand the operation of floating roof storage tanks (see Figure 1). This style of tank is used for the storage of products such as crude oil, diesel, jet fuel and gasoline which can emit large quantities of vapour at ambient conditions. The tank roof is supported by a number of buoyant pontoons, and floats on top of the liquid in the tank eliminating any vapour space that would be present in a fixed roof tank. Relevant to this incident, the floating roof is equipped with a pressure/vacuum valve which operates to expel air during the initial tank fill and to prevent vacuum formation when emptying the tank for maintenance.

This incident centres around Tank 231. Originally built as a fixed roof storage tank in 1929, this had been rehabilitated and converted to an internal floating roof tank before being placed back into service in the months prior to the incident. Crucially, a last-minute design alteration increased the height of the pontoon legs. This change was not indicated on the drawings

given to the operators. As a result, the tank was inadvertently brought "off float" meaning that the level was brought low enough for the pontoon legs to rest on the base of the tank. As the liquid level decreased further, the pressure / vacuum valve opened, allowing air to enter the void under the roof space.

in particular keeping drawings up to date. Floating roof tanks should never be brought off-float, except for in a controlled scenario where they are being emptied for repair.

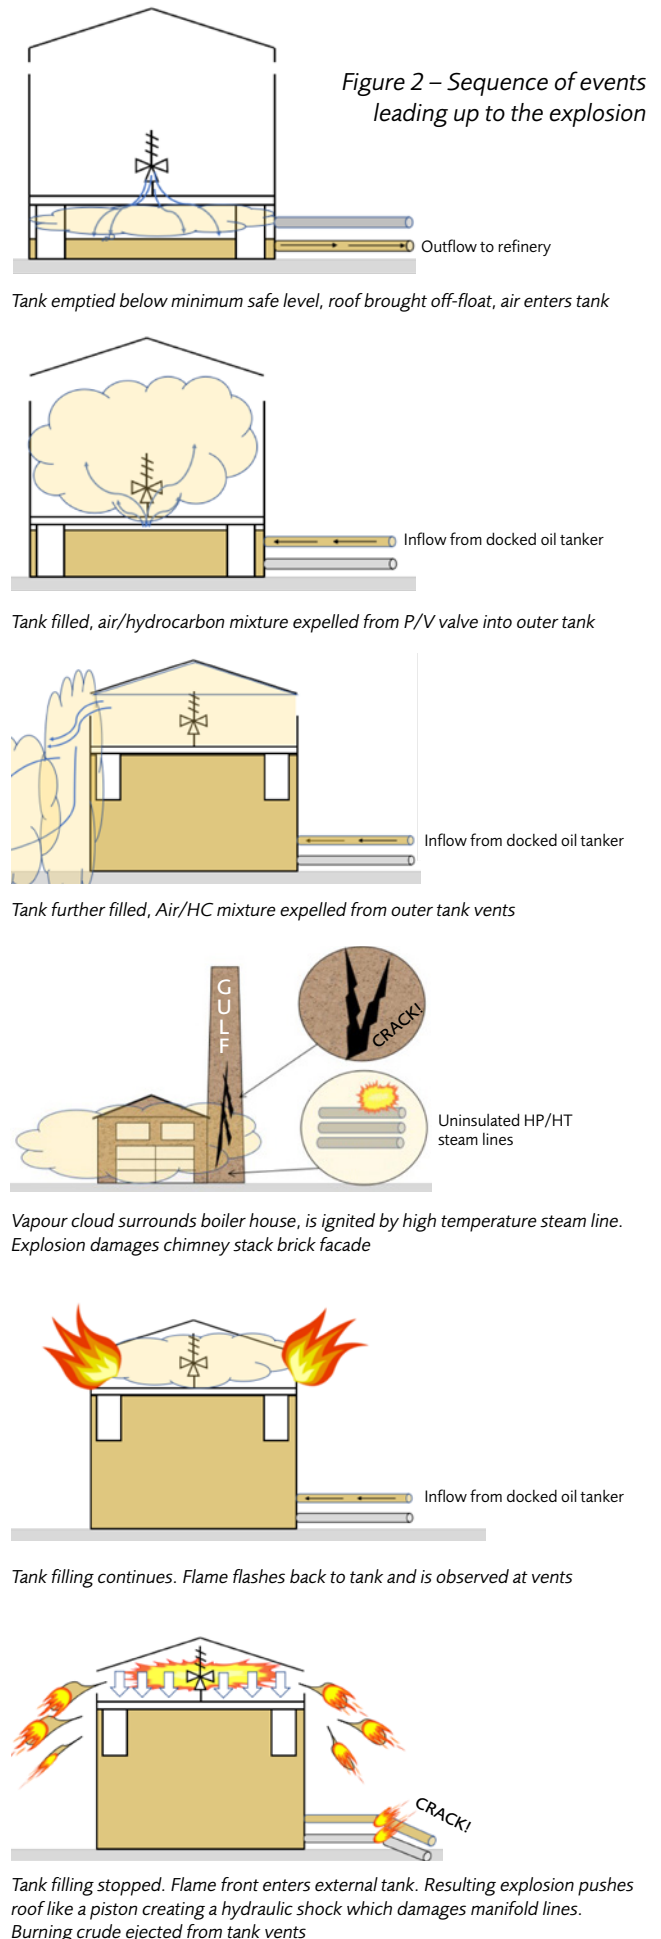
The flames flashed back to the vents of Tank 231 where a massive fireball erupted. As filling continued, flames were observed at the tank vents. The initial flash and explosion were seen and heard by the crew of the offloading oil tanker, who almost immediately shut-down their pumps. Without inflow to the tank, the space above the roof was no longer pressurised. This allowed the flames at the vent to enter the tank, where a further explosion occurred. This time, the floating roof was forced down like a piston. Displaced crude oil came up past the floating roof seal, and this flaming liquid was ejected from the tank vents. More importantly, the downward force on the internal roof created a hydraulic shock damaging the tank's fill lines at the manifold. This placed the fire in the street area where it was not contained by the dike walls.

Burning crude oil which had been forced onto the floating roof transferred heat through the floating roof pan and to the liquid surface below where the crude began to vaporise and froth. As the frothing liquid boiled over through the tank vents, burning crude streamed down the outside wall of the tank causing additional gaskets to fail on the inlet and outlet lines. The compromised lines and sustained fire around the tank and manifold valves removed all possibility of shutting down reverse flow from the tank, which continued feeding the fire from its 73,000-barrel inventory and 12m static liquid head.

As the burning crude flowed into the dike, it caused the collapse of several other pipelines which passed through the Tank 231 dike area. These pipelines contained benzene, aviation gasoline and jet fuel, which contributed to the fire already burning within the dike. A smaller tank, Tank 1114, within the dike was overpressured due to the intense fire and ruptured at its roof-to-shell seam with its vapours continuing to burn.

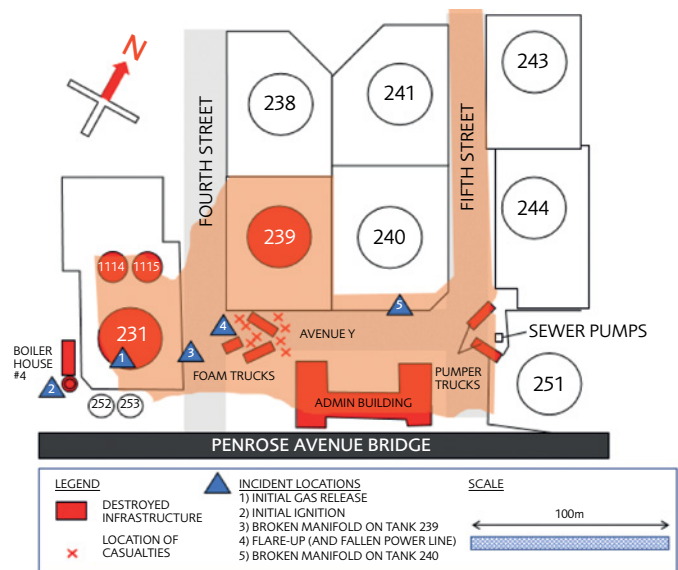
Figure 3 – Site map of the incident

pipelines running through the fire area be shutdown, however this did not reduce the fire's intensity. A further order was issued that all tank valves be closed, however only the manifold valves of two large naphtha tanks, 239 and 240 were closed. The valves at the tanks were left in the open position and this was to have a significant effect later.

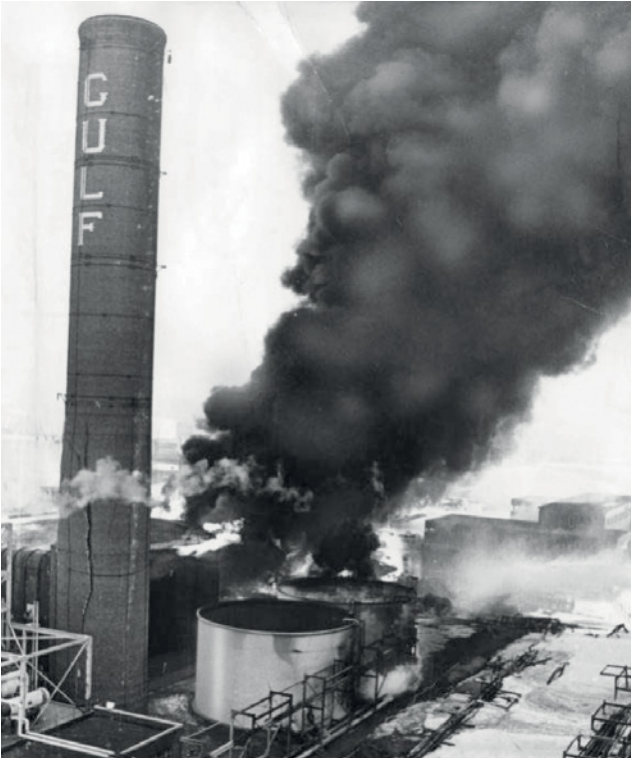
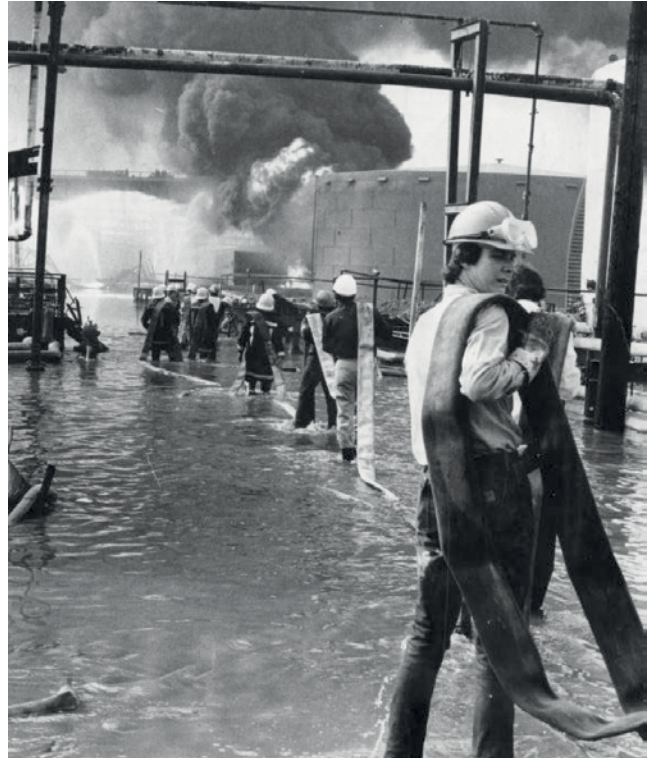
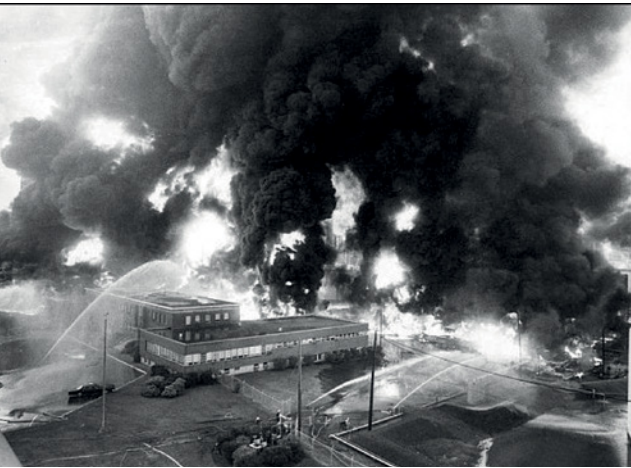
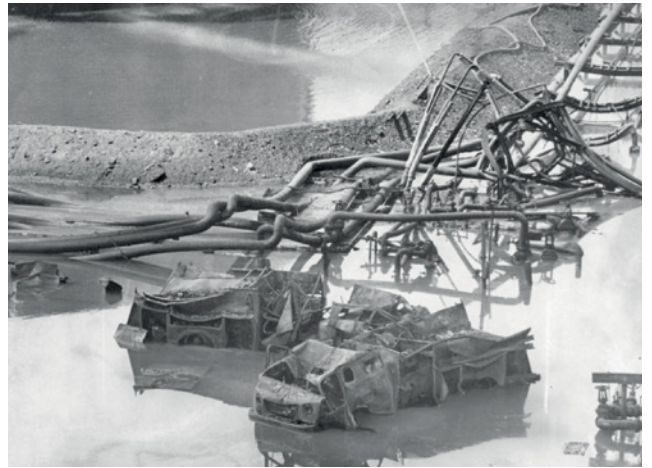
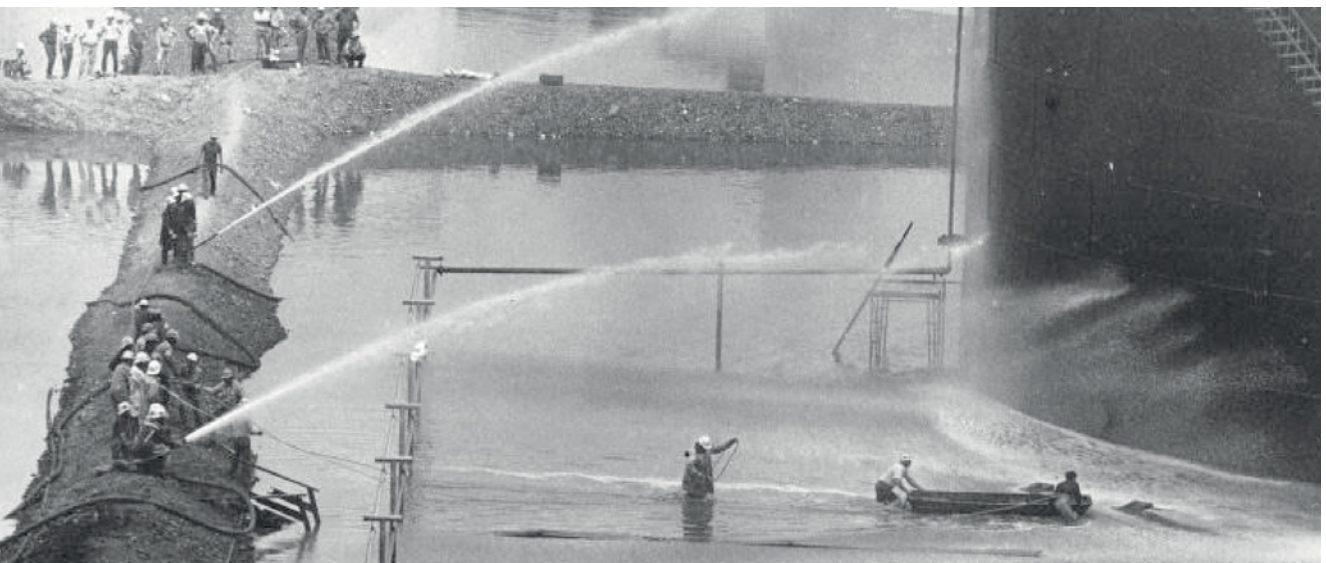
Opposite page: Images courtesy of Temple University Libraries, Urban Archives

A massive firefighting operation was undertaken throughout the night. By the following morning the fire was confined to the area of Tank 231. Six firefighters had died in the inferno and a further two would later die of their injuries. Four storage tanks appeared crumpled and melted and the administration building was destroyed, whilst the burnt-out carcasses of five fire trucks lay next to the mangled manifolds. In total, the damage was more than \$10 million. The decision was made to let the fire

Actuated shut-off valves: An iconic photograph from this incident shows three Gulf employees, clinging to a rowboat, wading out into a flooded tank dike. This operation was necessary to close off the valve at Tank 240 after the manifold had become compromised in the fire. Had an actuator been installed on this valve, then it could have been closed from a safe distance without putting further lives at risk. Newer plants at the time had automated systems to shutdown plant based on elevated levels, temperatures, and pressures, however these were not yet fitted at legacy plants where all valve operations were performed manually.
