## SIESO Medal paper

# Flixborough – looking forward

Joseph Carver, University of Bath; Sophie Manton & Steven Deane, University of Plymouth; Jake Bull, Falmouth University; and Alana Jones, Cardiff University

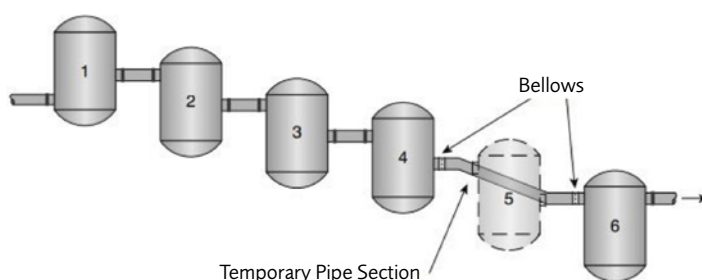
Two months prior to the explosion on 27 March 1974, a 2 m long vertical crack leaking cyclohexane was discovered on Reactor 51. Subsequently, the plant was shut down and the reactor removed for repair<sup>8</sup>. In order to permit continued operation of the plant, the site management team decided to remove Reactor 5 and install a 0.5 m diameter bypass pipe between the bellows to take its place. Due to elevation changes, it was necessary to incorporate a 'dogleg' shape into this bypass as shown in Figure 1.

Figure 1 - Reactor vessels showing reactor bypass and bellow<sup>9</sup>

tasked with making and installing the temporary pipe were not professionally qualified to do so<sup>5</sup>. The pipe was constructed and supported by scaffolding; however, no account was taken for the turning moment that would act on the pipe due to fluid flow. Consequently, the scaffolding support was not adequate to resist the shear forces<sup>1</sup>.

The temporary pipe performed satisfactorily for two months until, at the end of May, the plant was shut down to repair a leak. During the late afternoon on 01 June 1974, whilst the plant was being restarted, a slight rise in pressure occurred, well below the relief valve set point, causing the temporary pipe to twist<sup>5</sup>. The installed bypass ruptured, and tonnes of boiling cyclohexane were released. The cyclohexane formed a flammable vapour cloud and, at 4:53 pm, a massive vapour cloud explosion ignited. A brief outline of the timeline of events are presented in Figure 2.
