Incident

Lessons from Longford – 20 years on

Bob Weiss, Functional Safety Consultant, Australia

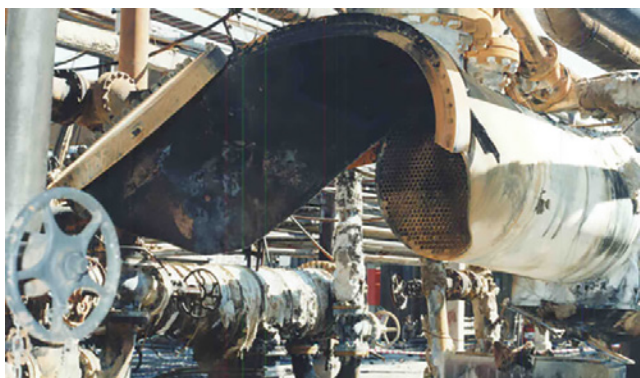
Figure 2 – ROD Reboiler GP905 after the accident

The Commission found that the immediate technical cause of the accident was the introduction of hot lean oil into GP905 while it was still at about -48°C and pressurised. This resulted in brittle fracture of the east tube channel releasing the hydrocarbon contents, which inevitably eventually found an ignition source. The low temperature occurred because of carryover of low temperature condensate into the lean oil and the inability to restart GP1201 pumps once they had stopped.

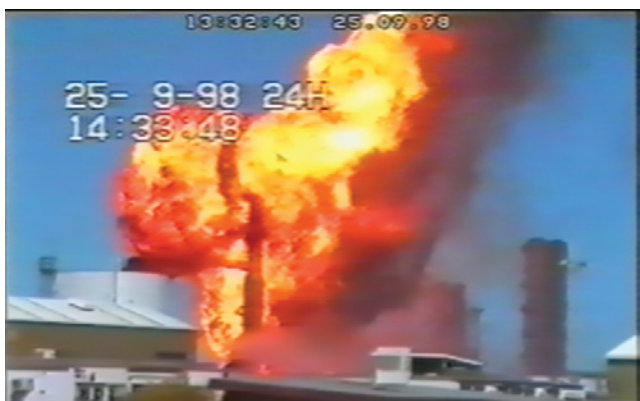
Figure 3 – The fire, two hours after the initial failure (from security camera)

To 13:35 A large fire up to 100m high at times now emanated from GP905, which was located adjacent to the intersection of two large pipebridges known as "Kings Cross". The fire impinged on these pipes and, as they failed and released their contents, small BLEVEs occurred, increasing the size of the fire (see Figure 3).
