Incident

Case study — Revisiting the Tacoa Power Plant boilerover 40 years on

Ewan Stewart, Senior Process Engineer at Wood & Queensland Joint Chemical Engineering Committee Chair

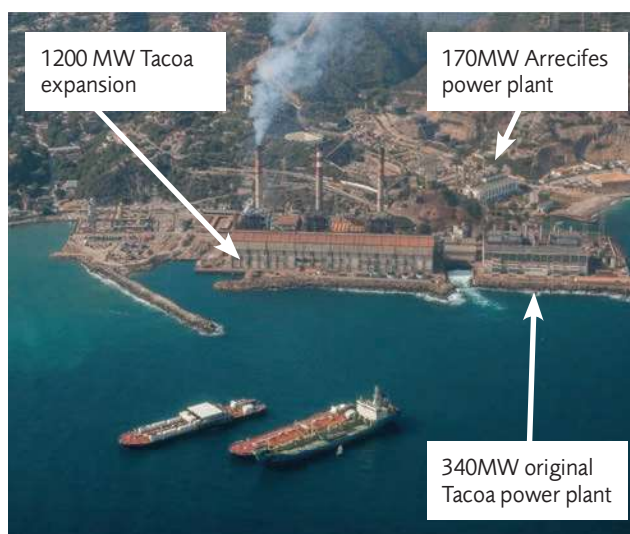
Figure 1 – The Ricardo Zuloaga Generator Complex. Tanks 8 and 9 were located at the site of the modern-day demineralised water tank (visible behind the tip of the expansion plant's middle stack)

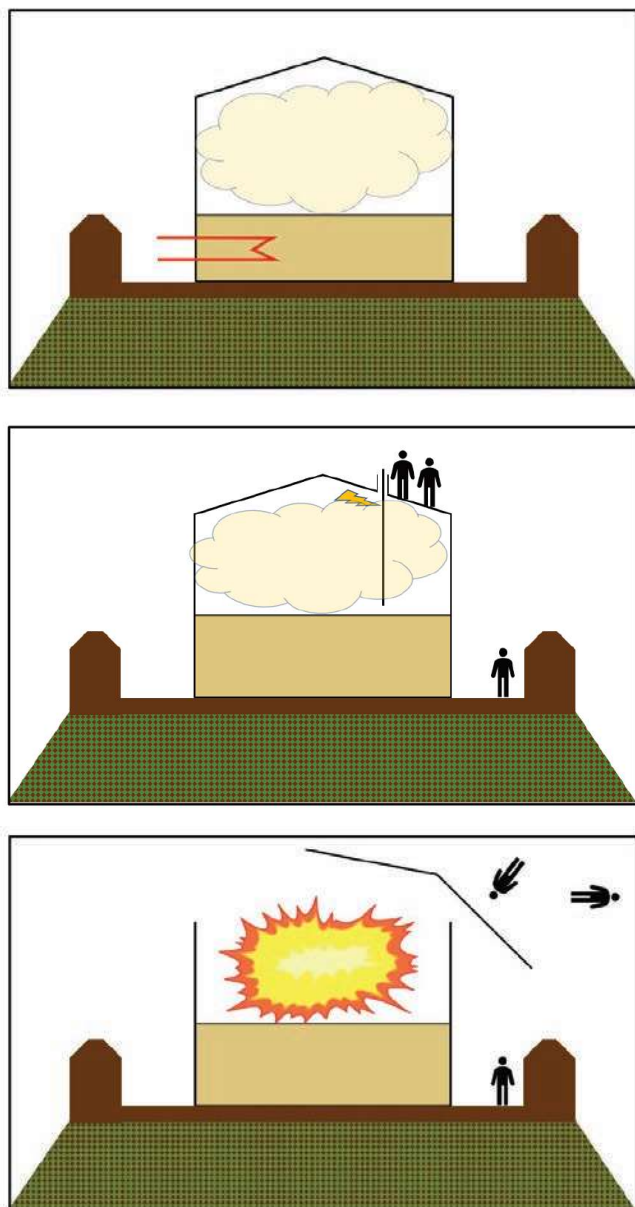
Figure 2 – (Top to bottom)

1. Fuel oil overheated above its flashpoint.
2. Opening of gauging hatch allows air to intersperse with hydrocarbon gas. Ignition source unknown.
3. Explosion expels tank roof. Two operators killed.

One might be curious as to how a heavy fuel oil is able to produce a flammable atmosphere. The answer is a combination of blending and inappropriate temperature. Firstly, the specification for number 6 fuel oil allows for lighter ends to be combined with the residual oil to achieve a reduced viscosity, provided that flash point limitations are met. Varying degrees of blending can produce fuel oils with wide-ranging characteristics far removed from the original residual oil. The evidence suggests that the alarms and trips at the Tocoa power plant were configured for a different blend to that which was in the tanks at the time of the incident. Despite the flash point of the fuel oil being 71°C, the high temperature alarms were set at 80°C, with the boiler feed observed as high as 88°C. The lighter components of the blended fuel oil were being boiled-off within the tank.

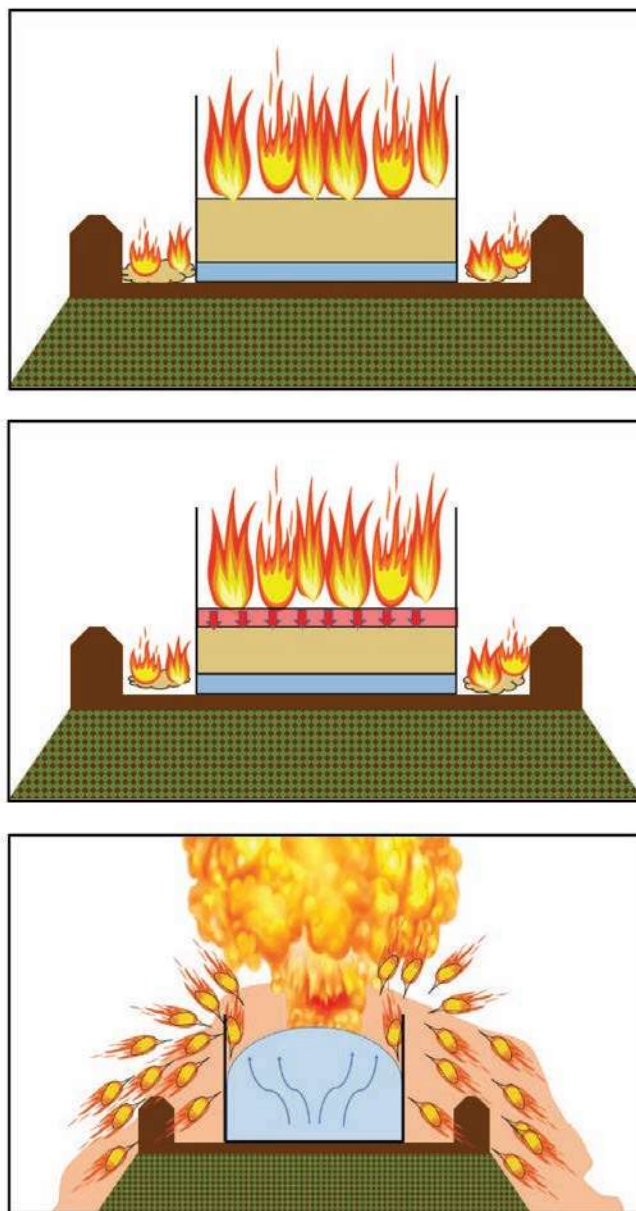
Figure 3 – (Top to bottom)

4. Loss of tank roof results in open-top tank fire.
5. Heat gradient starts to develop within tank as hot residues sink.
6. Heat wave reaches water heel resulting in rapid expansion into steam. A violent boilover occurs expelling the tank contents.

hydrocarbon components, including both light ends and viscous residues, for a *heat wave* to be generated within the tank. In an open tank fire of this nature, it is predominantly the lighter components that are consumed at the surface. The unburned heavier components, heated intensely by the fire, form a layer which is heavier than the surrounding oil. Gradually, this hot dense layer sinks and grows within the tank. At around midday, six hours after the initial outbreak, the heat wave had reached the tank's water heel at a temperature between 150 and 315 degrees Celsius.

Initially, the water would have superheated beyond 100 degrees Celsius due to the hydrostatic head of oil above it.

And then, suddenly, the water would have flashed into steam, expanding by as much as 2000 times, ejecting the contents of the tank in a vicious eruption.

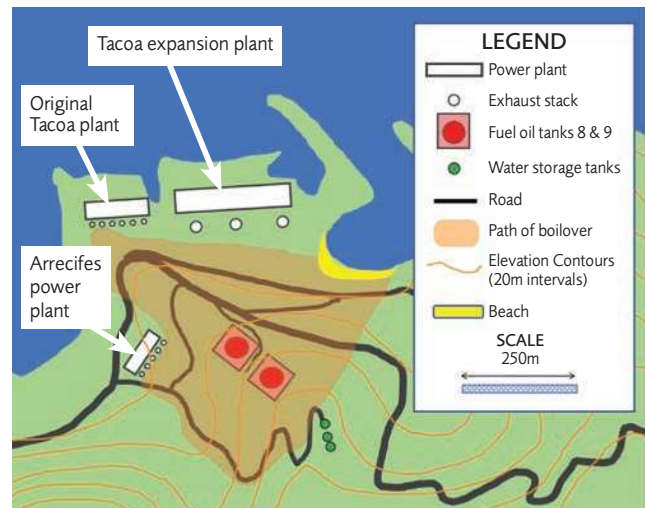
Figure 4 – Map of the Tocoa Power Plant and surrounds recreated by author from google-earth, photos, and videos. Indicative only.

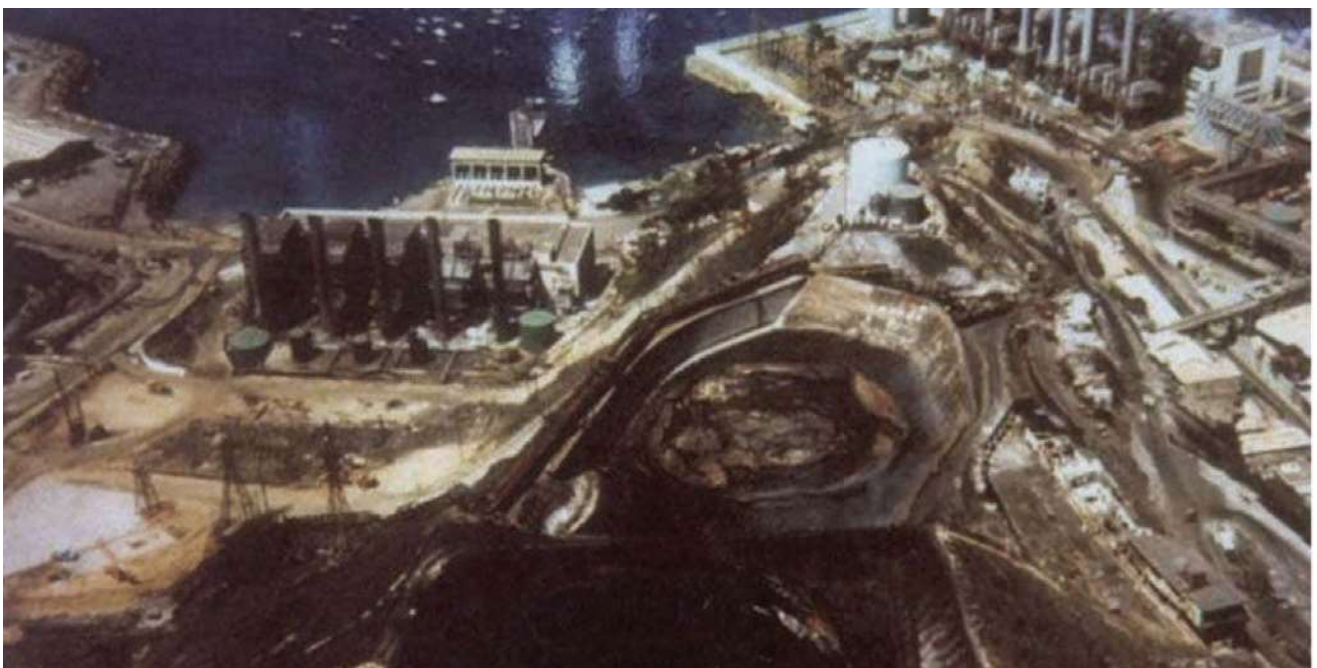
Figure 5 – Image extracted from "Incidents that Define Process Safety" shows the aftermath. Both tank 8 (foreground) and tank 9 (background) appear blackened and crumpled. Notice the steep drop-off of the dike walls and settlements underneath.

Electricidad de Caracas made widespread changes to the plant following the tragedy. Aided by the completion of a supply pipeline to the generator complex, the company shifted its dual-fuel turbines to run predominantly on natural gas. Tanks 8 and 9 were removed, and in their place was installed a huge, demineralised water reservoir to feed the boilers. The fire protection systems on all other fuel oil storage tanks were upgraded to include a dedicated ring main and anti-spark systems. As further measures to eliminate potential ignition sources, a hot work permit system was enforced, and smoking was prohibited throughout the plant.
