| <b>Incident Title</b> | | <b>Hydrogen Trailer Transfill Facility Explosion</b> | |
| <b>Incident Type</b> | | Explosion and Fire | |
| <b>Date</b> | | 1st June 2019 | |
| <b>Location</b> | | Santa Clara, CA | |

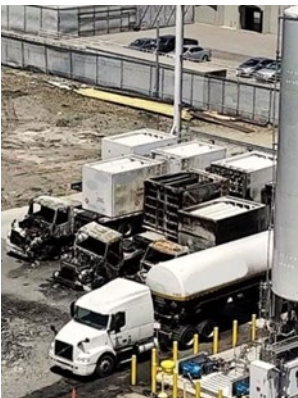
| <b>Incident Description</b> | | <p>The Santa Clara transfill facility supplies gaseous hydrogen (GH<sub>2</sub>) at 517 barg (7500 psig) and near-ambient temperature to high pressure tube trailers for delivery to retail fuelling stations. It comprises a liquid hydrogen (LH<sub>2</sub>) storage tank, cryogenic pumps, ambient air product vapourisers, 5 parallel un/loading bays, an elevated vent stack and multiple hose connections. Bay #1 is used by LH<sub>2</sub> delivery tankers for filling the LH<sub>2</sub> storage tank. Bays #2 - #5 are used for filling GH<sub>2</sub> tube trailers. At the time of the incident, Bays #1 - #4 were occupied. In Bay #3, a dual-module tube trailer with a total GH<sub>2</sub> capacity of 500 kg (1102 lb) was being filled by 2 drivers (a trainer and a trainee). Both modules were being filled simultaneously using the automated fill system.</p> <p>When both modules were almost full, the trainee noticed a GH<sub>2</sub> leak near the front module fill line isolation valve and reported it to the trainer who instructed the trainee to stop filling that module. However, the trainee stopped the filling process for both modules and did not uncouple the trailer from the fill system. The trainer then isolated the front module fill line, depressured the fill manifold, and removed a pipe spool. He soon realised he did not have all the required materials so instructed the trainee to shut off the GH<sub>2</sub> supply. The trainee misunderstood and pressed a "Purge/Enable Trailer" button which opened all pneumatic valves on the trailer, inadvertently restarting the fill process. GH<sub>2</sub> escaped from the open-ended pipe spool. The GH<sub>2</sub>/air mixture ignited within 3 secs, causing a deflagration explosion followed by a jet fire. The trainer immediately pressed the emergency stop button. All pneumatic valves on the trailer closed either by this action or by plastic air supply lines melting. The explosion and jet fire caused additional leaks which escalated the fire.</p> | |
| <b>Incident Analysis</b> | | <p><b>Basic cause</b> was a short duration release of high pressure GH<sub>2</sub> due to a cracked O-ring or leaking cone and thread fitting on the fill line isolation valve.</p> <p><b>Critical factors</b> included: 1) The 25-cylinder tube cluster in each module was partially enclosed in an open-top container (reduced leaking GH<sub>2</sub> dispersal rate and increased explosion overpressure), 2) Proximity of other tube trailers and cabs in adjacent loading bays (impacted by jet fires), 3) Brass pressure relief devices (PRDs) failed due to extreme heat from the fires.</p> <p><b>Root causes</b> included: 1) Inadequate training (leak repair), 2) Violation of Lock out/Tag out (LOTO) procedure (while attempting unauthorised repair), 3) Miscommunication (ambiguous control button labelling caused trainee to inadvertently initiate flow to open-ended pipe), 4) Inappropriate plant layout (un/loading bay spacing), 5) Inappropriate construction material (brass PRDs)</p> | |

| <b>Lessons Learned</b> | | <p>1) LH<sub>2</sub>/GH<sub>2</sub> delivery drivers should all be trained on safe isolation of leaks.<br/> 2) LH<sub>2</sub>/GH<sub>2</sub> system leaks require prompt (double) isolation of the leak source, depressuring to a vent stack and purging with inert gas (typically nitrogen).<br/> 3) GH<sub>2</sub> tube trailer module walls help contain internal jet flames and protect cylinders from external fire (but confinement can increase explosion hazard).<br/> 4) Flow-limiting devices (e.g. excess flow valves) can minimise leak rate in the event of an accidental release through an open or ruptured pipe.<br/> 5) Automatic water sprays can help mitigate escalation by cooling LH<sub>2</sub> tanks and LH<sub>2</sub>/GH<sub>2</sub> trailers (but water ingress to vent may freeze and restrict flow).</p> | |
