"BACKGROUND" - TO THE PIPER ALPHA TRAGEDY

R. Sylvester-Evans*

The purpose of this paper is to provide the background to the circumstances which led to the tragic loss of the Piper Alpha Platform on 6th July 1988. It is hoped that this will assist delegates to focus on areas where lessons may be learnt for the future.

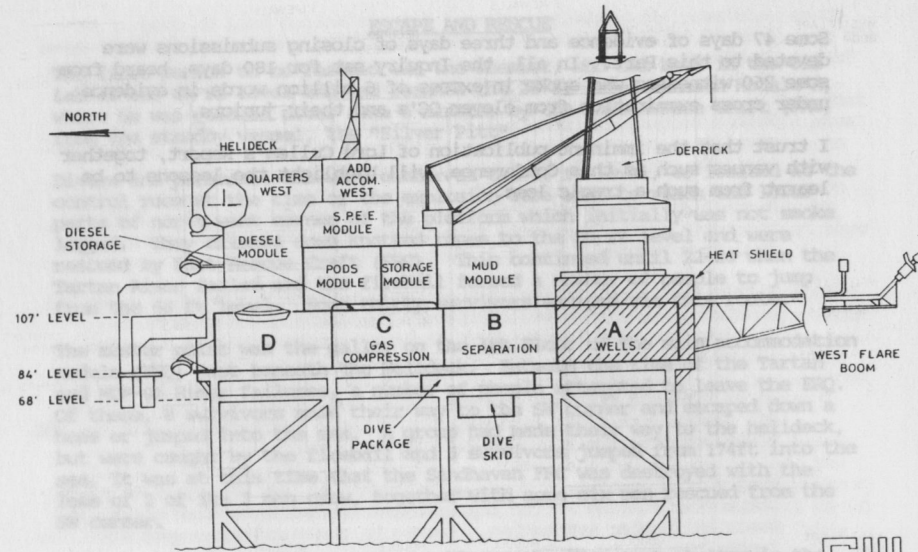
FIGURE 1 PIPER ALPHA - WEST ELEVATION

The general elevations of the topsides are shown in Figures 1 and 2. At the 84 ft. level there were four Modules A,B,C and D. The southern most Module was "A" which comprised the wellhead (36 slots) to which two angled flare booms were attached. Module B contained the manifolds, test and main production separators and main oil line export pumps; see Figure 3.

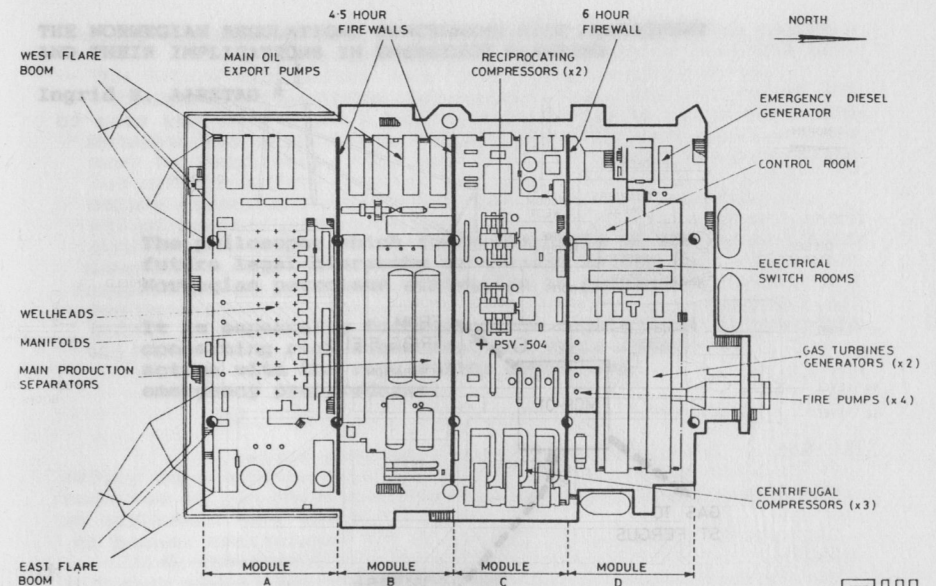
FIGURE 3 PIPER ALPHA - PRODUCTION (84 ft) LEVEL

Modules A,B,C and D were separated by firewalls, which were not rated for explosion overpressure. The firewall between Modules C and D was specified with an 6 hour fire rating whilst that between B - C, and A - B were specified for 4.5 hours (see Figure 3).

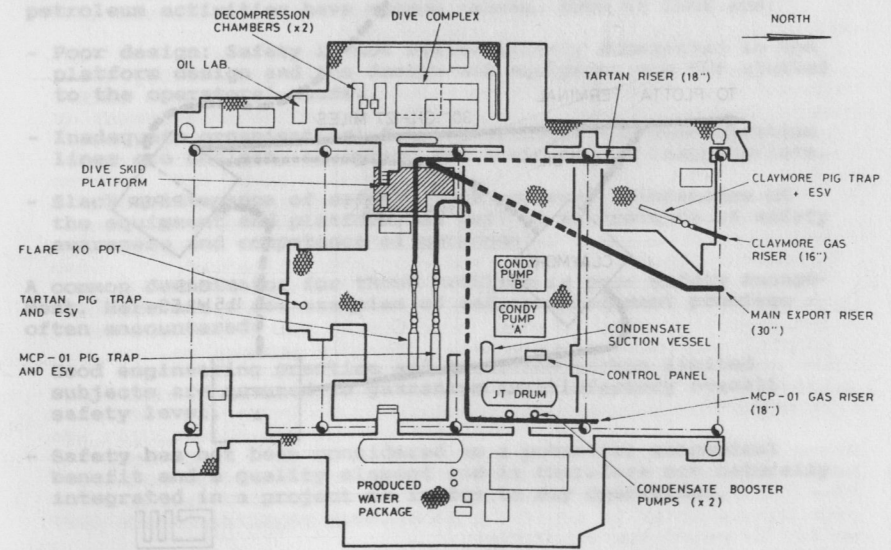
FIGURE 4 PIPER ALPHA - DECK SUPPORT FRAME (68 ft LEVEL)

The condensate collected in the JT Flash Drum was pumped into the main oil line for export to the Flotta Terminal by the use of booster pumps and condensate injection pumps (commonly called the "Condy" pumps), which raised the pressure to approximately 1100 psia. All this equipment was located at the 68 ft. level beneath Module C (see Figure 4).

The location of the risers on Piper are shown in Figure 4. Each pipeline had an emergency shutdown valve located in close proximity to their respective Pig Trap. During Phase 1 operation, at the time of the accident, no Piper Gas was being exported. Tartan gas was being imported but was exported to the Total Oil Marine Compression Platform, MCP-01, independently of any Piper process.

- o Within minutes a running fire occurred beneath Module C as crude oil commenced spilling over, or through the decking. A pool fire developed on the Dive Skid (58 ft level) beneath Module B. [See Figure 4].

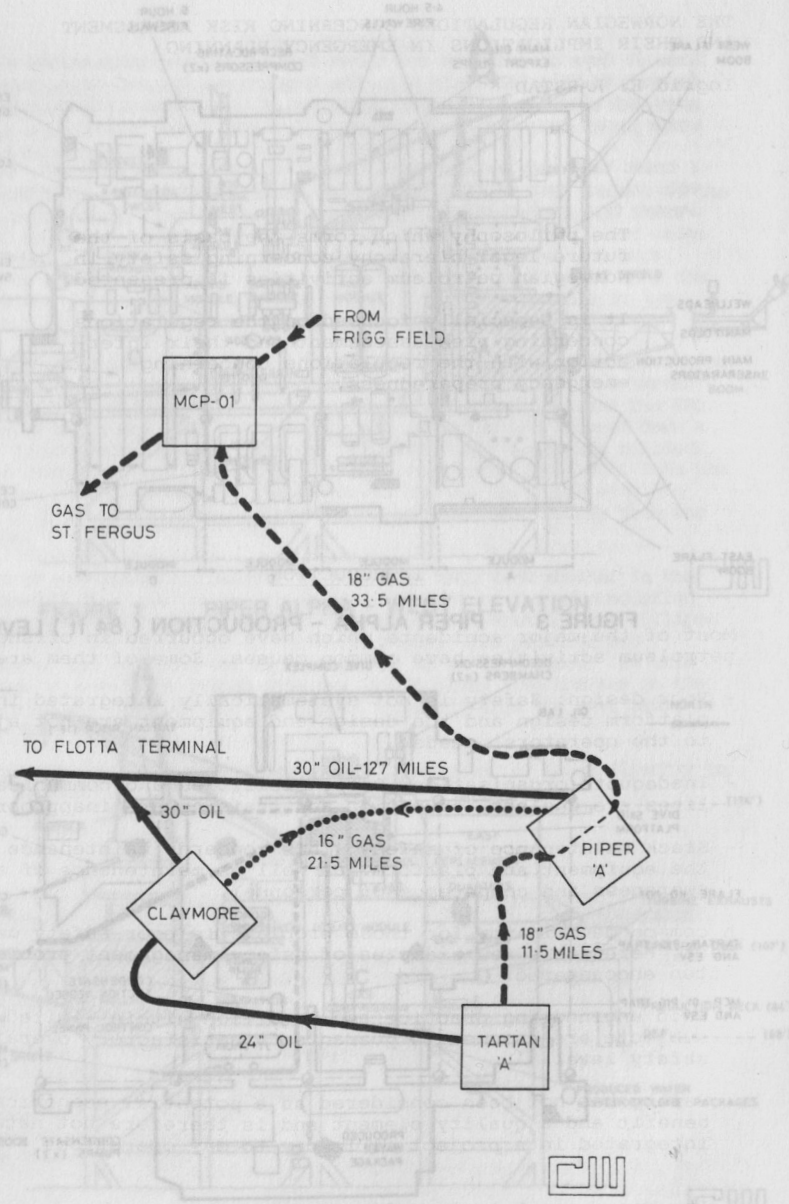
FIGURE 5 PIPER ALPHA - OIL & GAS PIPELINES

The Piper Platform was central in the Piper field with respect to the communication systems and the pipeline export network (see Figure 5). The pipelines/risers connecting Piper to other installations were as follows:-
