Taming the Beast - Lessons Learned from 5 Decades of Aluminium Dust Explosions

This paper describes six aluminium dust explosion incidents which have occurred at AMG's site in Anglesey over the course of 5 decades. The incidents have revealed that the use of good explosion prevention and protection practices at the time was often insufficient and the use of measures over and above what would be expected is necessary. Owing to their very high reactivity and rapid flame propagation, protection from dust explosions with fine aluminium powder is often at the limit of what best available technology can deal with reliably. The site has found it is necessary to restrict access even to explosion protected plant as a result. The incident history has revealed gaps at each stage and enabled them to develop the explosion prevention and protection systems to the point where personnel now have a high level of protection. The paper also re-enforces the huge benefits gained from incident learning in advancing our process safety knowledge and the authors would like to thank AMG for being willing to share their experiences.

Incident 1 - Dust explosion in 1973

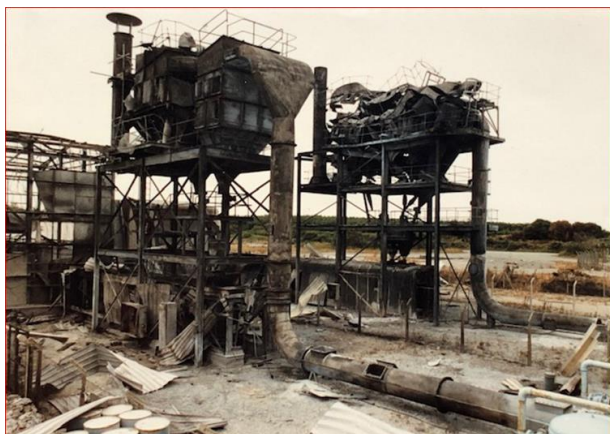
On 16th July 1983, the site had a large dust explosion on the atomisation line which caused substantial damage to the plant and injured two people. The damage can be seen in Figure 2.

Figure 2: Aftermath of 1983 explosion

This incident was widely reported, mainly because of the level of damage it created. The exact cause of the incident was not fully determined although the most likely ignition source was thought to be an electrostatic discharge. However, details of how or where this occurred remain uncertain. For example, the use of earthing and bonding was already well established on site leading to the conclusion that an electrostatic spark discharge from isolated equipment was unlikely. One theory was the possibility of aluminium powder becoming charged in flight and sparking to the wall of the duct or cyclone. Consultation with an electrostatic expert at the time deemed this unlikely although not impossible. One important point to note was that the plant had explosion venting fitted (as it did in 1973 too) although for a number of possible reasons (as explained later in this section), it did not work as expected and substantial damage occurred even to vented equipment. The incident highlighted the devastating effect of aluminium dust explosions and the new layout, selection of some of the replacement equipment and controls and explosion protection systems was clearly influenced by the lessons learnt from the analysis of this explosion. The company also looked at what other aluminium powder producers were doing from an explosion safety perspective in an attempt to gain further insight. From comments on record [Wright, 2001], it would appear that no significantly different precautions were being taken by other companies. Some of the key learning points and changes as a result of learning from this incident are detailed below. This incident influenced the biggest step change in dust explosion prevention and protection on site.

1. It was found that the close proximity and similar orientation of the two cyclone banks enhanced the level of damage. Therefore Line 1 and Line 2 cyclone structures were re-built at 90 degrees to each other and with a greater separation. This minimises domino effect potential, something which significantly impacted the level of damage in the 1983 explosion.

2. The explosion vent location on the cyclone banks was such that vents had obstructions directly in their path. The location of the explosion vents on the re-built plant ensured a much clearer venting path

3. There was no design basis for the explosion vents on the cyclone banks. They were re-designed after the explosion in 1983 using the vent ratio method for St3 dusts. This was chosen over the K_{st} Nomograph method since there were no recognised methods to estimate the pressure shock strength of weak plant at the time and the vent ratio method did not need to know the vessel strength. The vents fitted were pop out panels (due to time constraint to re-instate the plant) which AMG had tested independently for release pressure but the tests were limited to St1 powders. This still left some uncertainty over the performance of the explosion vents. For this reason, a fenced off compound was created around the cyclone banks and conveying duct with access strictly prohibited during operation.

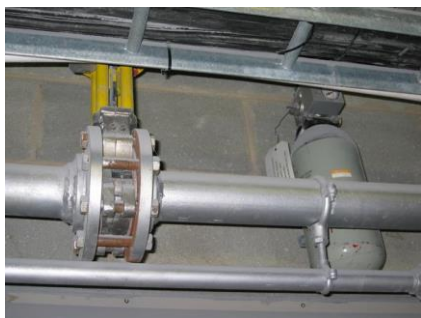
The explosion vent on the vacuum filter unit worked as intended but the main consequence that was not expected was substantial propagation of flame back along the suction pipework despite that presence of the vent diverters. This resulted in flame ejection from a number of the suction points which were only sealed with a spring loaded cap.

Figure 4: Rapid acting valve in vacuum suction line

As a result of this observed flame propagation, rapid acting valves were installed in each suction line triggered by pressure sensors on the vacuum filter units. An example is shown in Figure 4.

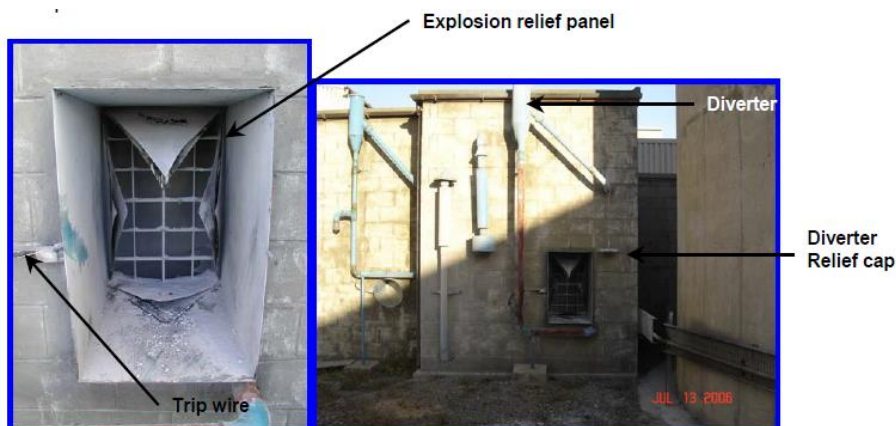
Figure 5: Vacuum filter no.2 explosion panel (LHS) and vent diverter (RHS)

1. The explosion most likely originated in the pipe near to where the operator removed the cap to inspect for blockage. This resulted in a flash out of the pipe and back to the vacuum filter causing ignition in the vacuum filter.

2. The protection systems all worked as expected and prevented both damage to the vacuum filter unit and significant propagation back to the suction caps. This means the explosion vent panels and rapid acting valve worked as expected.

A key change following this incident was to provide more robust access restriction controls to the vacuum filter room using an exchange key system. This now prevents access whilst the vacuum plant is running. Operators were re-trained in the use of the vacuum system and the procedure for inspection and cleaning of the filter traps was reviewed and improved. The vacuum plants have now been running effectively since 2006 without further incident. Prior to this incident, the packaging and blending line dust extraction filters also used a vent diverter principle to avoid propagation back to the workplace. This relied upon weak sections of duct with frequent change of direction in the expectation that the ducting would relieve the explosion and prevent propagation. However, the vacuum incident clearly indicated the need for positive isolation and rapid acting valves were fitted on the inlet to the dust extraction systems. This also allowed a less convoluted duct arrangement

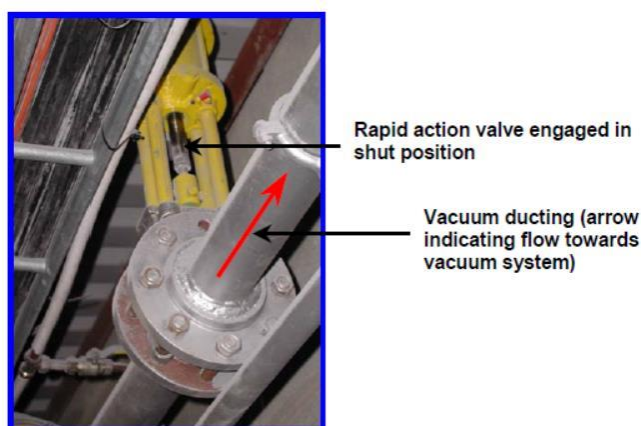
Another explosion occurred in the vacuum system on 13th July 2006. This occurred on vacuum plant no.2 whilst the operator was vacuuming gas classifier no.6. The operator noticed a loss of suction and so removed the cap covering the filter trap and upon removing the cap, there was a flash and flames were reported coming out of the opening. At the same time, an operator working in the corridor reported hearing a loud bang and saw smoke and dust outside the door to the vacuum filter room. Nobody received any injuries. The vacuum filter explosion vent had burst and the vent diverter cap had released as can be seen in Figure 5 (LHS showing explosion panel and RHS showing vent diverter). There was no evidence of damage to the filter unit although the secondary filter protecting the vacuum pump was extensively fire damaged. In addition, the rapid acting valve on vacuum system no.2 suction line had shut as can be seen in Figure 6.

Figure 6: Rapid active valve engaged in shut position

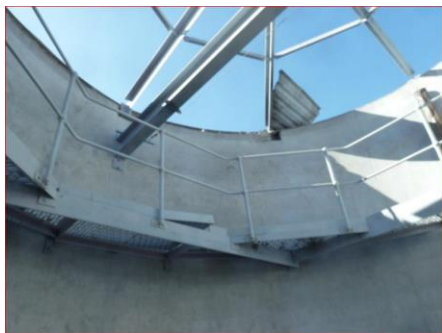
At approximately 03.15am on the 8th of June 2015 an explosion occurred within screen room 1. The explosion resulted in the weak roof of the tower being displaced as can be seen in Figure 7 which was the intended function of the roof under explosion loading. The explosion also resulted in some fire damage within the screen silo tower. No personnel were injured.

Figure 7: Roof blown off screen 1 silo tower

5. All safety systems within the area performed as designed and contained the explosion. For example, the roof lifted as intended and acted as explosion relief, there was no damage to the re-enforced concrete wall of the silo tower and the metal blast doors prevented the explosion entering the occupied corridor area. The decision to install screens and classifiers within these re-enforced towers in 1984 was therefore a very sensible one.

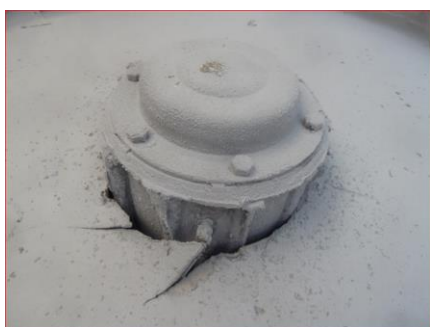
1. Fatigue had caused the steel area supporting the bearing to split open. See Figure 8.
2. Once the bearing had pushed through, the continuous motion/rotation of the bearing housing created friction/heat with the surrounding stationary base unit. This is a very credible source of ignition.

6. The bearing unit was found to be out of line by the engineering team. An external repair to the bearing housing had been undertaken 11 years earlier and this may have been the reason for the failure.

Figure 8: Bearing housing protruding through steel support area

- All the other screen units were removed and inspected for any faults.
- NDT (Non-destructive testing) was undertaken on each screen unit.
- Removing and inspecting the screen units on a 5 year plan is now part of the planned maintenance program.
- Screening silo 1 was replaced with a completely new unit.

- The screen bases are inspected on a regular basis by the Team Leaders and Maintenance team and all checks/findings are recorded.

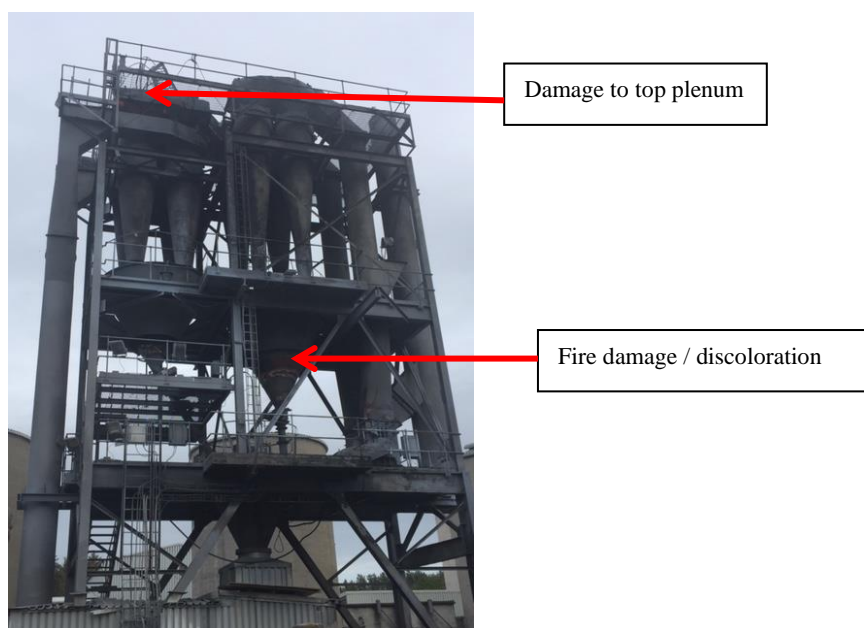
On 10th August 2019, an explosion occurred in the cyclone system on Line 2. Just prior to the incident, the atomising nozzle on Line 2 blocked and so the operator commenced a full line clean out procedure. During this time there was no compressed air to the nozzle but the cyclone conveying fan continued to operate and the discharge of powder into e-bins also continued under automatic control. The explosion happened during the line clean out and although nobody was injured, there was mechanical damage to the cyclones and heat damage from burning of residual aluminium powder in the equipment. The conveying line from the atomising furnace room to the cyclones is approximately 40 metres long and has six explosion panels fitted with restraining cages. All six panels had opened and the retention cages had been displaced and were located on the ground. The duct however, remained intact with no evidence of any mechanical damage. The cyclone structure has 24 blast panels and all these had opened and despite this, there was some mechanical damage to some parts of the equipment as can be seen in Figure 9 as well as fire damage / discolouration most likely from internal burning although also possibly from flame released from explosion vents.

Figure 9: Damage to Line 2 cyclones

1. The explosion may have been more violent than the explosion panels were designed for. So for example, the maximum reduced explosion pressure (P_{red})⁷ may have exceeded design expectations in some parts of the installation. For example, the K_{st} may have been higher than design. The amount of vent area provided was as much as could be physically fitted to the equipment and with high K_{st} metal powders, this may not always be sufficient to avoid damage altogether.

2. The P_{red} of the equipment may have been overestimated, particularly the northern plenum which was most badly damaged. This had rectangular geometry and so would not be expected to be as strong as the cylindrical cyclones.

3. The design of the cyclone system means that pressure piling within the system e.g. between the coarse and fine collection cyclone banks may have occurred again increasing the explosion severity beyond design intent.

4. The explosion panels may not have lifted at the pressure expected. The panels were ATEX certified panels so if maintained should have a certified burst pressure but factors such as product building up may have affected their ability to open. Prior to the incident, the site did not have a rigorous inspection regime in place for burst panels on the cyclone banks.

1. All explosion relief panels on Line 1 (line still operating) immediately removed and inspected to ensure that they were undamaged and free from powder build up.
2. Inspection regime implemented for the explosion panels.
3. Continuous earth monitoring system installed to Line 1 cyclone system (line still operating). Integrated alarming system also installed.
4. Maintenance inspection regime developed for the grounding systems.
5. Restricted automated access gates installed within the linear tunnel areas. This prevents unauthorised access into the 'hazard' areas.
