Flixborough

50 YEARS ON

Lessons for Managers and Engineers Today

Robin Turney says the lessons learned from the disaster are still as relevant now as they were in 1974

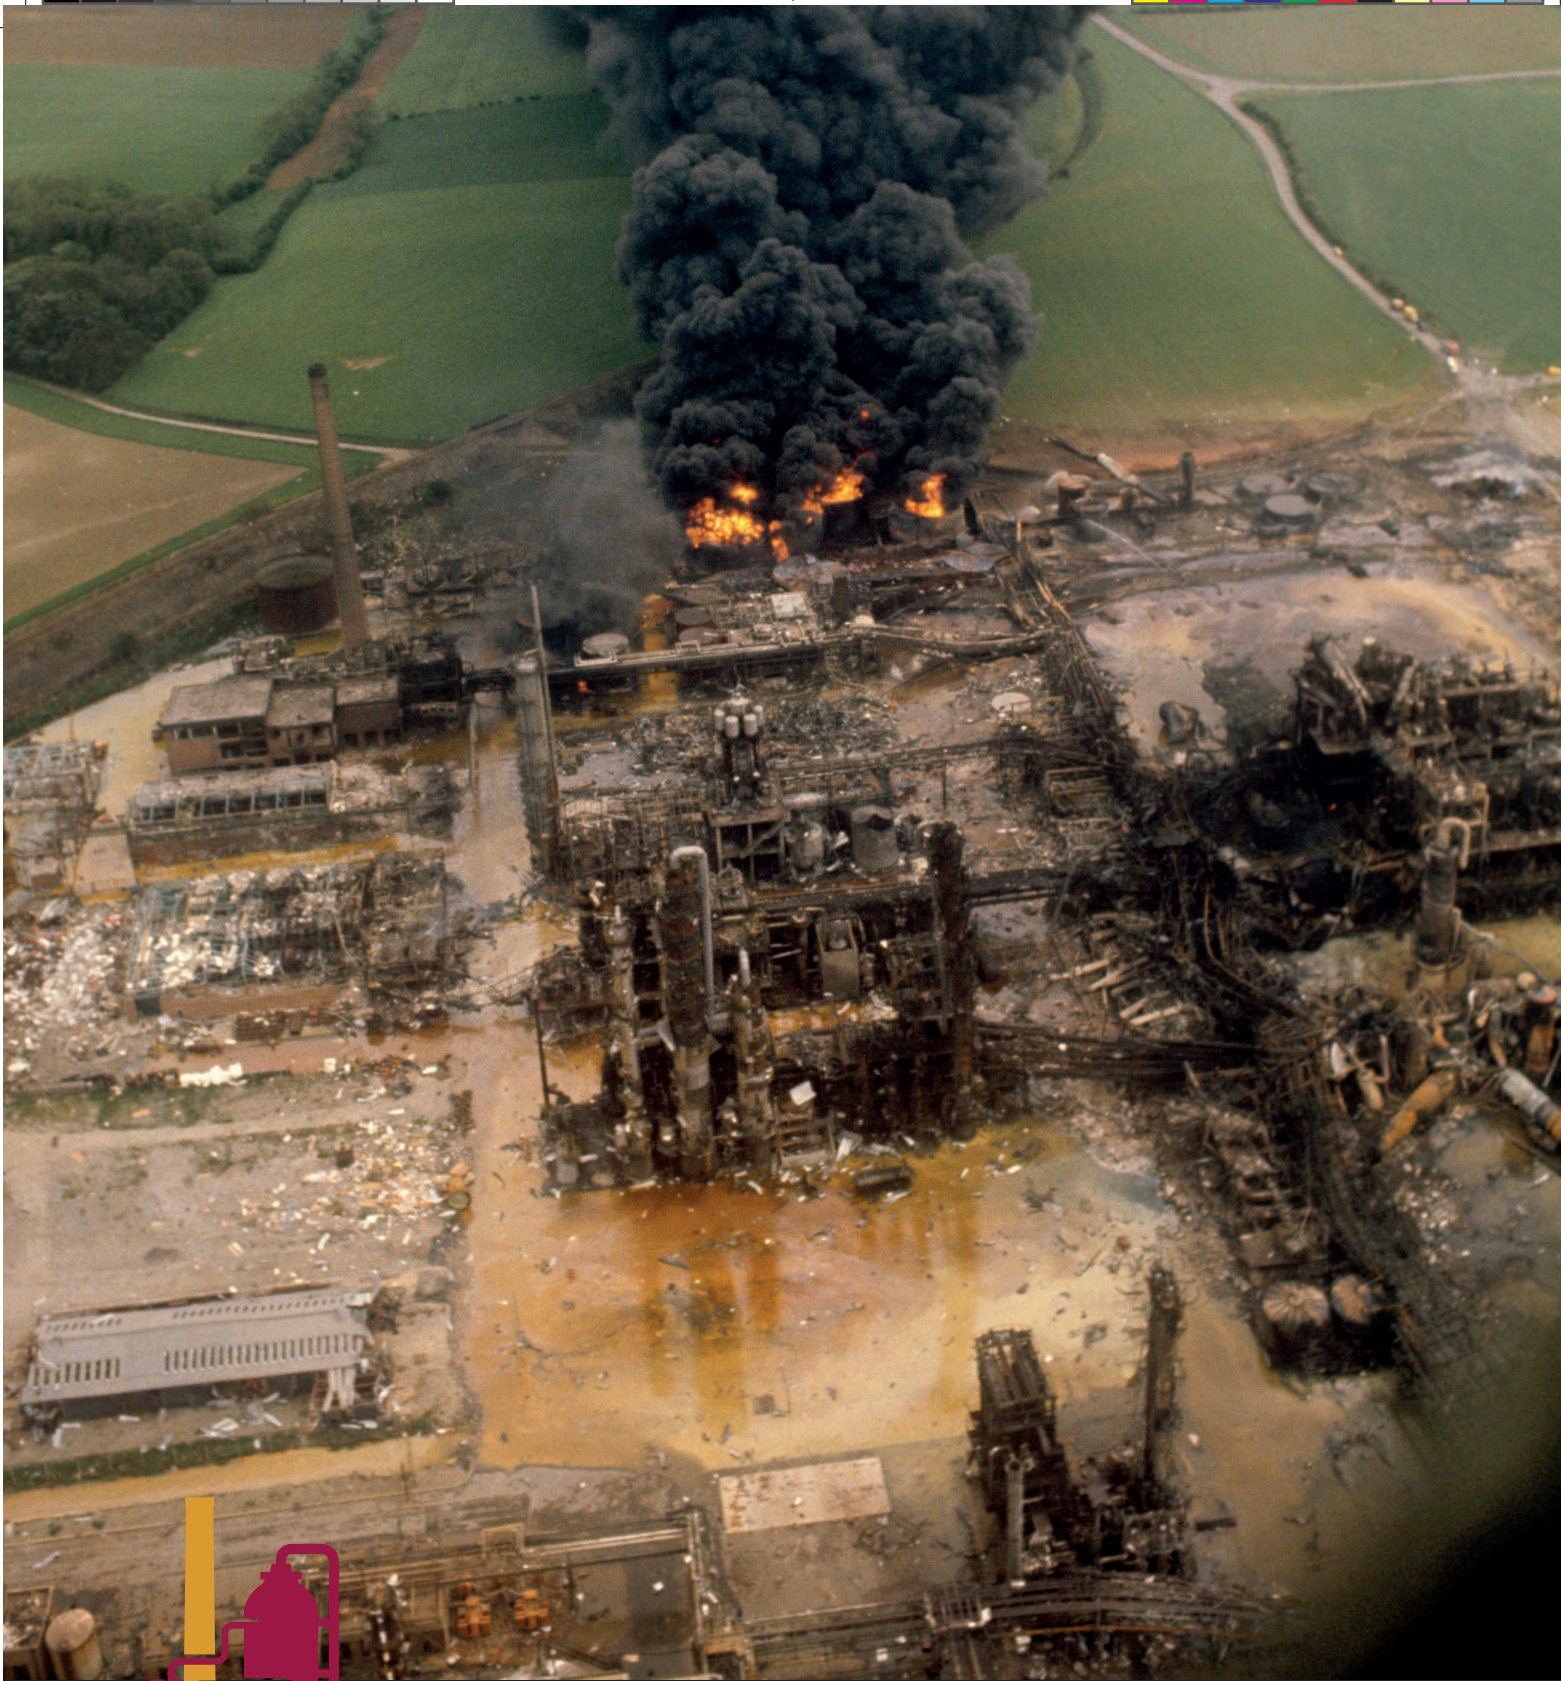
Left: Blast damage to the Nypro UK chemical plant at Flixborough, North Lincolnshire, after the explosion

- At 16:35 the bellows and the connecting piece failed. This resulted in two 700 mm openings and the rapid release of 10–15 t of cyclohexane – 75°C degrees above its atmospheric boiling point – which vaporised immediately

- The vapour cloud spread across the plant, quickly reaching a fired heater and igniting
- The resulting explosion destroyed the plant including the control room. Its power was estimated to be equivalent to 15–45 t of TNT

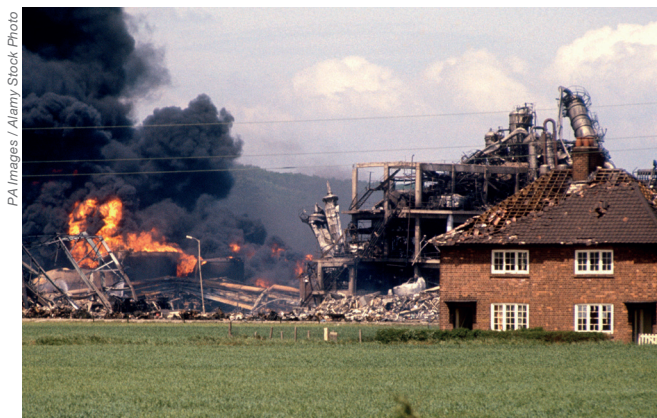
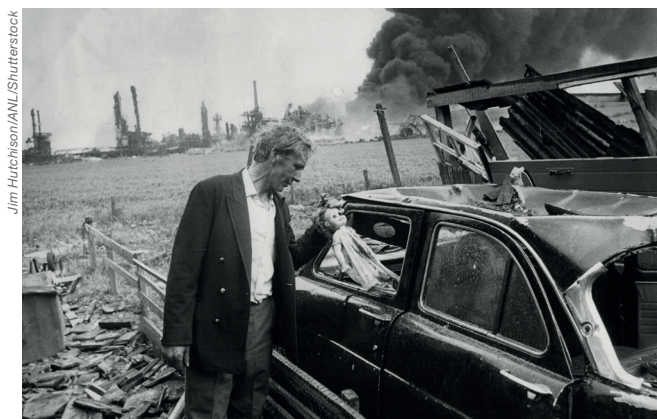
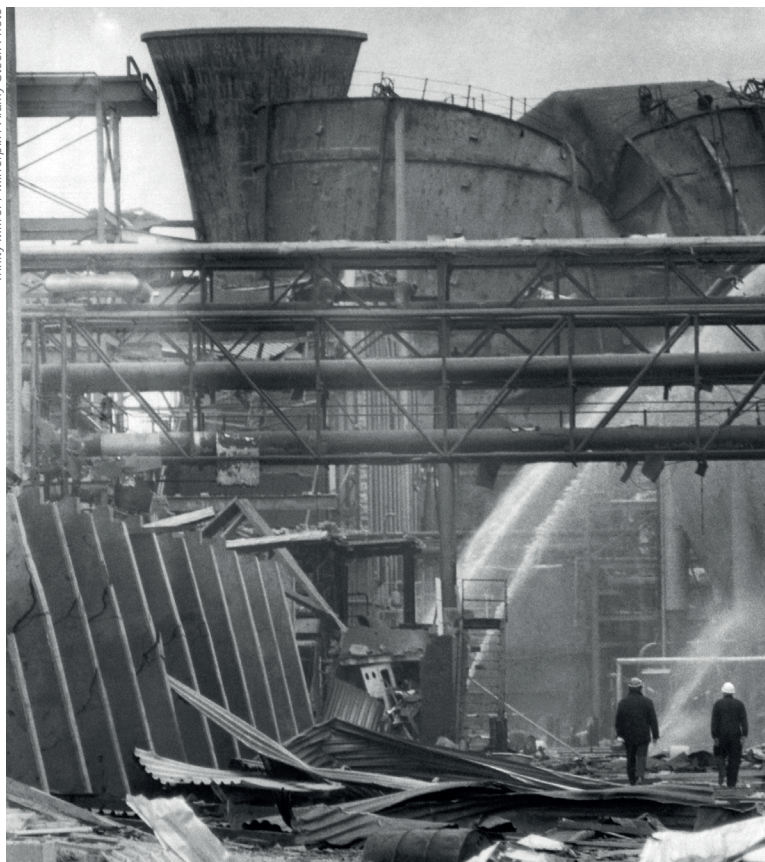
Clockwise from below: There were 12 homes in Stather Road only 600 yards from the plant; John Hulbert, whose house was nearest the factory, pulls a doll from the wreckage of his car; firemen survey the scene of devastation after the blast
