## Investigating unusual powder decomposition incidents

Stephen Rowe\* (Managing Director), Andrew Jennings (Laboratory Supervisor), Clive de Salis (Principle Process Safety Specialist), Simon Gakhar (Principle Process Safety Specialist)

All DEKRA UK Ltd, Phi House, Southampton Science Park, Chilworth, Southampton, Hampshire, SO16 7NS.

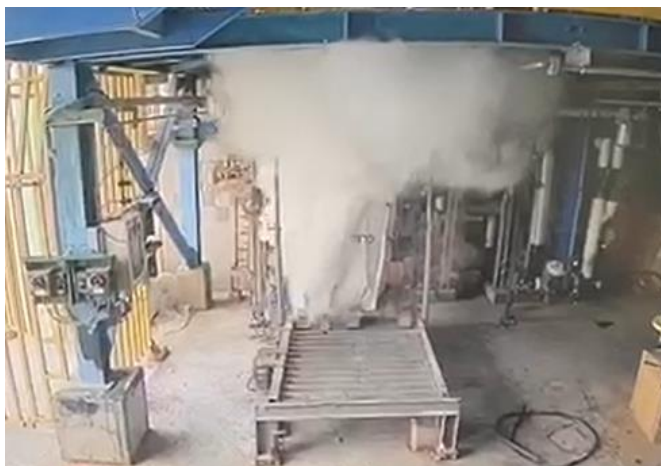
In mid-2020, a drying cycle of 1700 kg of Product A was completed routinely and material discharged to FIBC's. This was the fourth batch of a five batch campaign. There were no obvious deviations from the normal sequence. Several hours after the discharge, the last FIBC containing the final 200 kg of batch (rather than normal 400 kg), started to emit smoke / fume which became more and more dense. The first four bags containing 400 kg from the same batch remained unaffected despite being in close proximity to the final bag. The fuming event was captured by plant closed-circuit television (CCTV). A snapshot of the incipient stages of the fuming event is shown in Figure 1.

**Figure 1: Incipient stages of the incident event captured from CCTV images.**

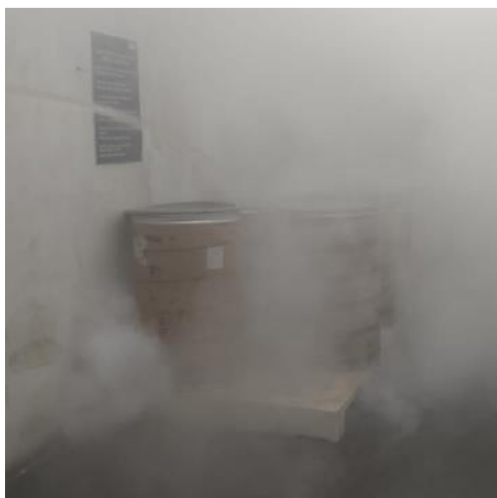
In late 2020, at a different manufacturing facility on another continent, the 17<sup>th</sup> batch of Product A manufacture was just being completed. The final bag of product discharged from the dryer was packed into a 200 L fibreboard drum contained in two polyethylene bags. The final discharge contained 35 kg of Product A, slightly less than normal. After nearly two days in the drum storage area, this single drum of the product began to emit fume / smoke. This continued until local fire fighters deluged the drum with water, extinguishing the event. Figure 2 shows the fuming event captured by a witness camera. After the event, a blackened residue was found in the incident drum, but product in surrounding drums, from the same batch, was found to be chemically unchanged / unaffected.

**Figure 2: Image of the drum fuming event captured by witness camera**

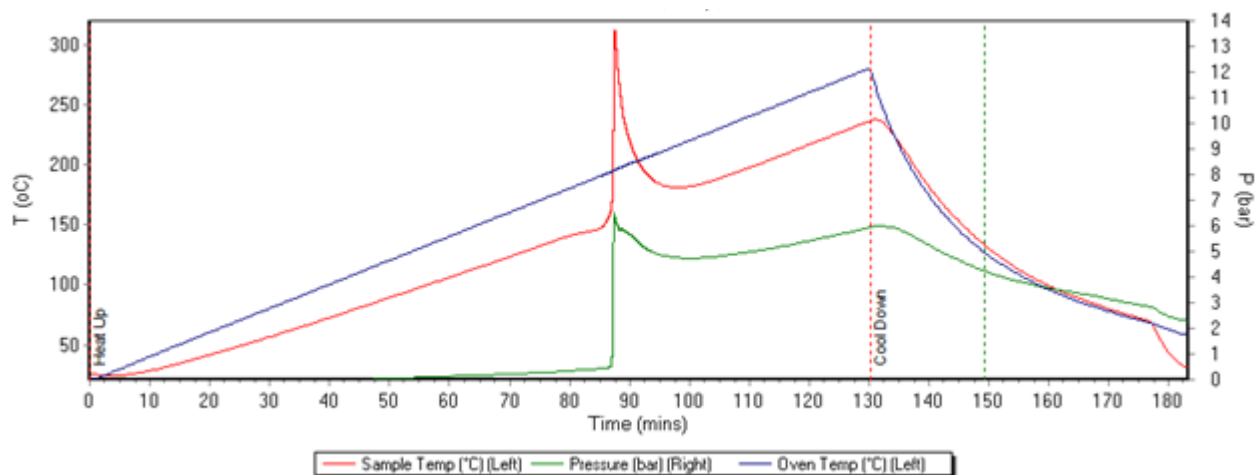
The TSu test result for material taken from the incident batch is displayed in Figure 3. This shows the decomposition reaction occurring from around 140°C – fully consistent with all prior data collected on the material. The operating company applied an industry standard 40 – 50 K safety margin to the measured onset – providing a maximum recommended safe handling temperature of 100°C. As this was above the drying temperature (75°C) and the powder temperature on discharge (40°C), a deeper investigation of thermal stability was initiated.

**Figure 3: TSu test results on sample taken from the incident batch**

TSu is a Differential Thermal Analysis (DTA) screening tool which is neither adiabatic nor thermally efficient – hence large safety margins are typically required to derive approximate maximum safe handling temperatures. More critically, as the test cells are sealed there is little / no oxygen available to support any oxidation events. For powders with a high relative surface area, oxidation must always be considered for elevated temperature operations where air is present. This is particularly true for powder drying operations.

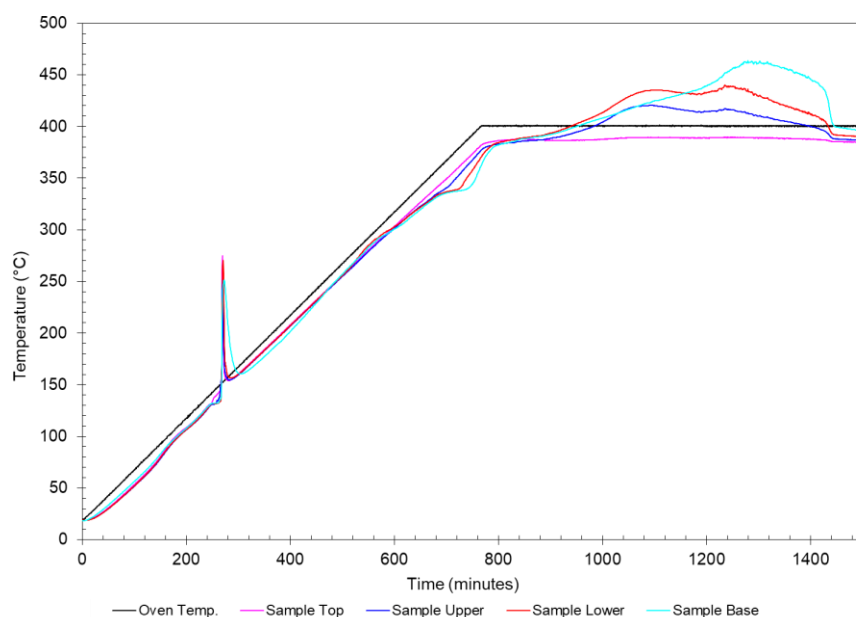
**Figure 4: Diffusion cell thermal stability screening test result**

Examination of the test data initially concluded, consistent with prior thermal stability data from TSu, that the material undergoes significant exothermic reaction from around 140°C. The shape of this event (i.e. very sharp temperature rise) is consistent with a self-decomposition reaction rather than an oxidation reaction (which are normally more prolonged, less sharp, events). Further activity is seen on reaching an oven temperature of 400°C – likely to be consistent with smouldering / combustion of the decomposed product at this high temperature.

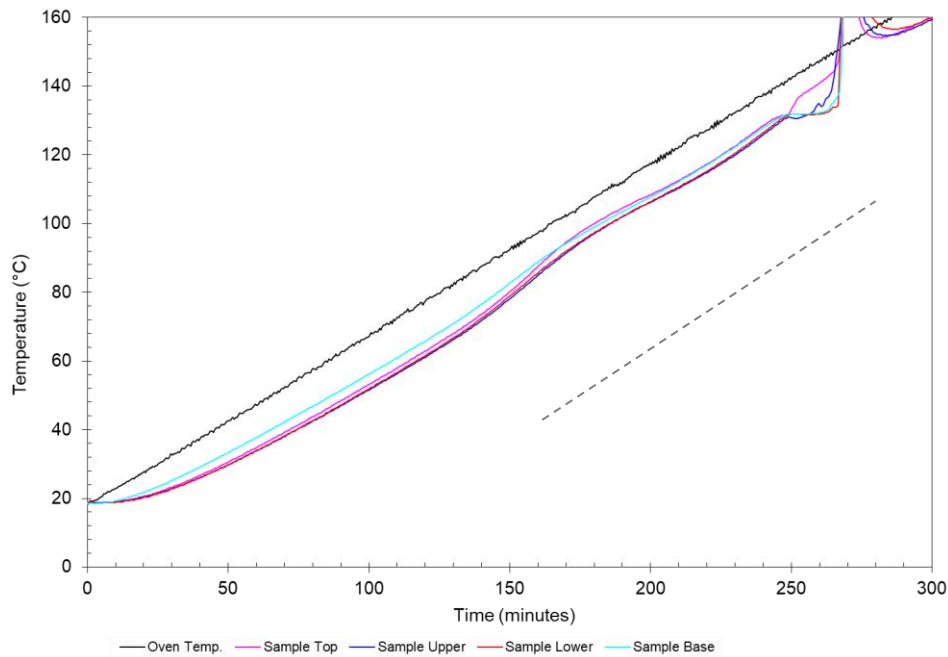
**Figure 5: Diffusion cell test – zoom in on initial ramp section from 20 – 160°C**

As can be clearly seen in Figure 5, there is a small, but prolonged upward deviation in sample temperature starting from approximately 60°C. Although the magnitude of this event is small, it suggested that there is some form of energetic activity. The fact that this activity is not observed in the sealed TSu or ARC tests strongly suggests that it is an oxidation event. To further investigate this phenomenon further isothermal tests in wire mesh baskets were performed.

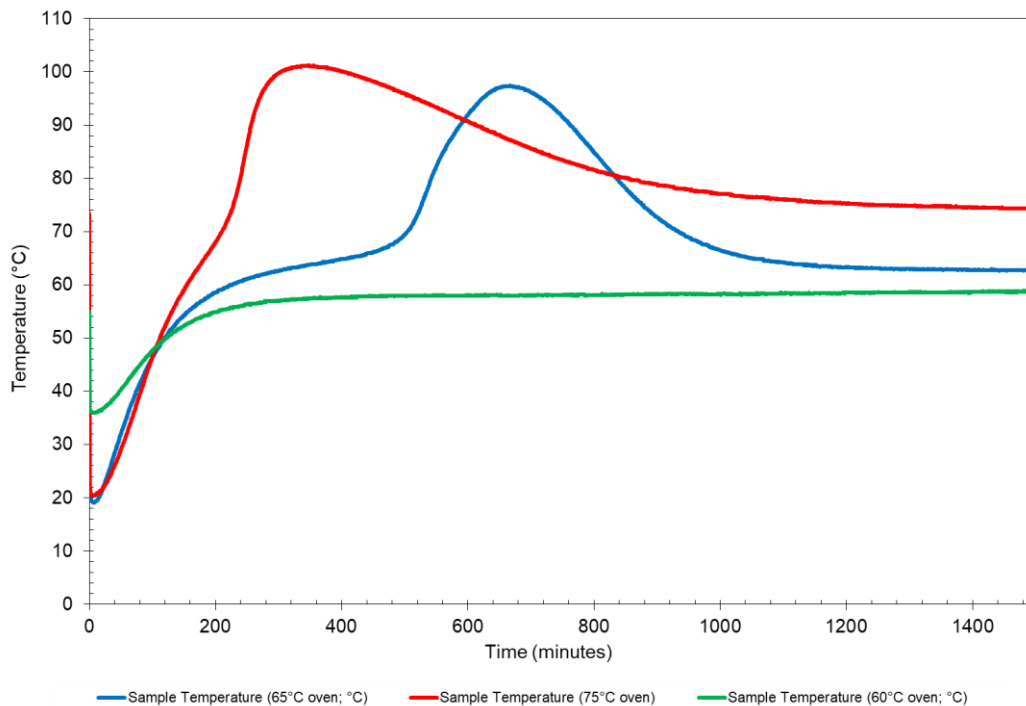
**Figure 6: Basket test results – 100 mm basket isothermal results at 60, 65 and 75°C**

At this scale, the 60°C isothermal test did not propagate the initial reaction whereas the 65°C basket did. Given the much larger scale of the plant storage vessels, it is highly likely that the oxidation events would propagate directly into the primary decomposition.

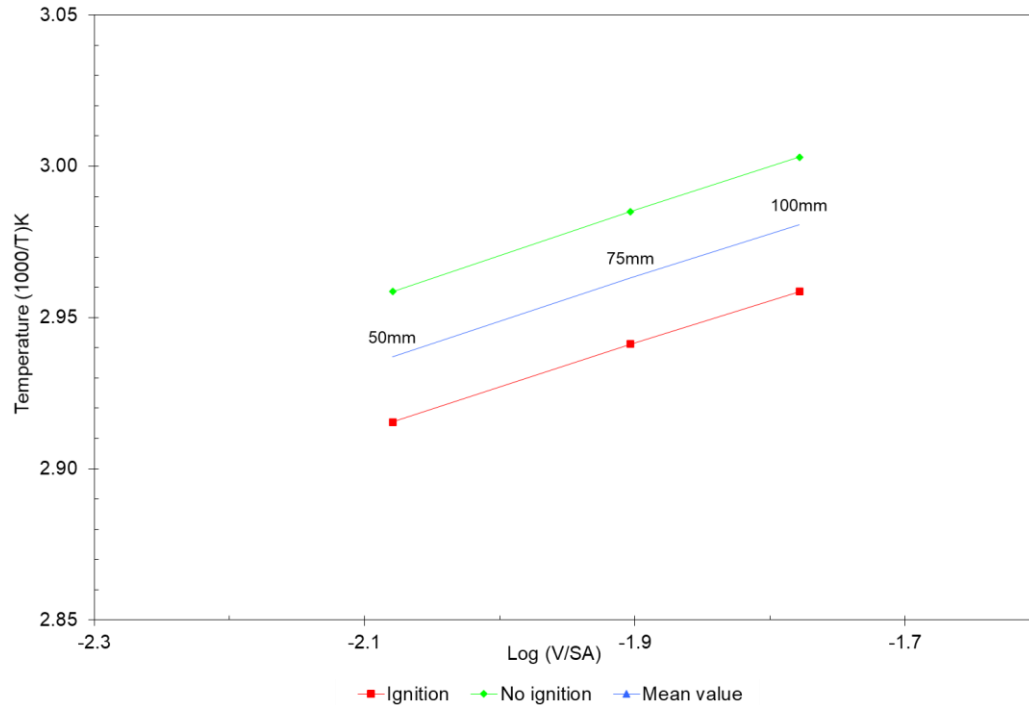
**Figure 7: Critical ignition temperature extrapolation from three basket sizes**

Extrapolating the mean ignition temperatures to the 1 m<sup>3</sup> FIBC indicated a likely “ignition” temperature of 44°C.

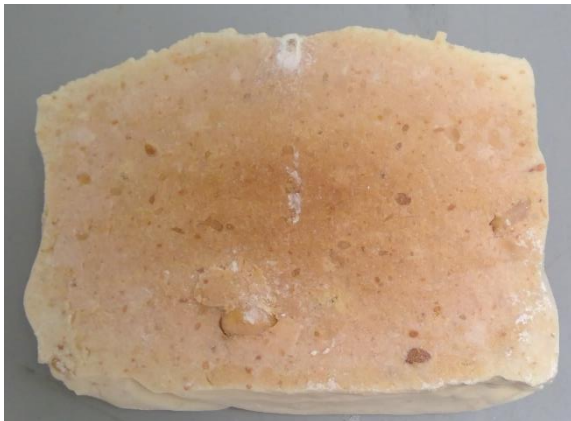
Examination of the product from the 100 mm basket test at 65°C clearly showed chemical changes / browning of the material focused at the centre of the sample (where heat losses are lowest and temperature would be highest). Figure 8 shows a section through the product taken after the 100 mm / 65°C isothermal test. The originally powdered product had all hardened with a brown colouration which was darkest at the centre.

**Figure 7: Post-test sample after the 100 mm basket test at 65°C**
