# Popcorn polymer – the forgotten threat that keeps coming back

Asma Al Badri, Asma Al-Farsi & Danah Allihyani, University of Sheffield, UK

## Summary

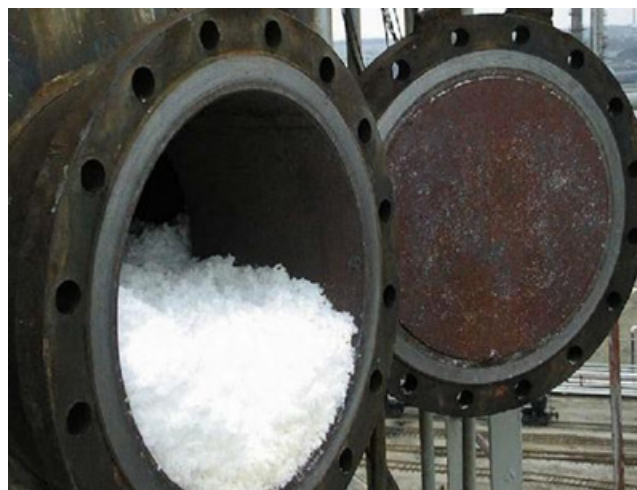
Figure 1 – Popcorn polymer in manhole (Credit: International Institute of Synthetic Rubber Producers Inc.)

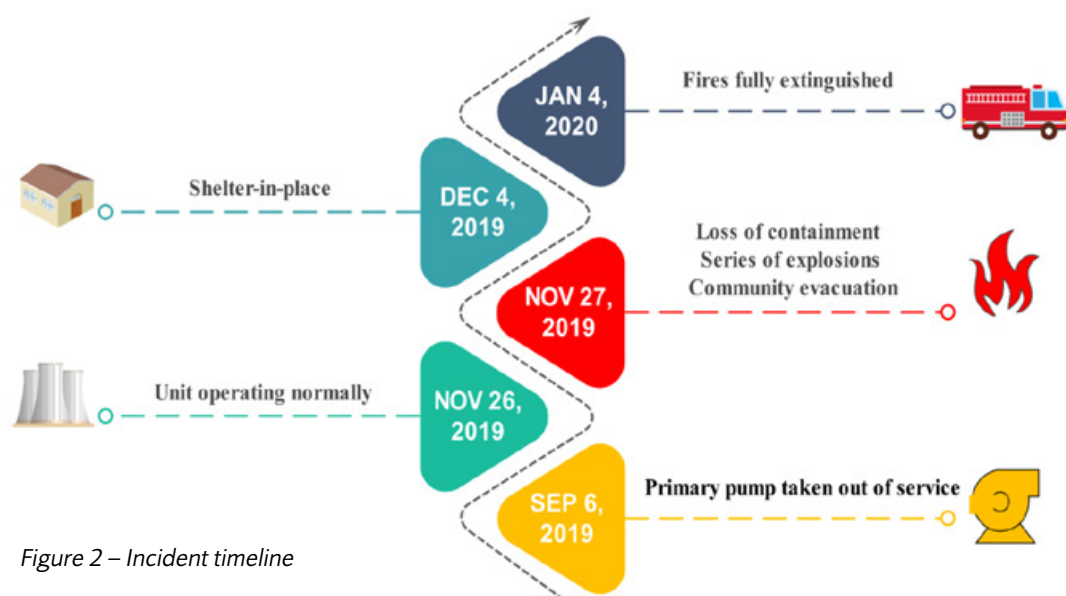
Figure 2 – Incident timeline
