HAZARDS ASSOCIATED WITH THE LARGE-SCALE STORAGE OF FIREWORKS – HUMAN FAILURE AND ITS CONSEQUENCES[†]

Myatt S G* and Bale E W**

*Health and Safety Laboratory, Buxton, Derbyshire, UK

**H. M. Explosives Inspectorate, Health and Safety Executive, Bootle, Merseyside, UK

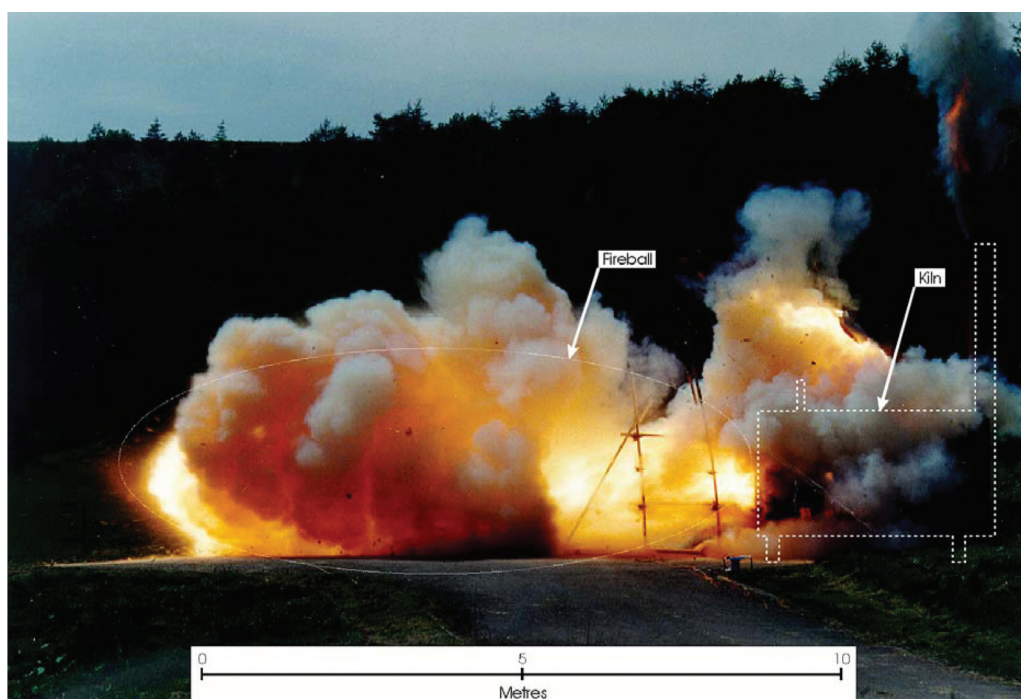
During HSL's investigation⁽⁴⁾ on behalf of HSE, a reconstruction of the incident showed that a fireball was projected 18 m in front of the kiln (Figure 1), and an over-pressure of 264 kPa (38.4 psi) was generated inside it. This caused the entire kiln (approx. 2 tonnes) to recoil 0.7 m as the gas vented through the doors before its motion was arrested by a grassy bank.

Figure 1. Ignition of 100 partially broken down rockets in a steel kiln

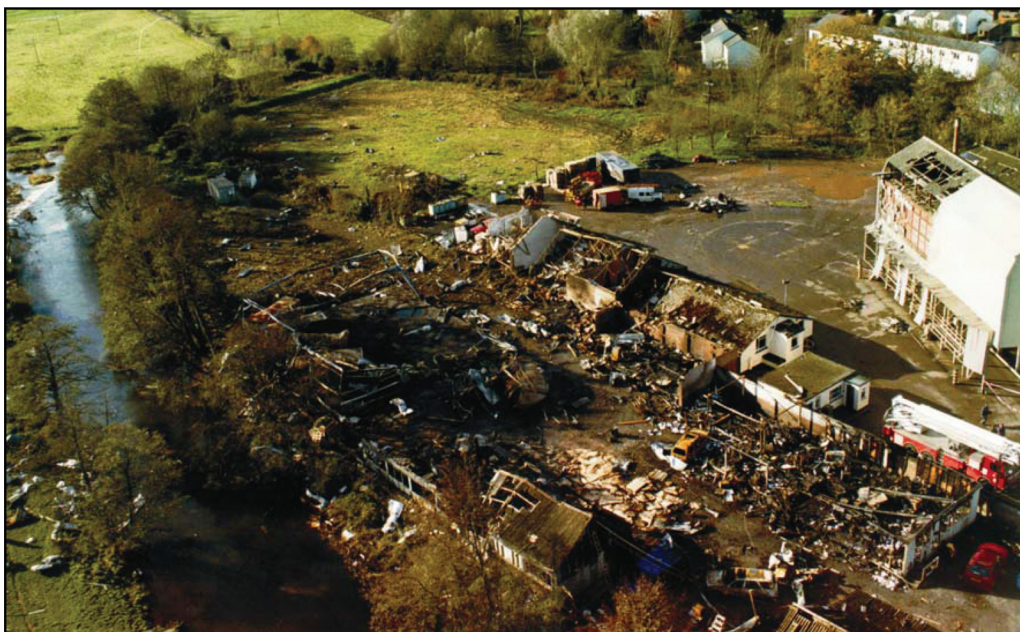
An operator was dismantling a string of firework shells in an open steel storage container when the shells ignited causing the fireworks in the container to catch fire and ultimately explode. In total eight containers used for the storage of fireworks were housed in the same building, which was constructed in a similar manner to many industrial units (i.e. concrete base, brick lower walls, and corrugated steel sheet construction above). Many of the containers subsequently exploded after the ignition of the fireworks in the first container. Buildings in the immediate area were destroyed (Figure 2) and others severely damaged. A portakabin 55 m from the explosion was also destroyed. Debris was scattered for hundreds of metres.

Subsequent investigation showed that the crushing action of the scissors acting on a matchhead fuse in the firework fuse system was sufficient to ignite the shell string and resulted in an explosion which scattered burning firework stars throughout the ISO-container causing more fireworks to ignite. As the fire and explosions continued they attracted the attention of the local population who gravitated towards the site, unaware of the danger in which they were placing themselves. Finally a large explosion occurred throwing debris into the air and destroying the magazine complex. ISO-container fragments were thrown up to 210 m⁽⁵⁾; in particular a steel ISO-container corner weighing 10 kg fell through an extension roof 140 m from the explosion, narrowly missing a child. Corrugated cladding from an adjacent mill (53 m) was ripped off and panes of glass were broken at distances of up to 100 m. Directly beneath the first container that exploded were two depressions in the 163 mm thick concrete base. The largest was approximately 113 mm deep and 4 m in diameter. The smaller depression was 3 m from the first and was 50 mm deep and 3 m in diameter. From the available data it was calculated that the explosion was equivalent to 200–250 kg TNT. As a result of the large explosion and ensuing fire, the office area was damaged and all magazine records were destroyed thereby making analysis of the incident more difficult.

Figure 2. Uffculme fireworks complex after incident (Reproduced by permission of Aerial Photos)

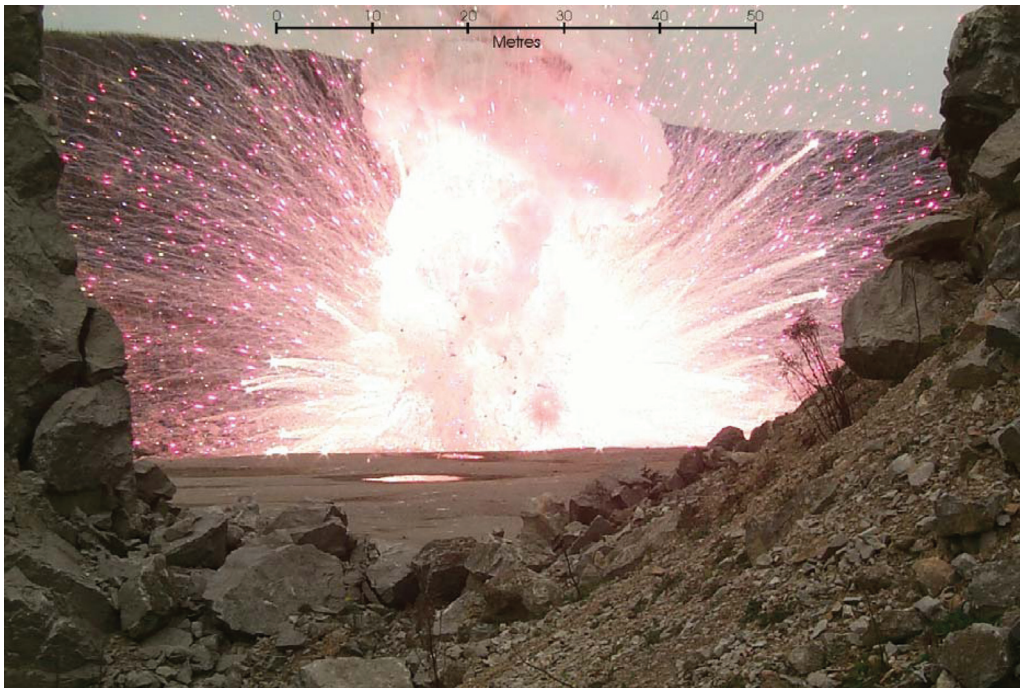
Research into firework storage in ISO-containers that was being performed at HSL⁽⁶⁾ at the time of the incident produced visual effects similar to those observed at the incident scene (Figure 3). A total of 2.6 tonnes NEC of firework

Figure 3. Effects of ignition of 2.6 tonnes NEC of firework shells in a 20 ft steel ISO transport container

shells, caused the doors of the container to burst open and the container sides to bulge. The shells ignited sequentially over a 20 second period and produced a sphere of stars in excess of 100 m diameter. An inner core of flame 36 m diameter was estimated to have an effective surface temperature of 400°C and exceeded 800°C over a diameter of 22 m.

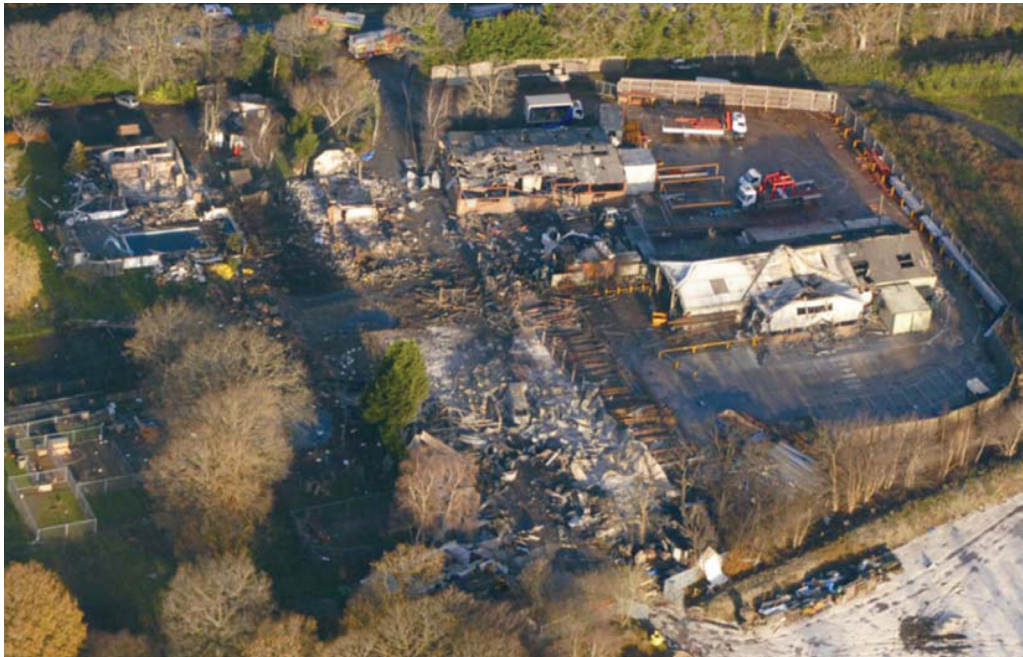
An operator was weatherproofing single-shot batteries outside the designated factory building for use at a display that evening and had some electric igniters close by. While moving the igniters the operator alleged that they burst into flames and ignited the single shot batteries. A fire ensued that spread through the site and eventually impinged on the ISO-container resulting in a violent explosion causing the deaths of two fire-fighters and injuring Police Officers, other fire-fighters and members of the general public. Fragments of the container were thrown hundreds of metres, windows in domestic premises nearby were broken and tiles on roofs were dislodged. An aerial view of the site after the incident is given in Figure 4.

The container that ultimately exploded was not licensed for the storage of fireworks and had no labelling on it to indicate the hazardous nature of its contents. When it exploded the container was ripped into relatively small fragments (1–4 m²) that were found up to 350 m from the explosion point. In addition, a 10 m³ crater was formed beneath the container, window damage was incurred up to 240 m from the explosion point and tiles on nearby dwellings were dislodged. A report by the Home Office calculated that the window damage and crater size suggested an explosion equivalent to 200–250 kg of TNT.

The investigation concluded that the single shot batteries were being processed outside the process building in contravention of the licence and that once lit, some of the ejected stars entered the load area of a near-by van by way of the open doors and ignited the 150 mm diameter shells and transport packs of ground maroons that it contained. These exploded causing the destruction of the van and scattering burning stars over a wide area causing fires to break out in combustible material stored between firework storage areas. Eventually the fires progressed through the site and impinged on the unmarked ISO-container, which the fire service was attempting to cool when the contents mass exploded with fatal consequences.

Figure 4. Festival Fireworks Ltd storage complex after incident
