THE BUNCEFIELD EXPLOSION: VAPOUR CLOUD DISPERSION AND OTHER OBSERVATIONS

J. E. S. Venart and R. J. Rogers, University of New Brunswick, Fredericton, NB, Canada

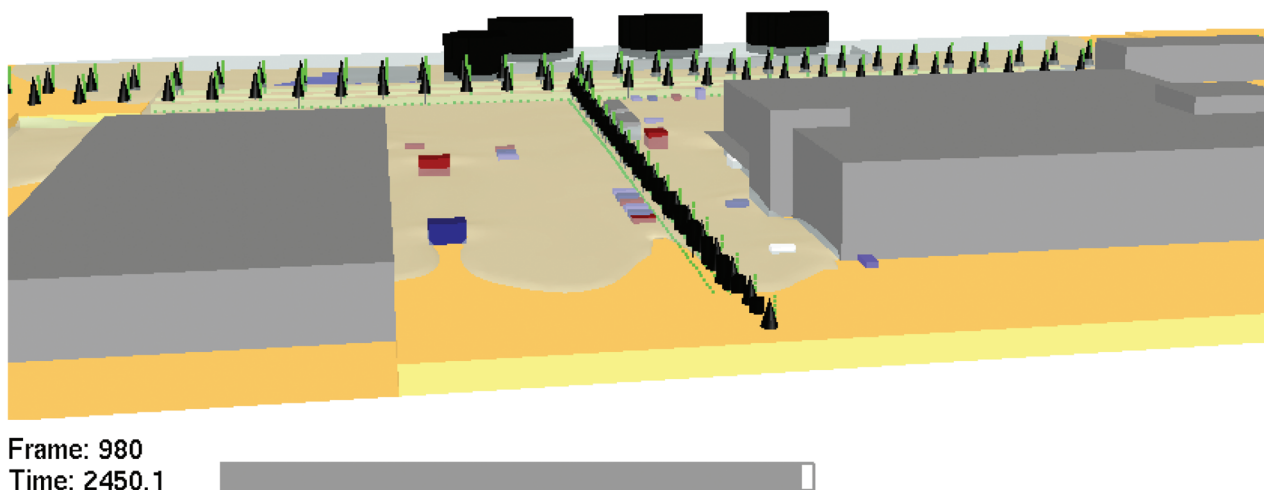
Figure 1. NIST FDS5 LES LFL dispersion model of the Buncefield release at ~2400 s: View East between the Northgate and Fuji buildings from the Western edge of the computational domain

Figure 1 illustrates the dispersion modelling result for the lower flammable limit (LFL) boundary at about 2450 s as seen from the W based upon the reported atmospheric conditions. The LFL boundary of the simulation can be seen to conform very closely to the observed regions of vegetative singeing in the western areas between the NG, Fuji and 3-Com buildings (Steel Construction Institute, 2009).

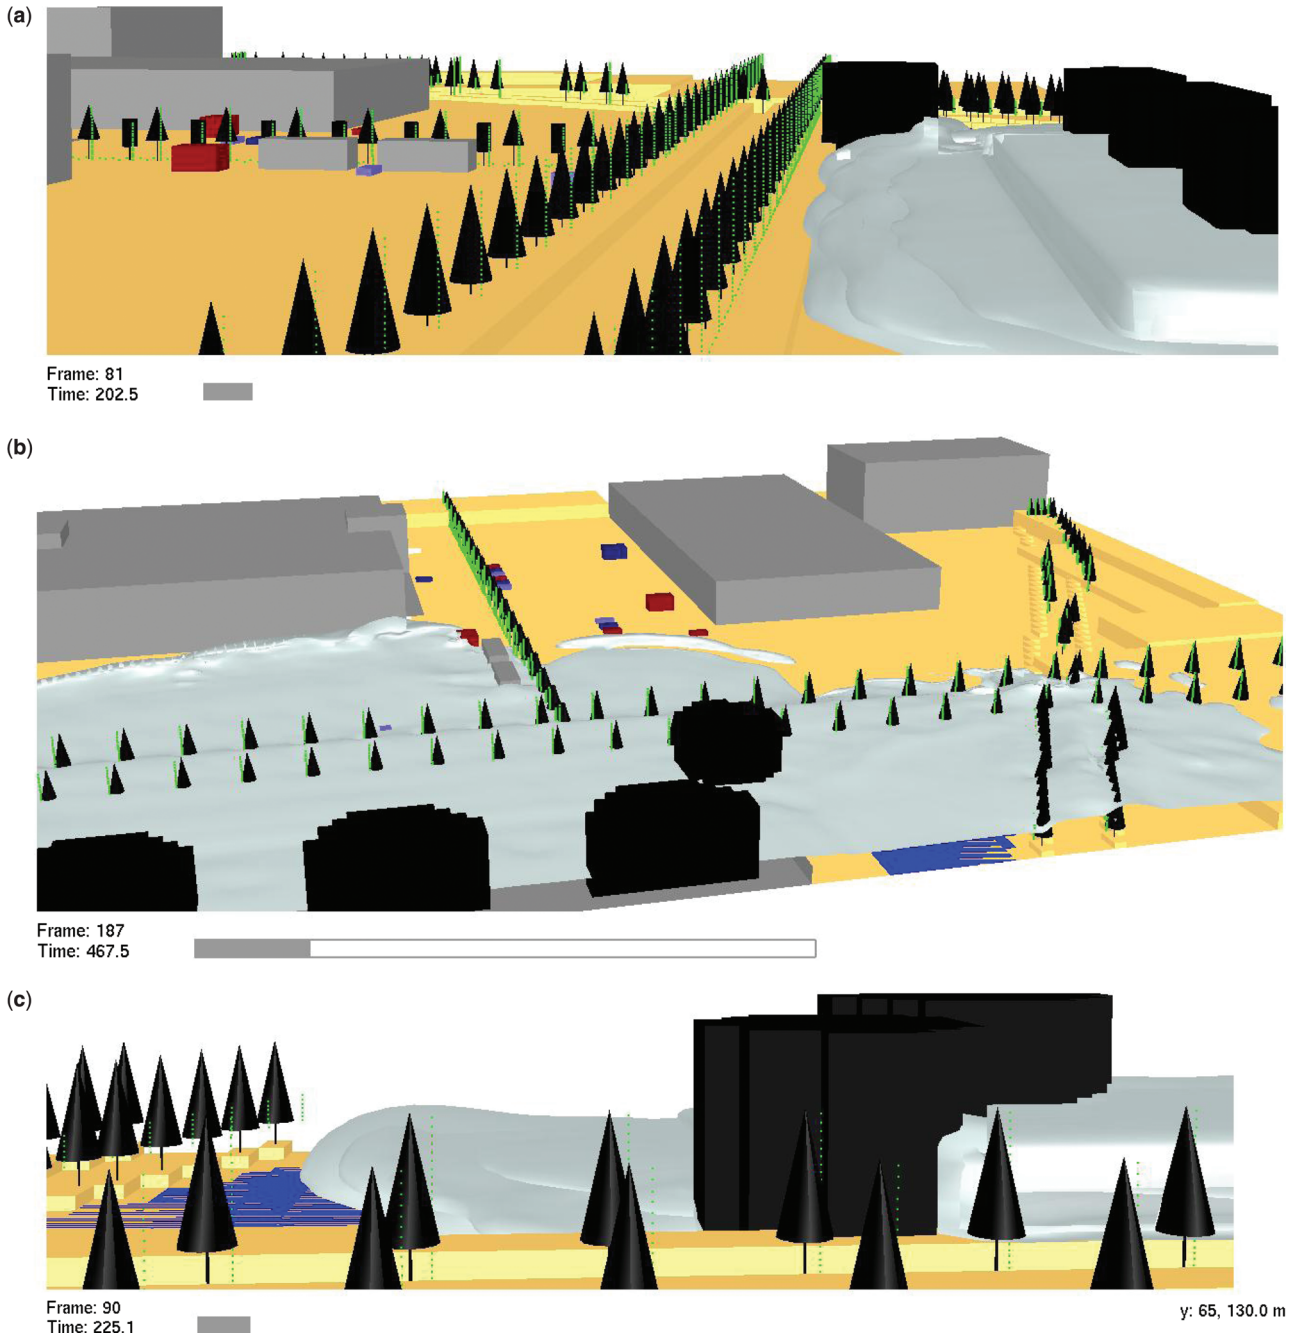
Figure 2(a) shows cloud development in the space between the tanks of Bund A and the tree line of Buncefield Lane as viewed from the S at time 225 s. Figure 2(b)

Figure 2. (a): -0.1°C vapour-cloud isosurface developing S over the space between Bund A and Buncefield Lane at 202 s; NIST FDS5 CFD simulation as viewed N towards the fire water tank. (b): -0.1°C vapour-cloud isosurface developing over the Fuji and NG carparks at about 468 s; NIST FDS5 CFD simulation as viewed towards the W from the top of the fire water tank. (c): -0.1°C isosurface developing over the PHL and around the fire water tank at 225 s as viewed from the W; NIST FDS CFD simulation

illustrates the same isosurface at 467 s looking W towards the Fuji Building across its carpark. Figure 2(c) illustrates the dispersion modelling result for the -0.1°C isosurface viewed E at 202 s in the region of the PHL. All views are in reasonable temporal and geometric agreement to the CCTV evidence given in HSE, 2010, CCTV².

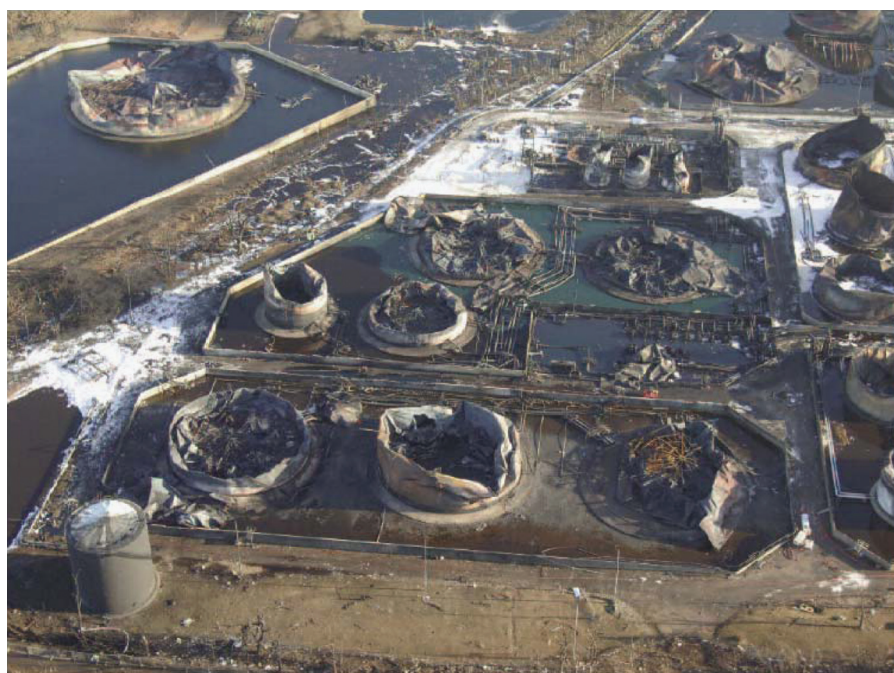
Figure 3. Aerial view to East of Bund A and its tanks. Tank T912 is in the centre foreground, T910, which was empty at the time of the incident, is to the right of T912 [*The Buncefield Incident, 11 December 2005; The final report of the Major Incident Investigation Board, Volume 1 (2008) p 1*]

Tanks T6, T911 and T914 appear similarly crushed with roofs either blown off or partially detached (Figure 3).

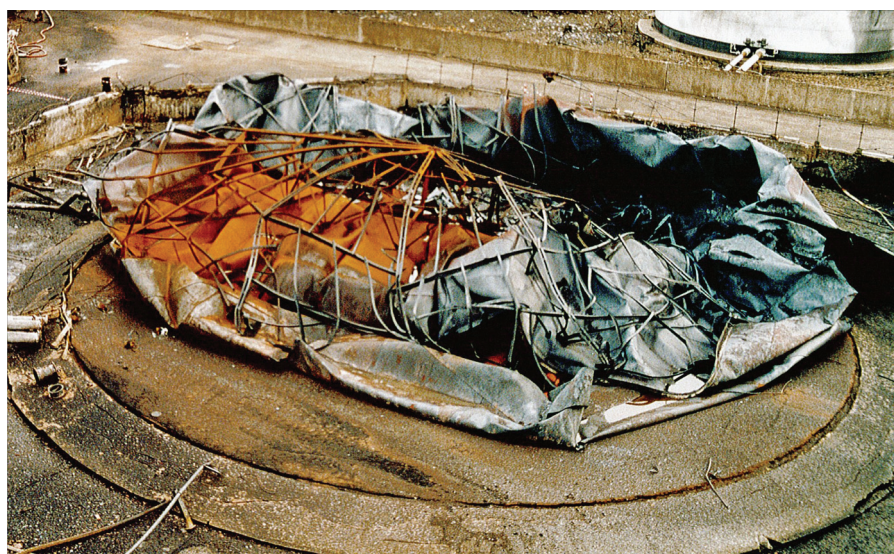
Figure 4. Aerial view of Tank T910 from the NW. Note bottom plates peeled back along with crushed sides from the NNW. The top of the tank has been blown off the underlying rafters which then have collapsed along with the crushed walls. The apparent number of elastic lobes or wrinkles is about 20 [Photograph provided by G Atkinson, July 2010]

In Figure 4 tank T910 is shown crushed and its plate roof torn and blown off – a piece of the roof was found in the Northgate carpark and another was just immediately over Bund A to the east. Blast impact appears to have been from the NNW with significant peeling of its base plate as well as tearing of the wall/base junction to the south⁵. Over much of the NNW side wall deformation appears to consist of many, nearly identical, lobes wherein there are significant regions of crushing followed by reverse bending/bulging and, in these locations, localized regions of plate tearing. The shell walls to the SSW

appear to have been torn away from their base plate and the roof. The roof structural steel rafters appear to have collapsed along with the top shell walls.

We know that the roof of T910 was torn off the tank edge and its radial rafters and transverse purlins. A lower bound of the internal pressure necessary to do this can be estimated. Based upon a tensile shock loading factor of say 1.3; a flow stress ((yield + ultimate)/2) for mild steel, $\sim 280 \text{ MPa}$; and a plate/weld thickness of 5 to 6 mm with the area of the roof $\pi/2 \times 25 \times 12.74 = 500 \text{ m}^2$; and knowing that the roof of T910 was torn from the necessary sealing welds to tank walls, as well as in half, the minimum internal pressure, P_{int} , can be estimated. This is $(\pi \times 25 + 25) \times 0.005 \times 1.3 \times 280/500$ or $P_{\text{int}} = 0.38 \text{ MPa}$.

Thus we have $PV^\gamma = \text{constant}$ and the crushed volume at the instant of top detachment 2879 m^3 ; or a reduction in volume of some 60%. The compression work on the gas necessary to achieve this is $9680 \text{ kg} \times 0.714 \text{ kJ/kgK}$ (127 K) or 895 MJ.

It can be concluded therefore that tanks T910 and T601 were crushed by elastic impulse pulse buckling with blast loading overpressures of between 0.38 and 0.85 MPa. The last of these values compare favourably with that

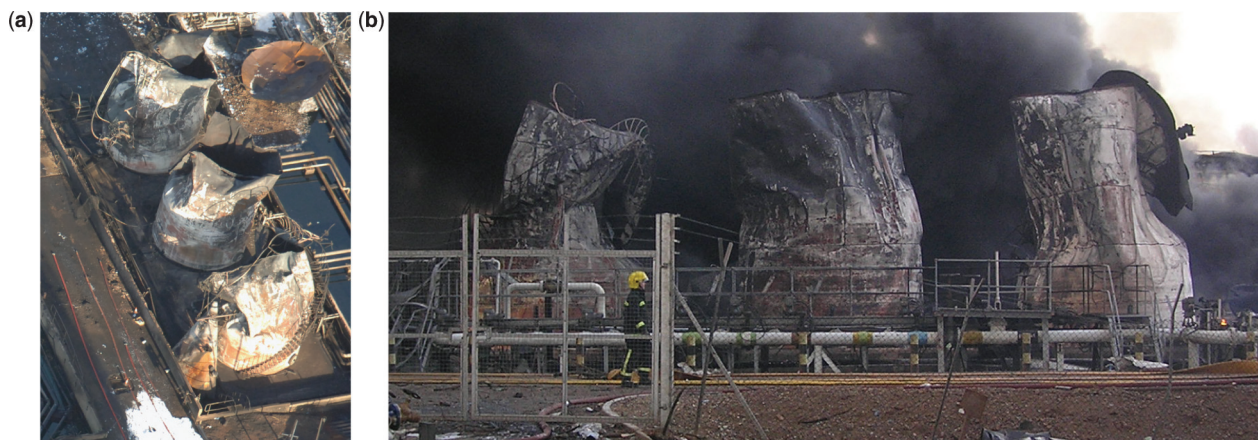
The crushing of the transfer tanks T601 to T603 (6.0 m D \times 9.8 m H) was much more complex than that for tank T910. Figure 6(a) is an aerial view of the tanks from the west and Figure 6(b) a view looking to the north-west. All tanks have had their membrane top roofs torn and blown off. The tanks were obviously only partly full at the time. Apparent reductions in volumes, based on the observed liquid level and deformation of the most northern tank, appear to be about 55 percent. Blast transit times, based upon an assumed CJ Butane detonation, would have been about 3 ms with elastic characteristic time of about 90 ms based upon an assumed wall thickness of 5 mm (assumed weld thickness 3.5 mm). Analysis, similar to that for T910, yields a minimum crushing pressure to tear off these roofs as 0.85 MPa.

Figure 6. (a) Transfer tanks T601 to 603 as seen from the SW; (b) T601 to T603 as seen from the NE. These tanks are 6 m in diameter and 9.8 m tall. The tanks were obviously partially full at the time of crushing (Atkinson, 2010)

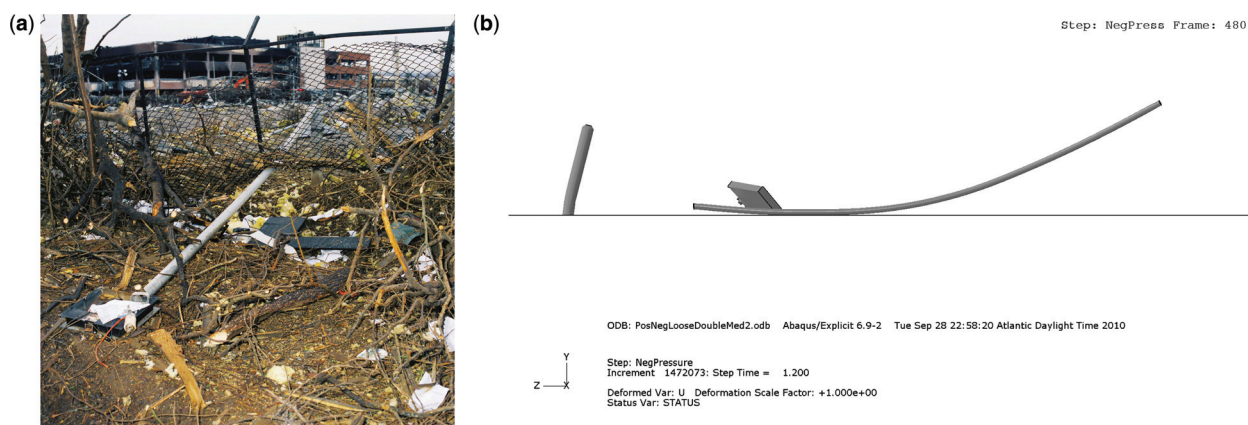
Figure 7. Fuji carpark lampposts: (a) Lamppost in foreground has been hit by blast, snapped and then felled NE. The Fuji carpark Buncefield perimeter fence has next been blown down, up over the felled lamppost base, and then dragged over the fallen pole. A similar pole in the background has also been snapped and blown down to the E. (b) Abaqus/Explicit 6.9 FE simulation of a similar lamppost indicating the fracture at base, removal of lamp housing, and displacement, all in the direction of the blast's positive phase.

For example Figure 7(a) shows a fractured lamppost felled to the NE (with another to the W behind it felled to the E). Here the perimeter fence between the Fuji carpark

Figure 7(b) shows the final configuration of a lamp-post simulation where its total length was exposed to blast. The simulated system is not quite at rest and further vertical settling will occur. The base post shows a permanent lean in the direction of the positive pressure. The pole snapped at the base-pole connection and lamp box landed to the east of the base post, consistent with the actual lampposts shown in Figure 7(a). The simulated lamp box separated at 0.063 s of pressure loading and landed rather close to the base post, whereas the lamp box in Figure 7(a) is near the far end of the pole.

The fence and debris overriding the felled post in Figure 7(a) suggests that after being felled by blast, debris was blown into the fence and then this collection was deposited overtop. This suggests strongly that the blast was followed by a powerful deflagrative event.
