BLAST DAMAGE TO STORAGE TANKS AND STEEL CLAD BUILDINGS[†]

Graham Atkinson, Health and Safety Laboratory, Buxton, Derbyshire, UK

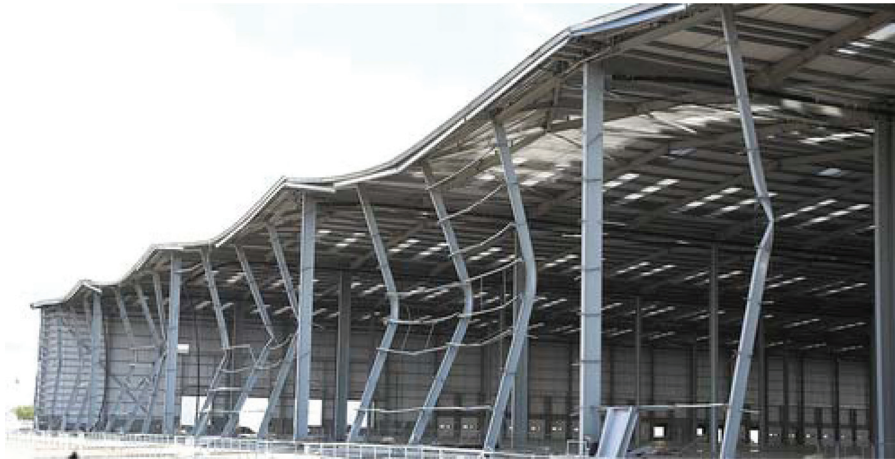
Cladding on the majority of the sidewalls and roof of Warehouse 1 (WH1) – apart from near the ends – was undamaged and did not have to be replaced when the warehouse was repaired. By contrast cladding on the roof and sidewalls of WH2 was all significantly damaged and had to be replaced (Figure 7). The reason for this difference is traceable to the type of cladding and the venting mechanism during the blast. WH1 was a “built-up” cladding system that remained intact to higher pressures. The building vented when wind posts along most of the front face failed, tearing purlins from intact frames and allowing large sections of (substantially intact) cladding to swing inwards.

In the case of WH1 the fractional open area of the vented face at the end of the positive phase was around 30%. Table 1 in Appendix 1 shows how the transmitted

Figure 2. Warehouse 1 after remains of cladding removed

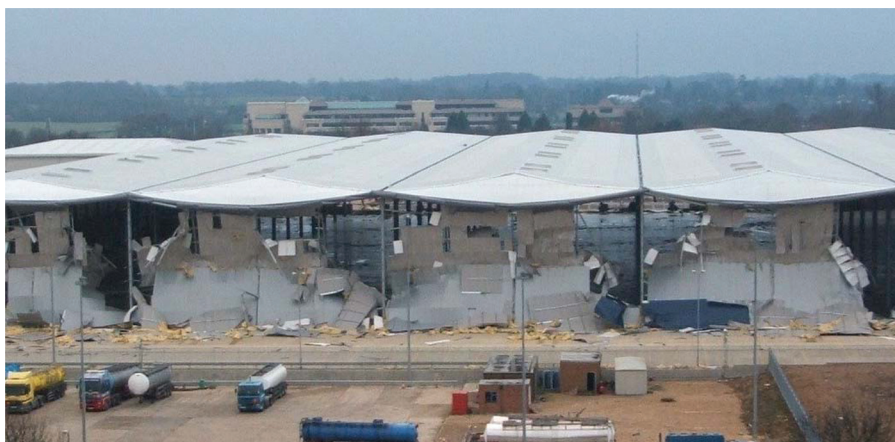
Figure 3. Warehouse 1 before cladding was removed

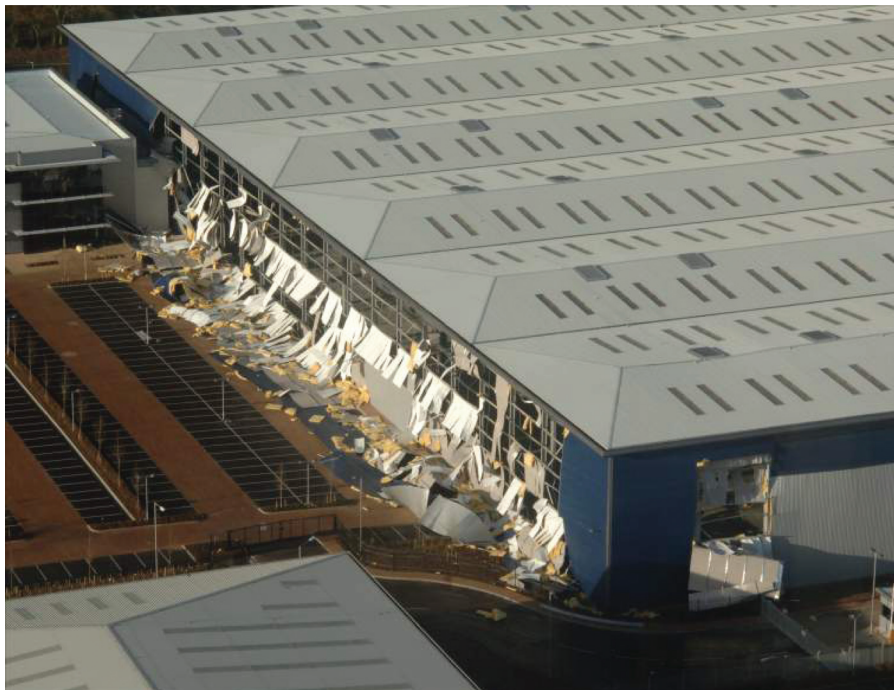
pressure varies with the external pressure for a vent this size. If the external pressure is in the range around 1000–4000 Pa the net inward pressure on the roof and sidewalls is less than the threshold likely to cause damage whilst the reflected pressure at the back wall exceeds the external pressure by enough to cause cladding loss. These results explain the general form of the damage observed to different parts of the structure.

Figure 4. Warehouse 1 showing outward displacement of cladding on or near the back wall by an internal pressure surge

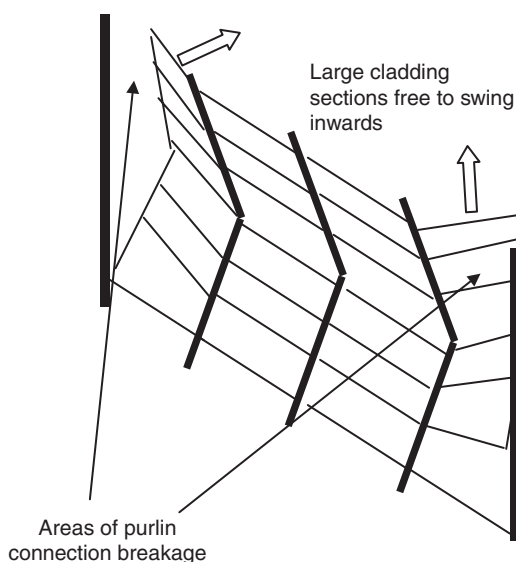
This mechanism is illustrated schematically in Figure 5. Where the underlying structural steel framework did not fail the strong built-up cladding suffered no permanent deformation and remained serviceable.

Figure 5. Schematc showing mechanism of venting of WH1

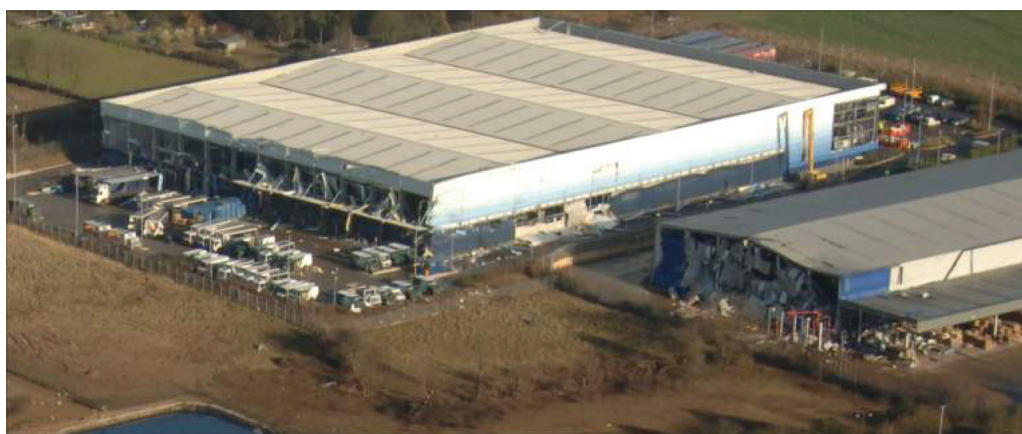
By contrast in Warehouse 2 (WH2) the cladding panels and support frames were weaker than the structural steels (which remained substantially intact). As the blast pressure rose large parts of the cladding and support frame suffered inward deformation without opening up substantial vents that could allow pressurisation of the interior. When the connections between the cladding frames and the main structural steel failed (finally venting the structure) cladding on almost all of the roof and sidewalls had already been damaged and had to be replaced. Examination of shows the outward deformation of cladding supports on and near the rear wall of WH2 showed that approximately

50% of the support frames yielded (in an outward direction in this case) before failure of the cladding fixings – in the other cases the fixings failed first. This suggests the cladding system was rather carefully designed to withstand suction forces with support frames and cladding fixings well-matched in strength.

Figure 6. Warehouse 2 showing inward venting of front face and outward cladding loss on the back face caused by an internal pressure surge

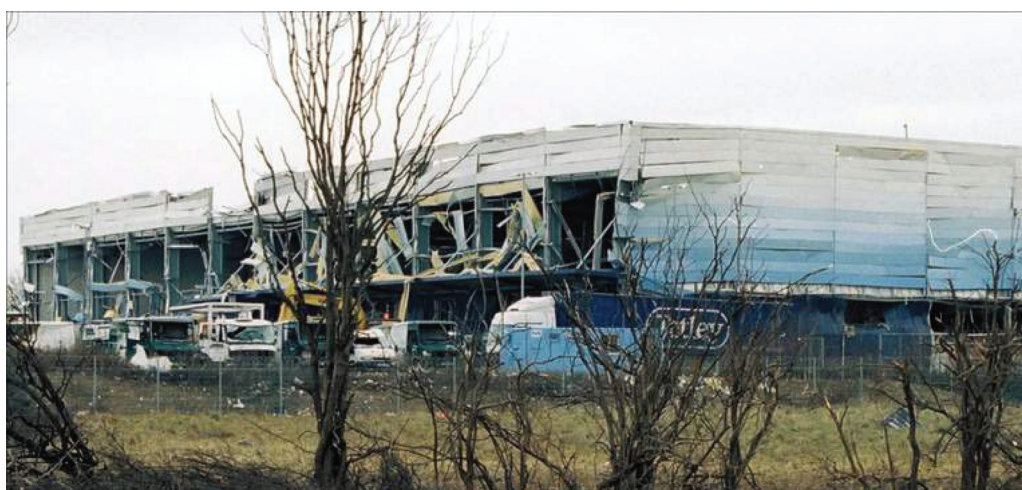
Figure 7. Warehouse 2 showing pressure damage to the (unvented) sidewall

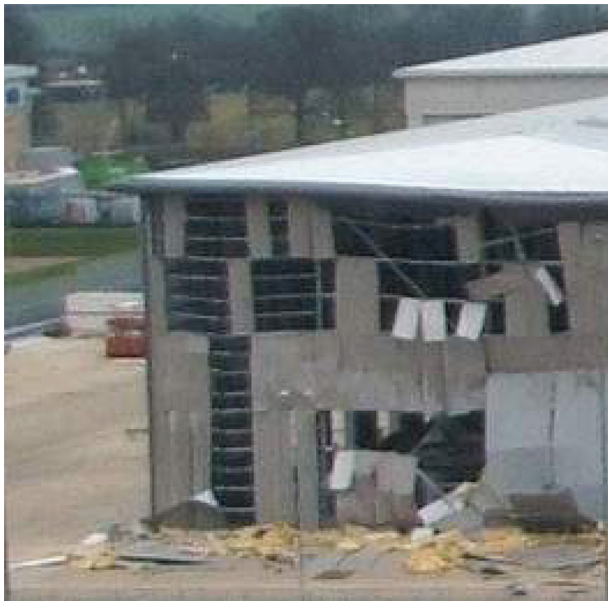
of the structure but they are sufficient to curtail or even prevent local failure. By the time the pressure rises to the point where the (minor) stiffening of the wind-posts provided by the additional purlins would be overcome, there has been large scale venting of the rest of the wall and differential pressures between inside and outside have collapsed.

Figure 9. Doubling of purlin density near corners of WH1

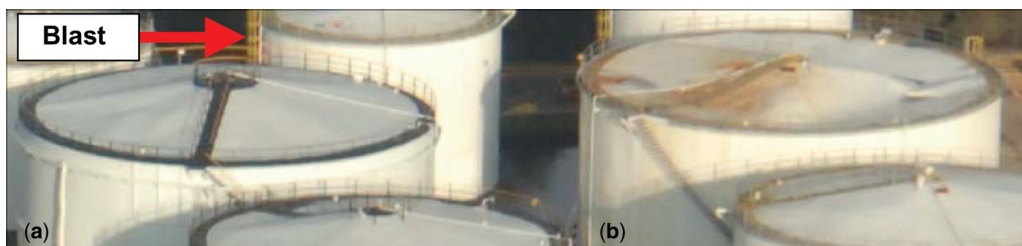
At significant distances outside the flammable cloud maximum overpressures are relatively low but still well above the strength of the roof. The roof rapidly moves downward to equalise the internal and external pressure. An illustration of this from Buncefield is shown in Figure 10; the two tanks A and B in the centre are of similar design and both contained low volatility liquids. They have both only suffered significant plastic deformation of the roof. Tank B was empty at the time of the explosion and high levels of plastic deformation occurred before internal and external

Figure 10. Deformation of tank tops outside the Buncefield cloud – Tanks A and B

pressures were balanced. On the other hand Tank B was 60% filled at the time of the blast and, despite being closer to the edge of the cloud, it shows significantly less plastic deformation because pressure balancing would have occurred at much lower levels of compression of the ullage.

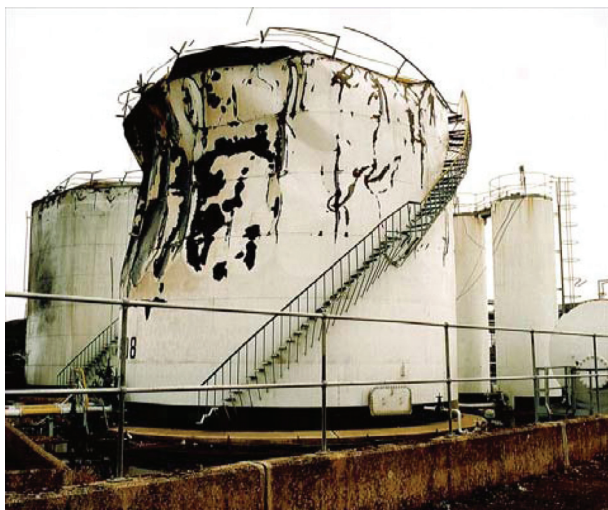
Within the cloud the degree of plastic deformation of tanks depends on the fill level and the cloud depth. Figures 11 and 12 show Tank 908 at Buncefield: this tank was completely immersed in a cloud of depth approximately 1.25 m deep. The tank experienced a prolonged ramping up of pressure as the sub-sonic explosion approached. Given the flame speed observed in CCTV records at Buncefield it is possible to show that the pressure would have risen to around 20 kPa over a period of around 600 ms. The tank had a relatively low fill level and, after a certain stage, such a high pressure could not be balanced simply by downward deformation of the roof. At this point the net pressure on the upstream face would exceed the yield pressure of the wall and it would start to fail. Once plastic failure commenced the wall would move quickly and the internal pressure would rise – tending to delay and (in the event) prevent failure of other faces of the tank.

Badly crushed objects at ground level all around the tank show that very high (but short lived) pressures were developed all around the tank at low level. These high pressures that were developed within in the cloud clearly weakened very markedly with height and this diffraction process, combined with the short duration of the high pressure shocks, meant that vulnerable parts of the tank above the fill level suffered only small permanent deflections.

Figure 11. Front (North) face of Tank 908 showing extensive plastic deformation

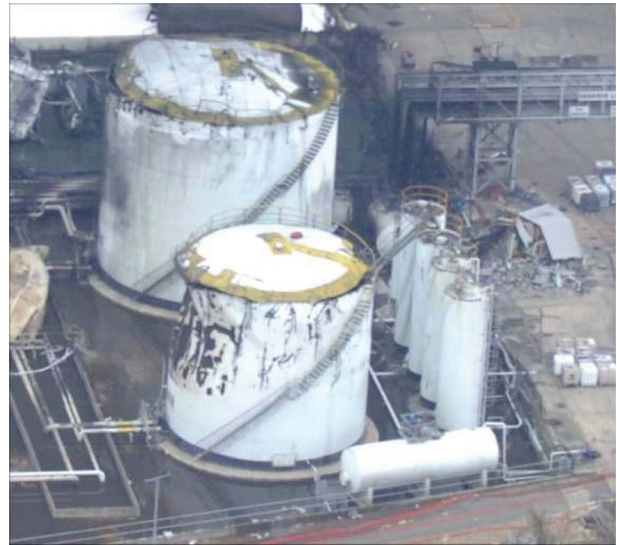
Figure 12. Side (West) face and roof of Tank 908. The weak, lightweight roof has bowed upwards at the end of the positive phase. E, W and S faces undeformed

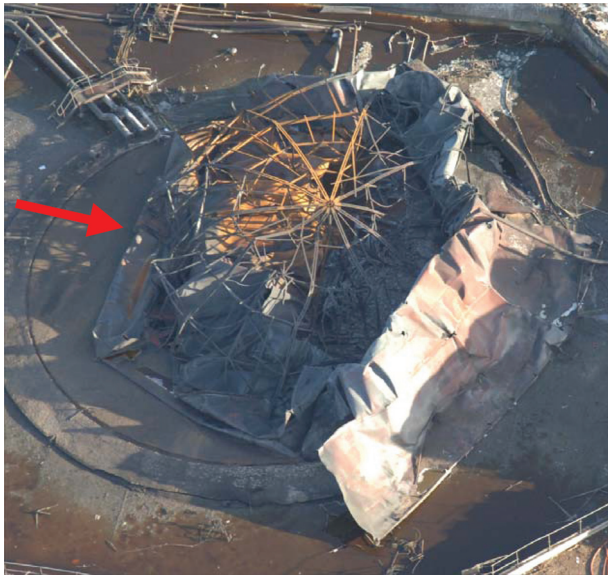
Close to the overfilled tank the average depth of the Buncefield cloud was probably well in excess of 5 m [Ref 8]. The dramatic effects of explosion in such a deep layer on an adjacent empty tank (Tank 910) are shown in Figure 13. The external overpressure exerted by the approaching explosion would have rapidly exceeded the level that could be accommodated by downward deflection of the roof. Very rapid inward deflection of the upstream wall then occurred with peeling back of the base a corresponding increase in internal pressure. As the explosion reached the front of the tank very high pressures (several hundreds of kPa) would have been applied to much of the upstream wall (none of which was supported by any liquid fill). The inward wall movement and corresponding internal shock was so pronounced that the opposite wall was blown outwards, tearing vertically through the wall. This pattern of deformation is analogous to the outward deflection of the end wall in portal frame buildings but the extent of the internal compression is of course massively greater. It is worth noting that at the end of the positive phase internal pressurisation of this tank led to the roof being thrown off – coming to rest around 70 m from the tank.

Figure 13. Tank 910 – the red arrow indicates the direction of explosion propagation
