ICL PLASTICS INVESTIGATION, GLASGOW, MAY 2004[†]

SJ Hawksworth, D Pritchard, J Hodges, R Parrot, G White and T Mellor
Health & Safety Laboratory (HSL), Harpur Hill, Buxton, SK17 9JN

At approximately twelve noon, on 11th May 2004 an explosion occurred at the Grovepark Mills premises of ICL Plastics Ltd, in the Maryhill district of Glasgow. This explosion was caused by leakage of LPG into the building basement, which then ignited causing an explosion subsequent collapse of the building, resulting in a number of deaths and serious injuries.

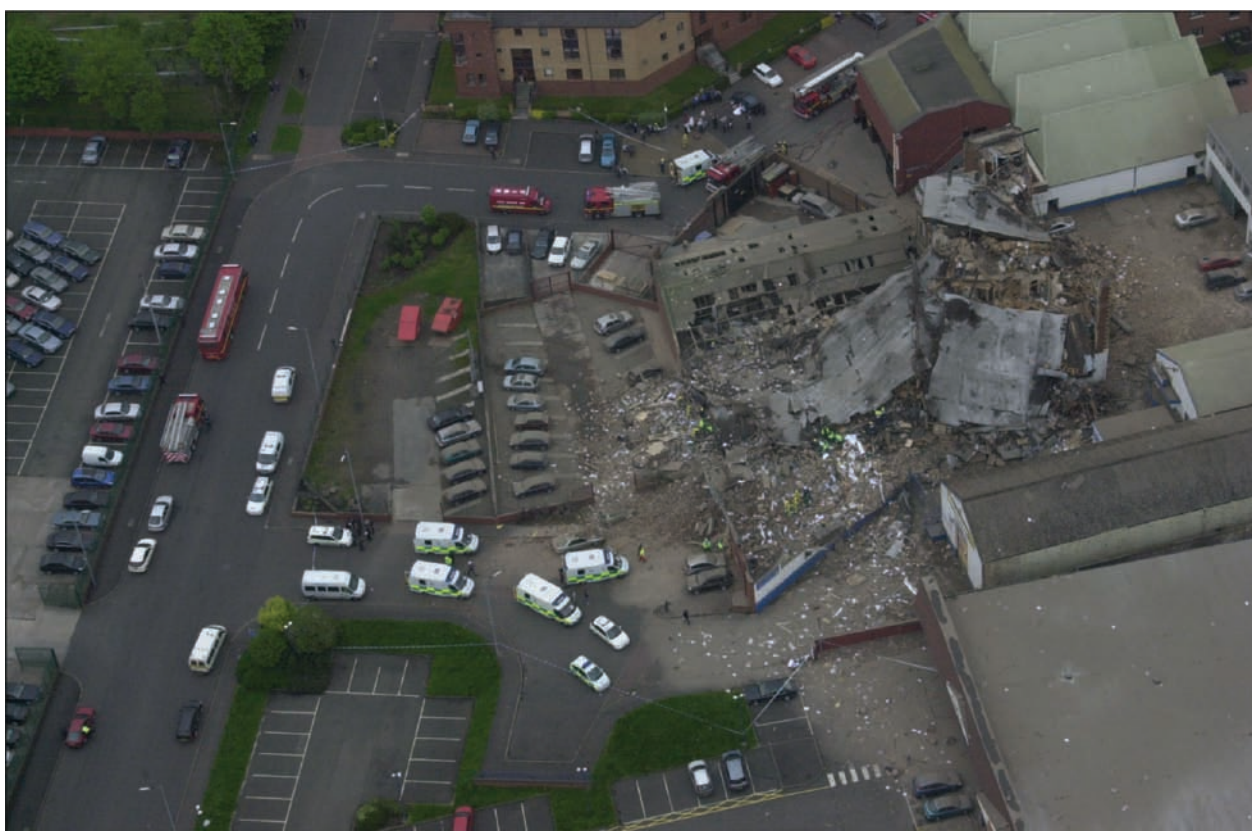
Figure 1 shows a Strathclyde Police aerial photograph of the Grovepark Mill site shortly after the incident (within 1 hour). At this time the recovery and rescue operation was in its early stages and so the site was more or less undisturbed following the collapse. As already described, witness accounts indicated that the building collapse was preceded by a loud noise suggesting an explosion. At this early stage, it was also clear that one of the deceased found in the basement of the building had burn injuries and damage to his clothing consistent with engulfment in a flash fire.

Figure 1. Aerial view of the site shortly after the incident

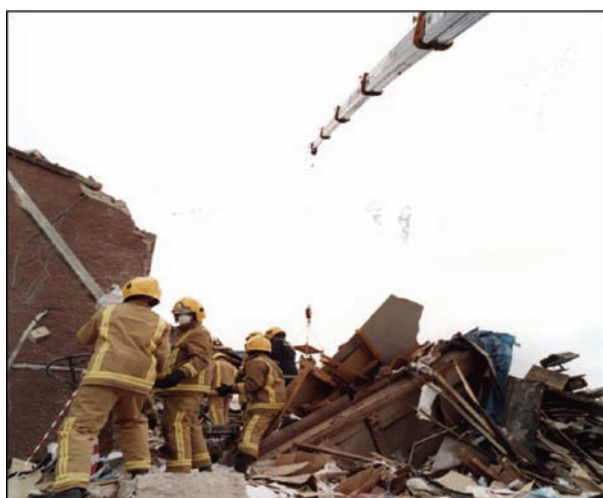
Figure 2. Elevated steel and concrete floor section

attached to the underside. The position of this floor section shown in this photograph clearly suggests that it had lifted.

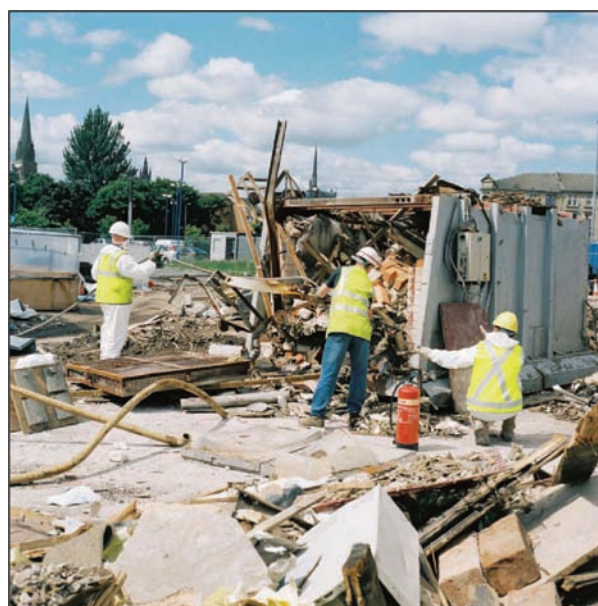
Figure 3. The “Cleny oven”

condition, the operation of the control systems, and the wider evidence that by that this stage was clearly indicating that there had been a gas explosion in the basement of the building. It is now well known that the explosion was as a result of a LPG leak, which is discussed further below. However, as part of the investigation other sources of explosive atmosphere were investigated and eliminated as briefly discussed below. One of the most significant other potential sources under investigation was a natural gas leak from the extensive natural gas system within the building.

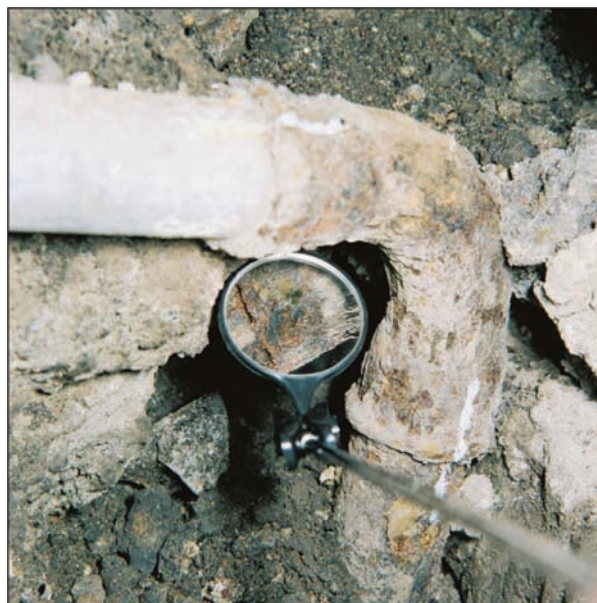
The metallurgical aspects of the leak were investigated in detail, by my colleague Dr Parrott, 2006 (4), which showed that the leak in the pipe was due to a

Figure 5. Photograph showing corrosion/crack in pipe elbow

combination of corrosion and mechanical load on the pipe associated with large pieces of concrete resting against it. It was not caused by the building collapse. In his report he describes the opening/leak in the pipe developing in three stages: initially just corrosion, then a combination of mechanical loading and corrosion accelerating the failure, followed finally by the opening of the crack due to its weakened state. He suggests that the rate of LPG release

increased during the final period when the pipe was in its most weakened state.

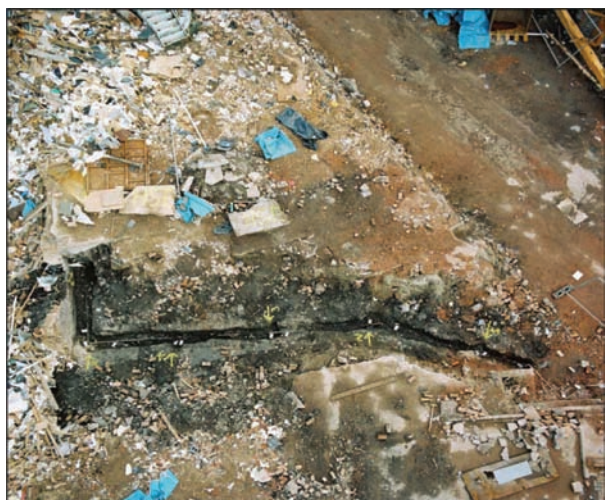
As already indicated, there were a number of pieces of evidence that indicating something unusual with regard to LPG. Significantly, the investigation identified a leak in the buried LPG pipe, which connected the external LPG pipe to pipe-work inside the building. This leak was just outside the basement area. Figure 4 shows the route of the excavated pipe from the external tank to the basement wall. Figure 5 shows the corroded elbow where the leak occurred. Figure 6 shows the LPG pipe where it entered the basement on the inside.

Figure 4. Excavated LPG pipe coming down from LPG torch (was bottom right but removed by this stage) to the basement wall visible centre left.

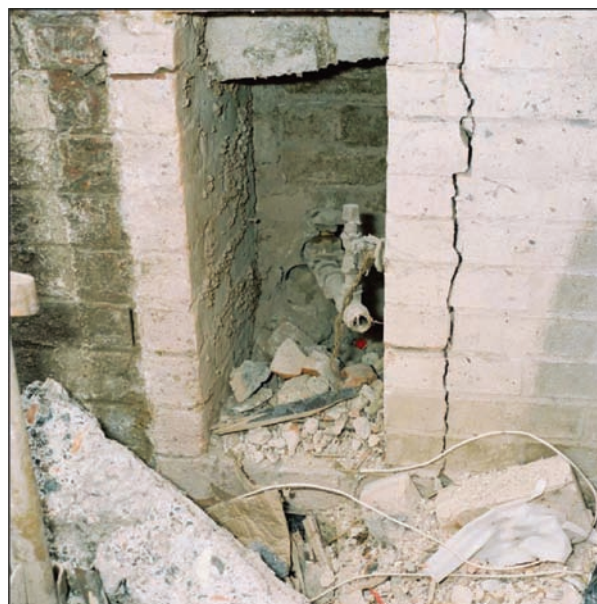
Figure 6. Shows the location of where the LPG pipe entered the basement. Note sheared off by building collapse

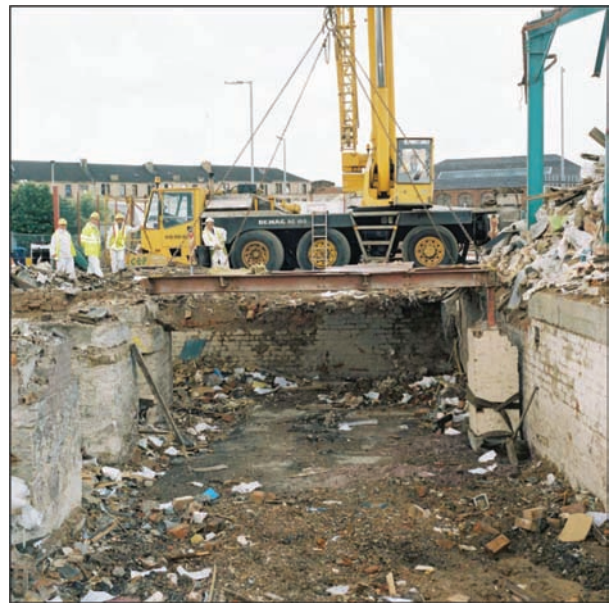
At around the same time as the excavation of the LPG pipe, other significant evidence indicating that an explosion occurred in the basement area was beginning to appear. This was most clearly evident from damage observed to the steel sections of the dispatch floor. This was a retrofitted steel floor in this area of the building which effectively created the basement from the large pit in this end of the building, which we understand was originally associated with its use as a paper mill. The floor was an approximately rectangular shaped table structure constructed from an of steel I-beam frame, covered with checker plate and supported by 12 box section steel legs. One section of this structure is shown lifted back into place in Figure 7.

Figure 7. Showing floor section lifted back into place

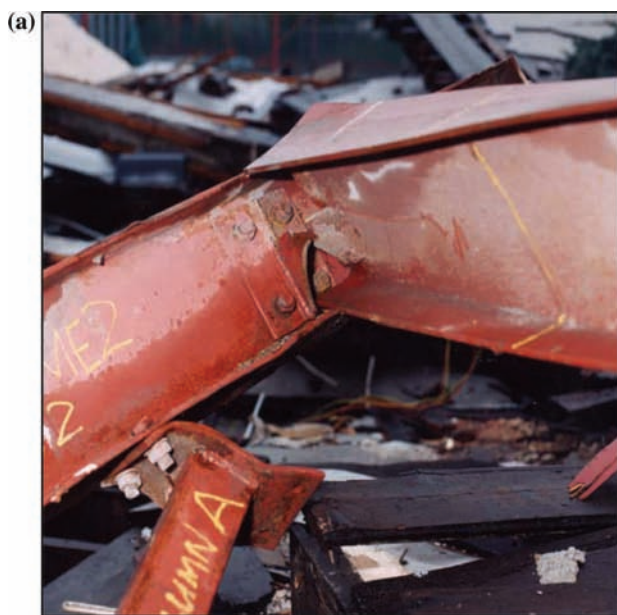
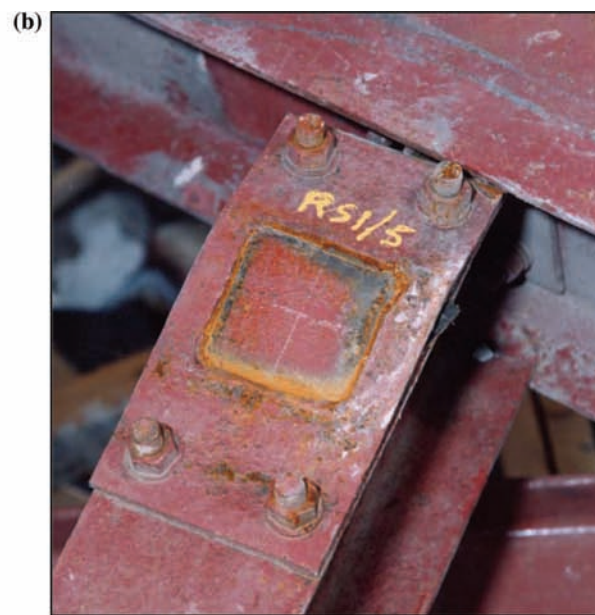
- i. Floor section lifted into the air, already note in Figure 2.
- ii. Broken welds, bolts and distorted fixing plates where supporting legs were joined to the steel floor section (see Figures 8 a & b). This was found on both floor sections.

Figure 8. (a,b) Showing the damaged steel I section structure with characteristic detachment of supporting leg, bottom right
