INVESTIGATION INTO A FATAL FIRE AT CARNAULD METALBOX LTD

M Iqbal Essa¹ and Dr. Aubrey Thyer²

¹Health and Safety Executive, Grove House, Skerton Road, Manchester, M16 0RB UK

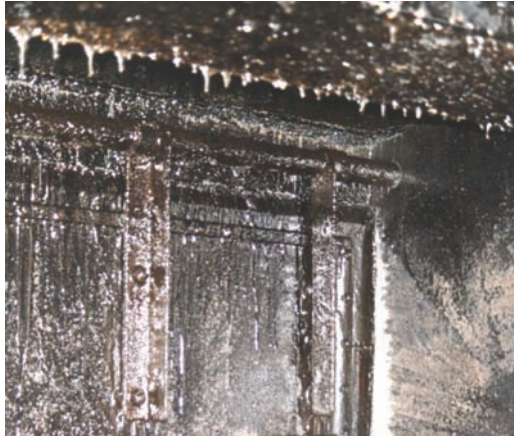
Prior to becoming redundant, the chimney in which the fire occurred had been used to vent fumes from a number of drying ovens/lines associated with the application of paint/lacquer to steel sheet used in the food canning industry. Over many years, these fumes coated the inside of the chimney and extract ductwork, giving a tarry layer several millimetres in thickness, which, it was thought, rose for a considerable height inside the chimney. The appearance of the deposit within the ductwork can be seen in Figure 1.

Figure 1. Appearance of tarry deposit in extract ductwork

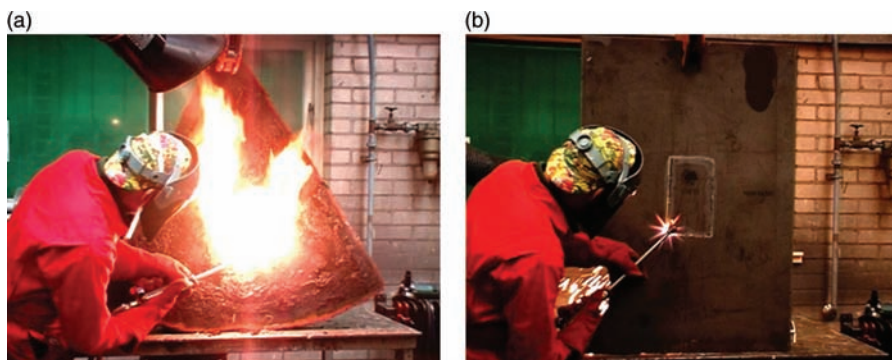
Figure 2. Behaviour of coated and un-coated steel plate during oxy-propane cutting

It is immediately apparent from Figure 2 that large flames are produced on applying the cutting torch to the coated plate, along with significant quantities of smoke. This should have been taken as a strong indicator that, given the wrong circumstances, the deposit was able to continue to burn. This behaviour also would have been seen during initial screening tests to establish the properties of the material prior to commencing work on demolition.

The appearance of flames such as these led to CMB undertaking further screening tests, which concluded incorrectly, that the deposit did not present a fire risk. CMB and the contractors wrongly assumed that because the material did not continue to burn after the removal of the cutting torch it would not pose a risk. A working procedure was therefore adopted of pre-heating the deposit with the cutting torch and then scraping the softened material away from the area to be cut. This would have limited the potential for clogging the nozzle of the cutting torch with tarry material, but instead introduced the alternative hazard of allowing significant quantities of flammable vapours to form.
