‘INCREDIBLE’

CATASTROPHIC FAILURE OF SHELL AND TUBE PRODUCTION COOLER

Safety alert: 01/2006

Issue date: May 2006

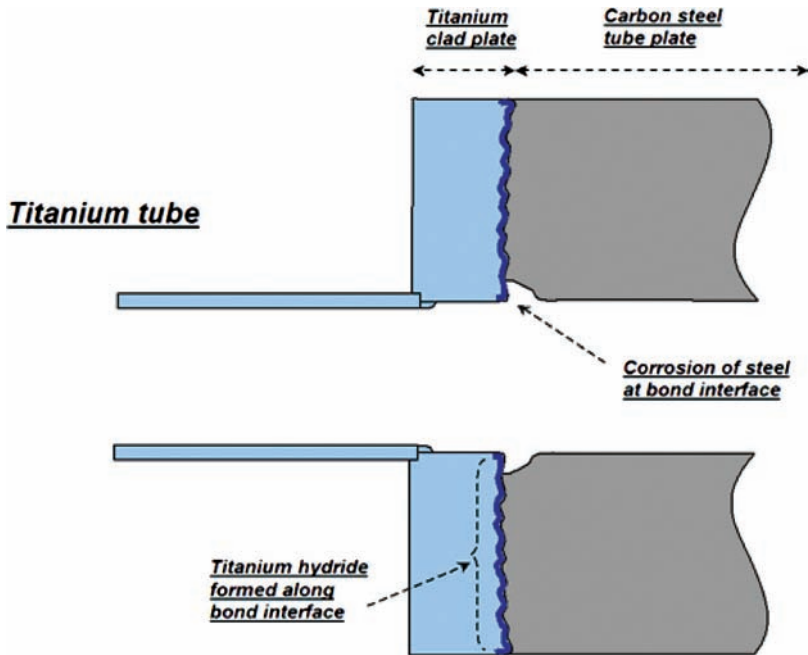
3. The heat exchanger operates with sea water on the shell side and HP hydrocarbon gas plus condensates and water on the tube side. The tube sheet had been manufactured from carbon steel with an explosively bonded, 13 mm thick titanium cladding plate on the sea water side to provide corrosion protection. A key feature of this design is that it allows the HP hydrocarbon gas, condensates and water to come into contact with the steel tube sheet/titanium interface, thus creating the potential for in-service degradation mechanisms as detailed in paragraph 4 below.

Tube to Tube sheet and Titanium cladding to Steel tube sheet interface detail.

- That the explosively formed bond between the titanium cladding and the tube sheet was fit for purpose at the time of manufacture.
- It is probable that liquid in the process stream led to galvanic corrosion of the steel tube sheet at the intersection of the tube holes and the steel/titanium interface (bond interface).
- Hydrogen released by the corrosion process had reacted with the titanium and resulted in the progressive formation of brittle titanium hydrides at the bond interface.
- The growth of titanium hydrides weakened the bond interface sufficiently to cause a sudden, dynamic failure of the bond.
- Failure of the bond resulted in rapid pressurisation of the bond interface, complete separation of the titanium cladding plate from the steel tube sheet, followed by over pressurisation of the shell and catastrophic failure of the cooler.

- Identify whether they have any heat exchangers manufactured to the same design or to a similar design incorporating this type of steel-titanium interface.
- In the light of this notice, undertake a risk assessment of the continuing use of any heat exchangers so identified, in collaboration with the plant manufacturer (if still in business) and/or third party verifiers and other specialist advisers.
- Implement any remedial actions in the light of the risk assessment.
