EXPLOSION AT THE CONOCO HUMBER REFINERY – 16TH APRIL 2001

Jonathan Carter, Peter Dawson and Robert Nixon
Health and Safety Executive, Hazardous Installations Directorate

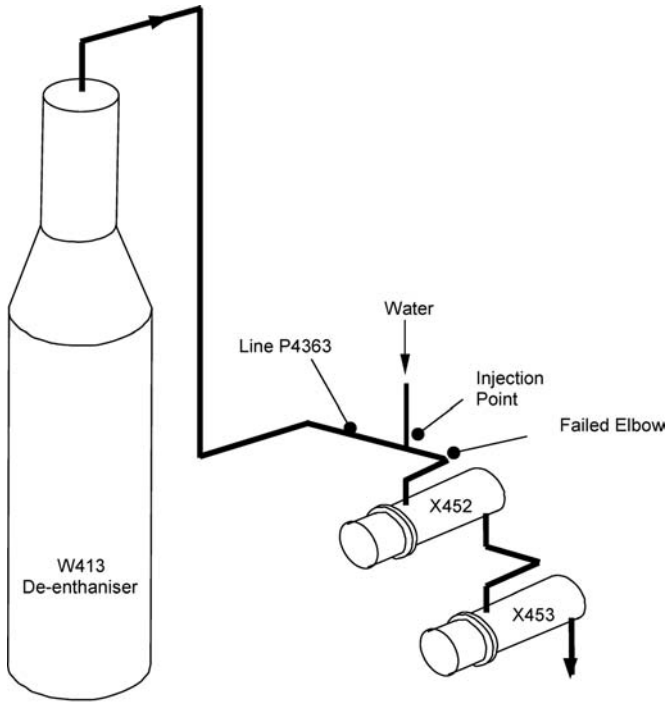
Figure 2. Diagram of the pipe P 4363 and the location of the pipe failure

This day was Easter Monday, and therefore a Bank Holiday. For this reason there were only 185 staff working on the site. Shift handover was due to occur at 3 pm, so relatively few people were working around the plant in the open air when at 2.20 pm pipe P 4363 failed catastrophically. The 6" overhead line carrying highly flammable gas at high pressure ruptured and released a huge cloud of vapour. About 20 to 30 seconds later the cloud found a source of ignition and ignited. As a result a massive explosion and fire followed. As the fire burned it caused failures of other pipework, which resulted in another explosion and a further fireball about 15 minutes later, and subsequent lesser explosions. It has been estimated that at the point that the released gas cloud ignited it would have measured up to 175 metre by 80 metre at ground level. It is thought most likely that a fired heater on an adjacent processing unit 70 metre away from the failed pipe was the

The pipe had failed at a 90° elbow that had been 67 cm. downstream of a water injection point (see Figure 3). Scientists at the Health and Safety Laboratories examined the failed section of pipe. They concluded that the pipe, when installed, met the requirements of the relevant API code for refinery pipework. They further concluded that the elbow on P4363 failed due to the effects of corrosion – erosion reducing the thickness of the pipe wall to such an extent that the elbow burst when it could no longer contain the pressure of its contents. The examination of the pipe revealed that its wall thickness had been reduced from originally being approximately 7.1 mm to a minimum of approximately 0.3 mm (see Figure 4). The extent of the metal loss of the elbow and neighbouring sections due to corrosion–erosion appeared to be directly associated with the injection of water upstream of the affected areas. It was consistent with the erosion of a protective layer of iron sulphide on the inner wall of the pipe by the physical action of the water injected into the pipe just upstream of the elbow.

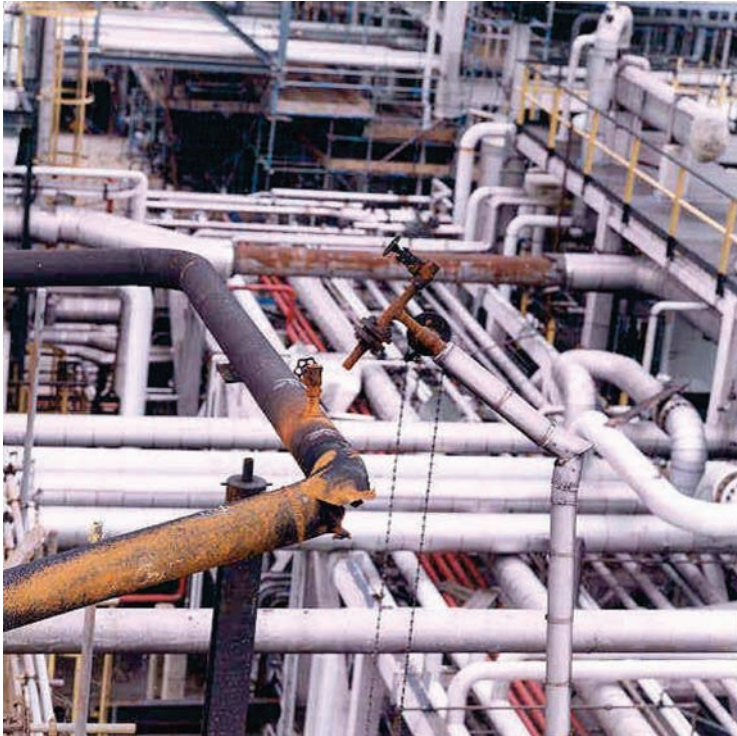
Figure 3. Photograph of the failed pipe elbow in situ showing the location of the water injection point

It appears that an available nozzle in pipe P 4363 was used to retrofit the water injection line. At this point P 4363 is about 9 metres above the ground without access facilities. The water injection was via a 1" diameter pipe fitting vertically into P 4363. The water injection point was not fitted with a mixing device, but entered the pipe as a free jet of water by a simple vertical T-junction. The valve to open and close the water supply was operated by a chain mechanism. The water entered at a temperature of about 150°C and 300 psi (20.7 bar, 2.07 MPa). The pipe P4363 downstream of the water injection point included two right angle bends, the first to change the horizontal position of the pipe and the second to direct the flow vertically downwards into the heat exchanger.

The elbow downstream of the injection point was not included in the scope of the inspection of P 4363.

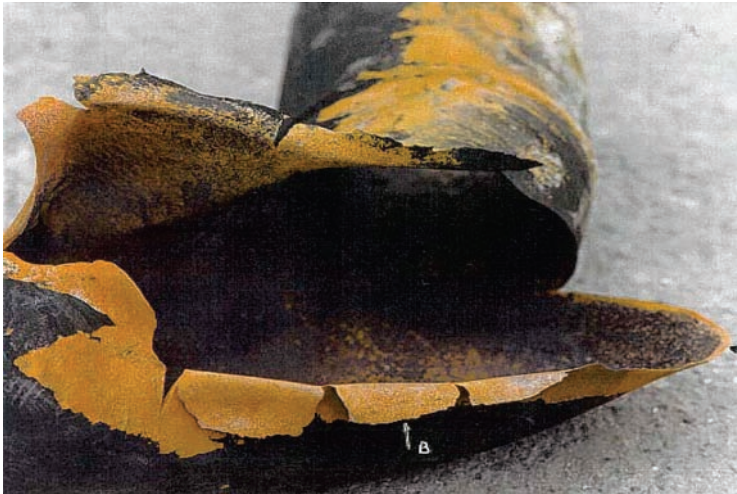
Figure 4. Photograph of the failed elbow showing the degree of pipe wall thinning
