HYDROGEN FABRICATION CRACKING: HSE's INDUSTRIAL EXPERIENCE, AND RESEARCH INTO DEFECT DETECTION WITH A NUMBER OF NDT TECHNIQUES

Harry Bainbridge¹ and Bernard McGrath²

¹HM Principal Specialist Inspector, Health and Safety Executive

²Inspection Validation Centre, Serco Assurance

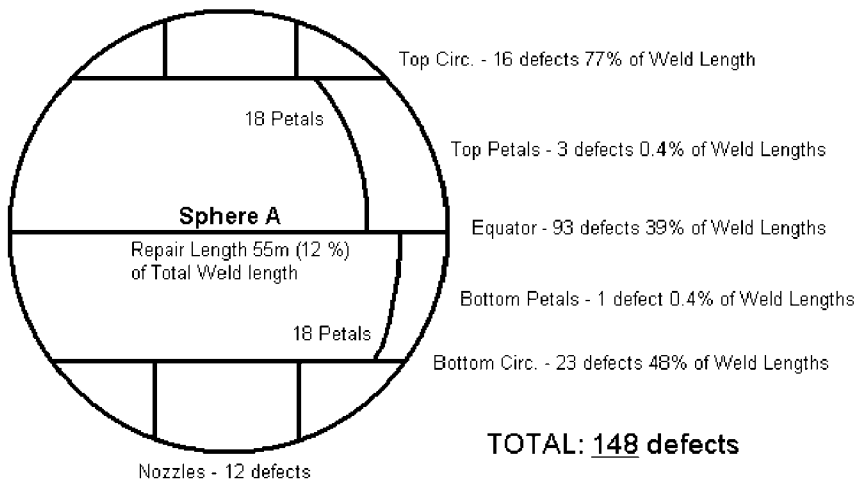
Figure 1. Defects detected sphere A

Following the discovery of the embedded defects, the inspection procedure for this sphere was modified to 100% MPI on both the inside and outside, with 100% manual ultrasonic inspection being applied to the weld from the inside. Sphere A was found to have a large number of defects on the equator weld, with a small number in the other horizontal welds, and only three defect areas on the vertical welds between the petals. 30% of these were surface breaking defects, but the vast majority were defects approximately 10 mm below the inner surface of the sphere in the weld Heat Affected Zone.

Following the work on sphere A, the identical Sphere B was investigated. The equator weld of Sphere B was first inspected non-invasively by manual ultrasonic inspection. This indicated that a similar problem with embedded defects was present, and the sphere was decommissioned and a full inspection identical to sphere A carried out. This sphere had defects in most welds. Only 5.5% of cracks were surface breaking, the remaining being embedded as in sphere A. The low number of surface defects can be explained by the fact that the sphere had been subjected to 100% MPI in 1996, and other surface defects had been removed or repaired at that time. The defects found in Spheres A and B are summarised in Table 1, Figure 1 and Figure 2.

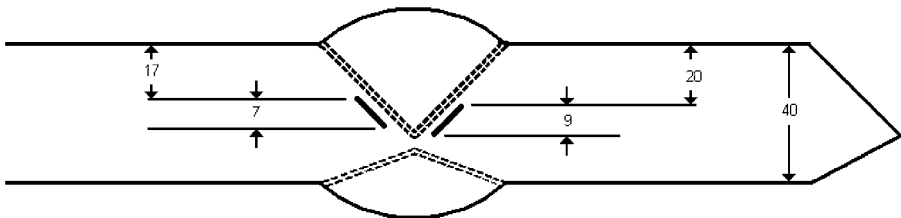
Figure 3. Boat samples 1 & 2 — crack locations

by two laboratories. The sample from sphere A was of an embedded crack. From sphere B, samples 1 to 4 were all embedded cracks (Figures 3 and 4), sample 5 was parent plate for chemical analysis, and sample 6 was an inner surface breaking defect. Tests carried out by both establishments gave the following results:

- i) The source of the cracks appeared to be Hydrogen Fabrication Cracking (HFC) during original manufacture.
- ii) The HAZs were considerably harder than the parent plate material. (Table 2.)

- iii) The surface breaking defect exhibited no crack growth.
- iv) The embedded defects exhibited crack growth towards both the inside and outside surfaces. The crack growth towards the inner surface was considerably larger and values measured are listed in Table 3.
- v) The material composition was correct for BS 1501-223-32B-LT40.
