## BLAST FURNACE NO. 5 INCIDENT, CORUS, PORT TALBOT, 8TH NOVEMBER, 2001<sup>†</sup>

J. Hodges and S. Curry, Health and Safety Laboratory, Buxton, Derbyshire, UK

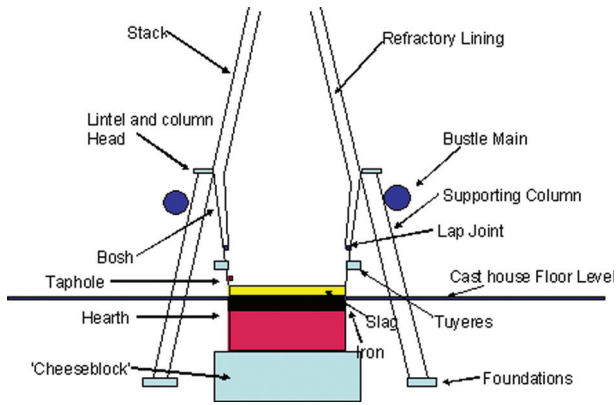
Figure 4. Furnace no. 5 main structural features

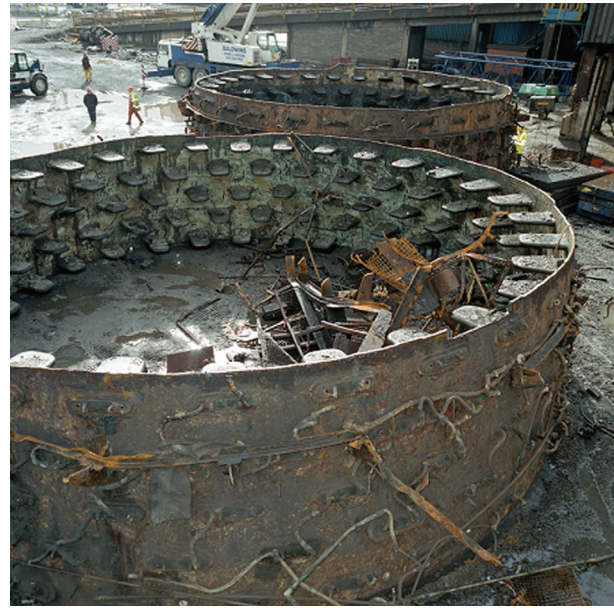
Figure 6. Sections of furnace showing coolers (refractory removed)

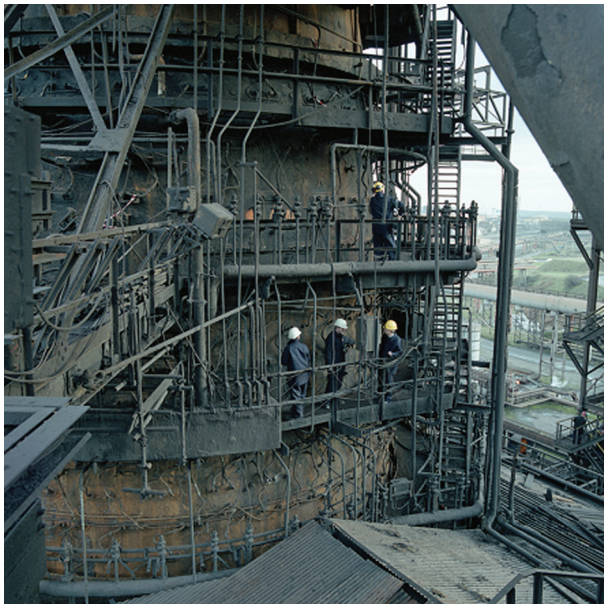
Figure 5. External view of furnace cooling system

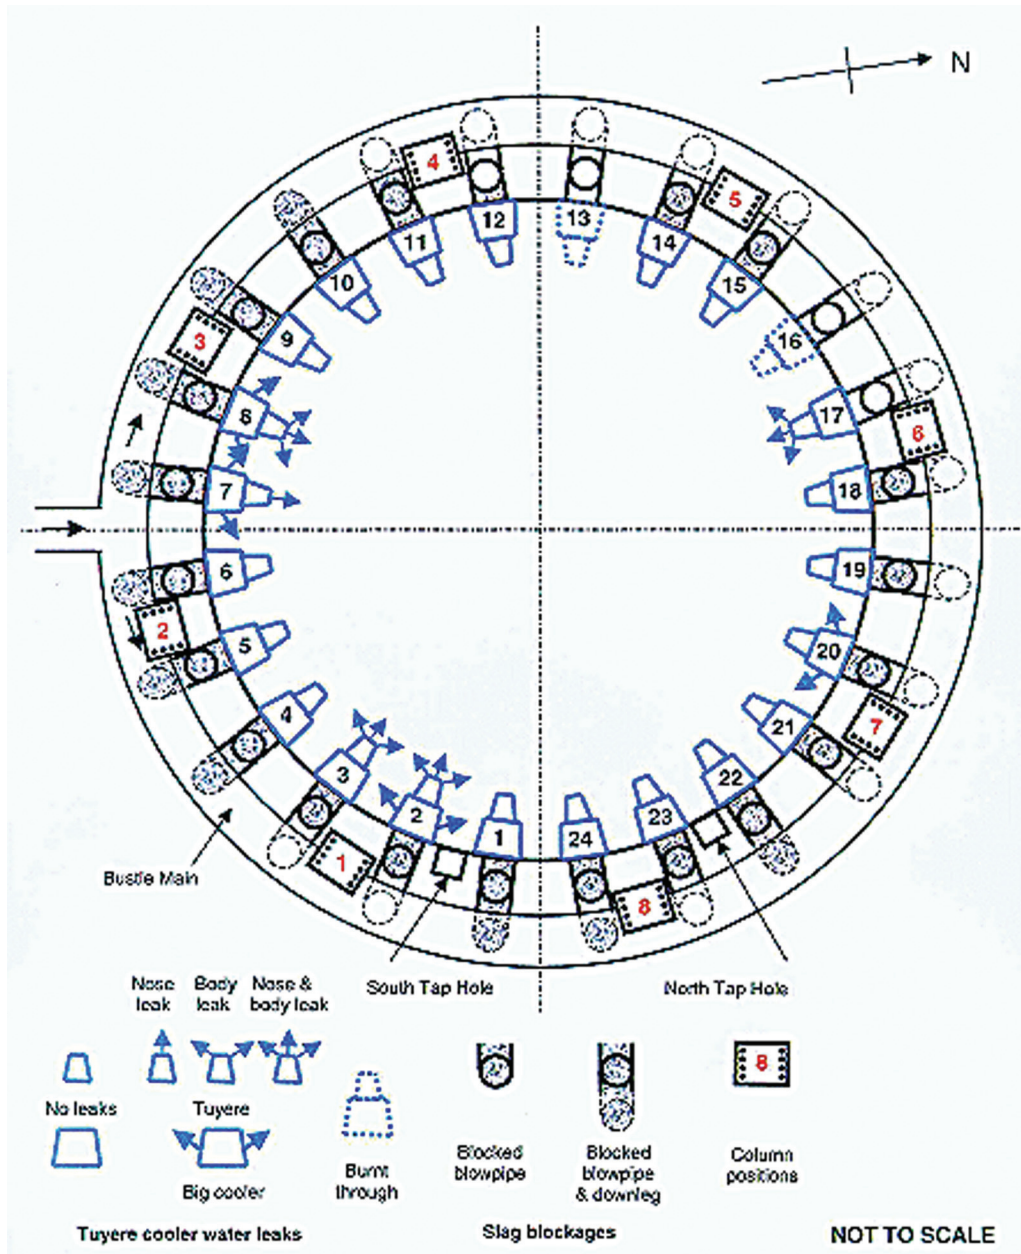
Figure 7. Tuyère blockages and water leaks

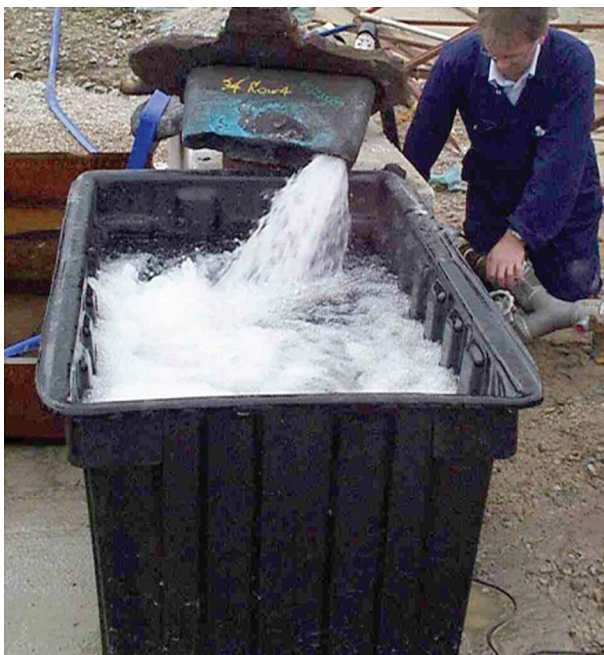
**Figure 8.** Determination of leakage rate through flat cooler

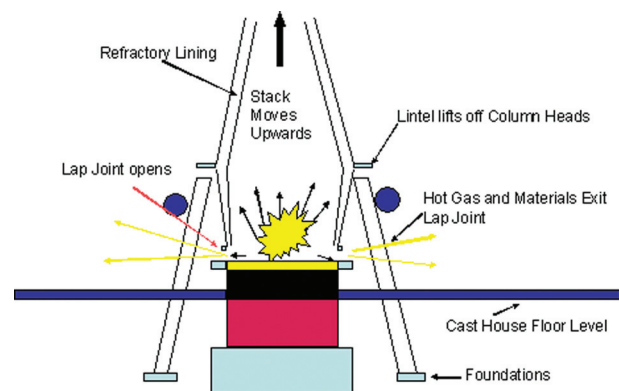
**Figure 9.** Main structural features during event
