AN EXPLOSION ACCIDENT – CAUSES AND SAFETY INFORMATION MANAGEMENT LESSONS TO BE LEARNED

Tzu-Lien Tzou^a, David W. Edwards^a and Paul W.H. Chung^b

A terrible accident occurred at a process plant in Taiwan on May 18, 2001. The plant was destroyed by a series of explosions that resulted in the death of one man, 112 injuries and extensive damage. The accident was caused by the ignition of a leak of mixed flammable vapours from an out-of-control exothermic batch reactor, which produced water-born acrylic resin. Most of the victims, who were employees of nearby factories, were cut by glass splinters and other debris that rained down over an area of radius 200 metres around the plant.

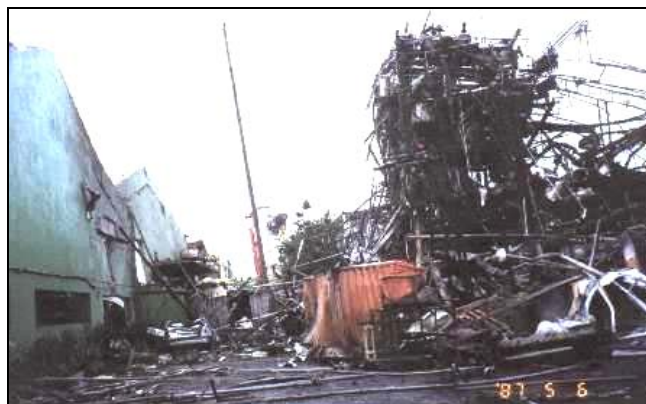
Figure 2. Explosion at Fu-Kao chemical plant

After the explosions the resulting pressure wave and fire completely destroyed the plant (see Figure 2) and extensively damaged the surrounding structures of neighbouring factories (see Figure 3), resulting in the death of one man and 112 injuries. The man who died was an employee of a factory next to the plant. He was killed by the flame/blast while he was working outside the factory building very close to the Fu-Kao plant. Most of the injuries were to employees of nearby factories or residents around the industrial park. They were cut by glass splinters and other debris that rained down over an area of radius 200 metres around the plant, or/and felt dizziness and nausea after smelling the odours. Whereas, responding to an emergency alarm, most of the plant workers were evacuated about 5 minutes before the first explosion occurred and most escaped serious injury.

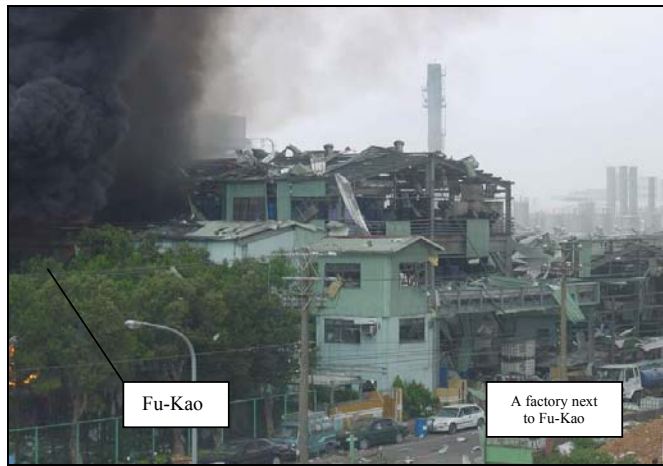
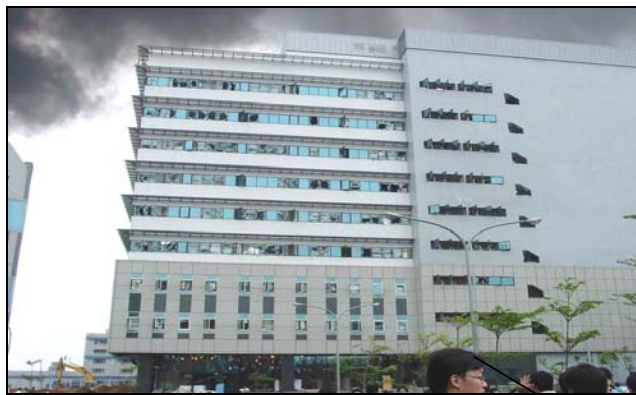
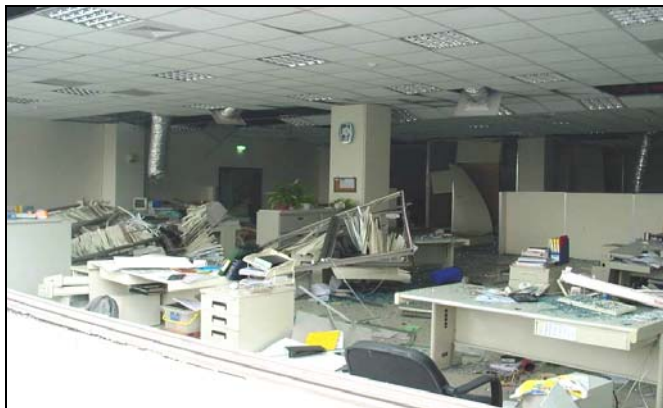
Figure 3. Explosion effects on neighbouring factories

The accident totally destroyed the plant and seriously damaged 46 nearby factories including 16 high-tech companies that produced IT-related products. These factories had to stop their production for at least 5 days and some of them took more than 30 days to recover. The total property loss was estimated to be US \$12m and the total loss due to business suspension was estimated to be US \$50m.

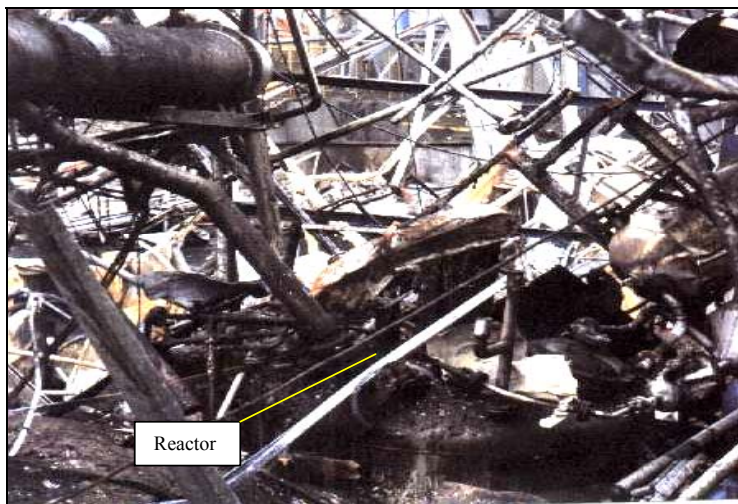
Figure 4. Post-accident photo of the 6-ton reactor

2. According to evidence gathered on-site, such as the agitator pump was blown far away and the condenser and decanter had unfolded outwards but the vessel was not blown away (see Figure 4), the explosion location was assessed to be 1–2 metres above the reactor.
