No. 102

IMPERIAL CHEMICAL INDUSTRIES LIMITED
PETROCHEMICALS DIVISION

102/1 PREPARATION OF EQUIPMENT FOR MAINTENANCE

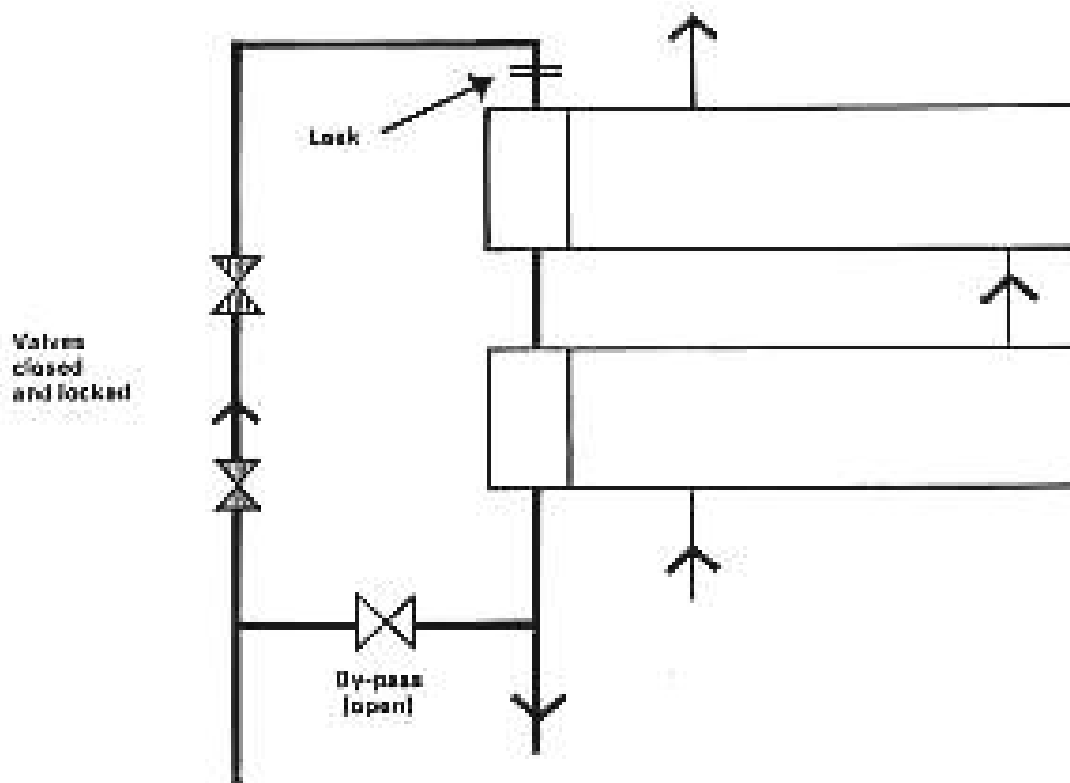
An operator who was training as a deputy supervisor found a leak on the inlet flange to a bank of heat exchangers.

He closed the inlet valves and locked them shut. The leak stopped. There were no valves on the exit line but he assumed that, as the leak had stopped, the pressure was now so low that the leaking joint could be remade. He issued a clearance. The regular supervisor counter-signed it but did not check the job.

When the joint was opened a stream of oil 5 feet long sprayed out. Fortunately the fitter had slackened the bolts away from him, there was no injury and the joint was remade. The plant was then shut-down.

The Works concerned have now decided that in future clearance certificates will not be countersigned. The regular supervisor will sign them until the trainee is judged to be sufficiently well-trained and then the trainee will sign them. In order to judge whether or not the trainee is well-trained, the regular supervisor should allow the trainee to prepare the job and then inspect it.
