No. 108

CLEARANCE ERRORS AND A PIPE FAILURE

**IMPERIAL CHEMICAL INDUSTRIES LIMITED
PETROCHEMICALS DIVISION**

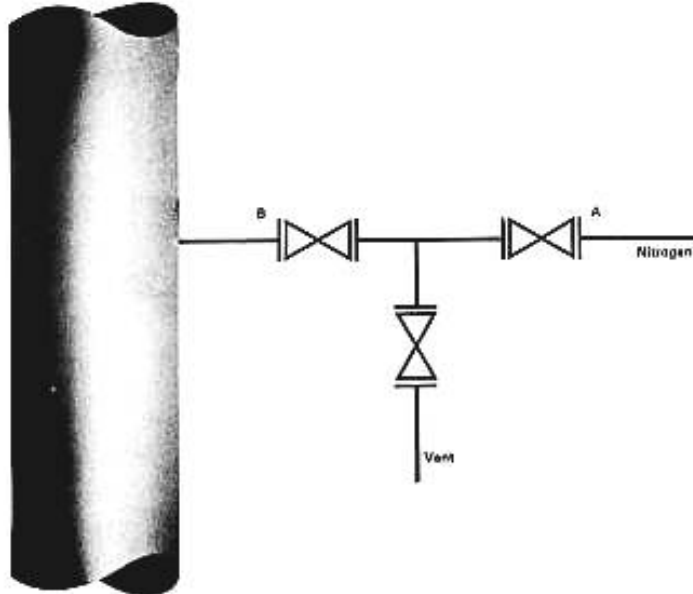
A clearance was issued to connect a nitrogen line at point A and then disconnect it after a leak test had been carried out.

When it was time to disconnect, the acting process supervisor asked the fitter to break joint B and blank.

He should have asked him to disconnect joint A which should have been tagged. As this job is done several times per year there could be a permanent tag.

The fitter, who was new to the Works, broke joint B and blanked the nitrogen line.

This left an open end on the vessel.

This incident would not have occurred if either:

The correct joint (A) had been tagged.

The fitter had realised that we do not leave open ends on vessels.

The lead fitter had checked the job before signing off the clearance.

The acting process supervisor had checked the job before signing off the clearance.

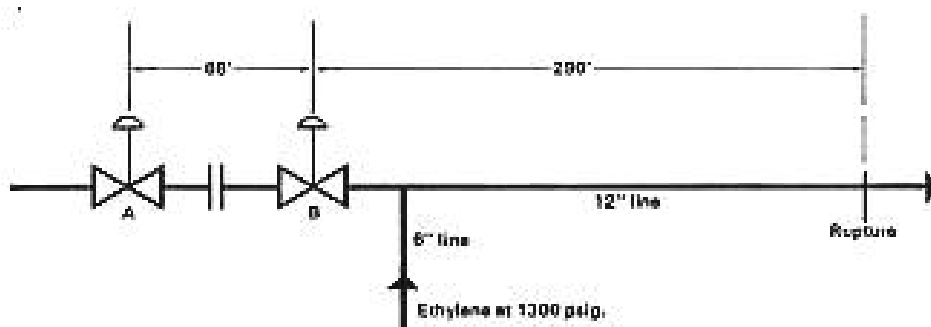
Ethylene at 1300 psig was flowing along the 6 inch line and into the 12 inch line. The two motor operated valves A & B were closed so that the flowmeter between them could be maintained — the space between them contained air.

Valve B was opened. A few minutes later the paint on the 12 inch line was bubbling and after 15 minutes the line burst.

When valve B was opened taking -3 seconds - the high-pressure ethylene acted like a piston, compressing the air between valves A & B and raising its temperature to about 800°C. At this temperature ethylene decomposes, giving out heat — it burns without air — and the “flame” travelled along the ethylene in the pipeline. After 290 feet the flame speed and flow rate were such that the flame stayed in the same place and overheated the pipe until it burst.

The amount of air between A & B was insufficient to cause an air/ethylene explosion and the result would have been just the same if the space had contained nitrogen.

To prevent similar incidents happening again, pipelines containing ethylene or other gases which can decompose should be brought up to pressure slowly.
