No. 114

PAGES FROM OUR CALENDARS

PETROCHEMICALS DIVISION

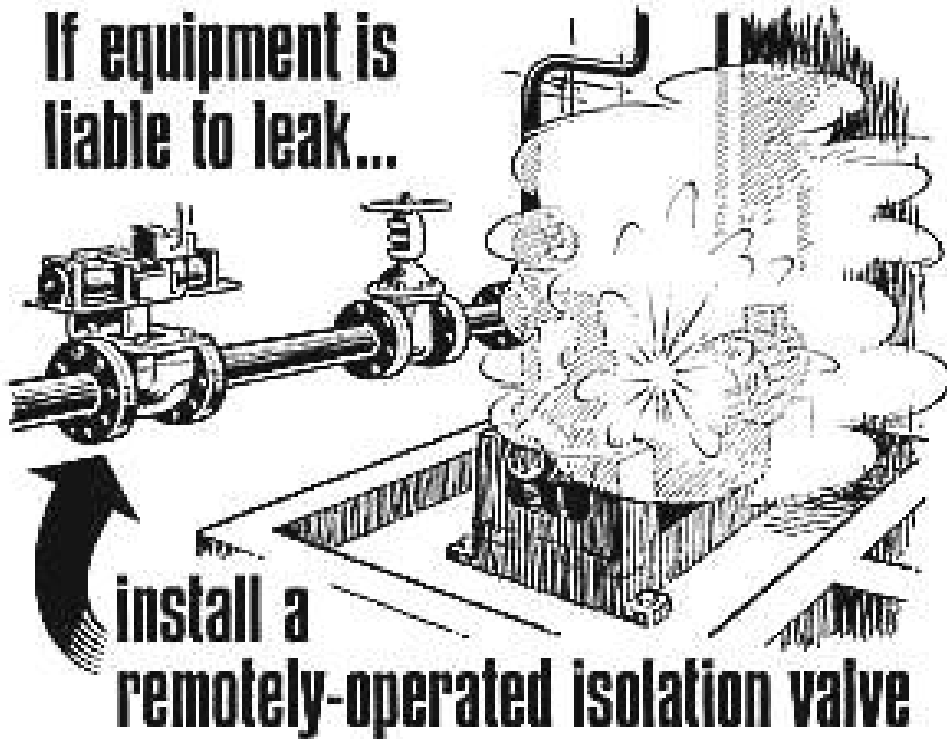
If equipment is liable to leak...

install a remotely-operated isolation valve

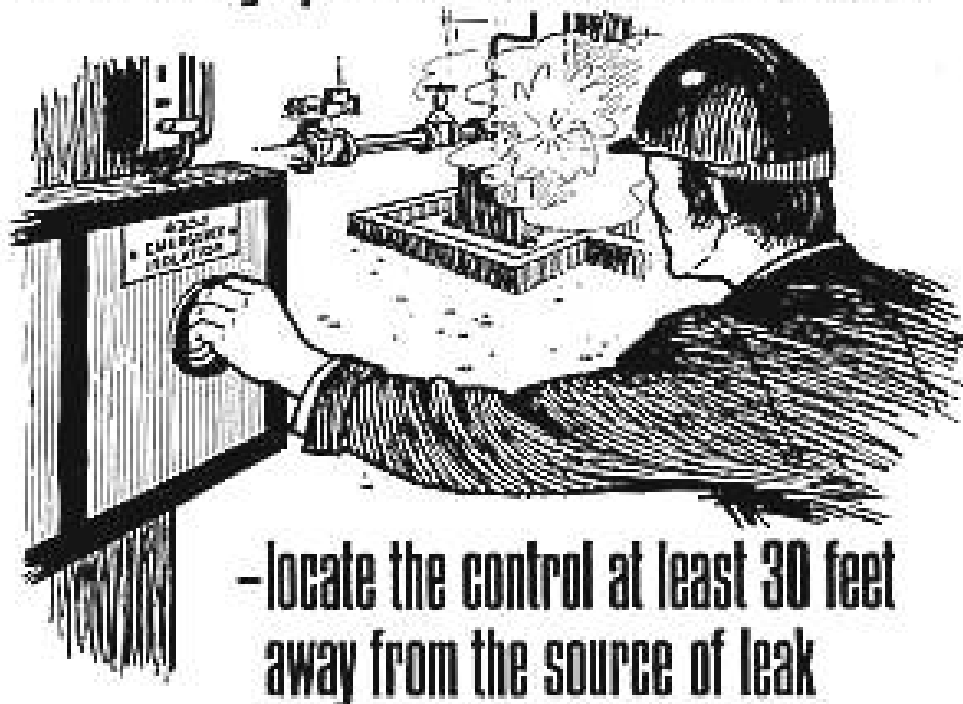
If a remotely-operated isolation valve is installed—

—locate the control at least 30 feet away from the source of leak

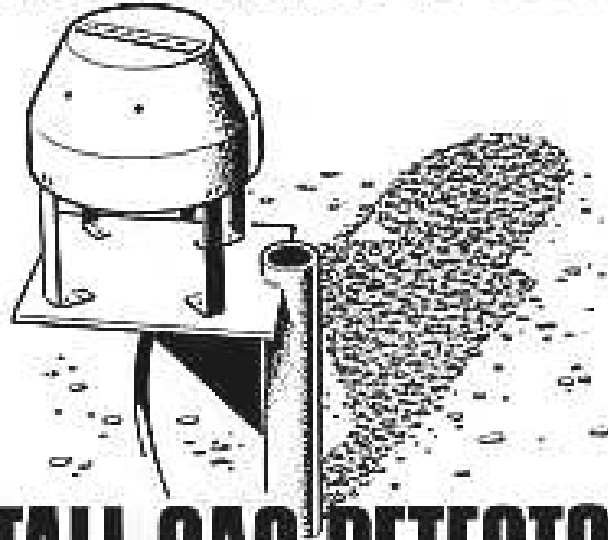
If leaks are liable to occur...

INSTALL GAS DETECTORS

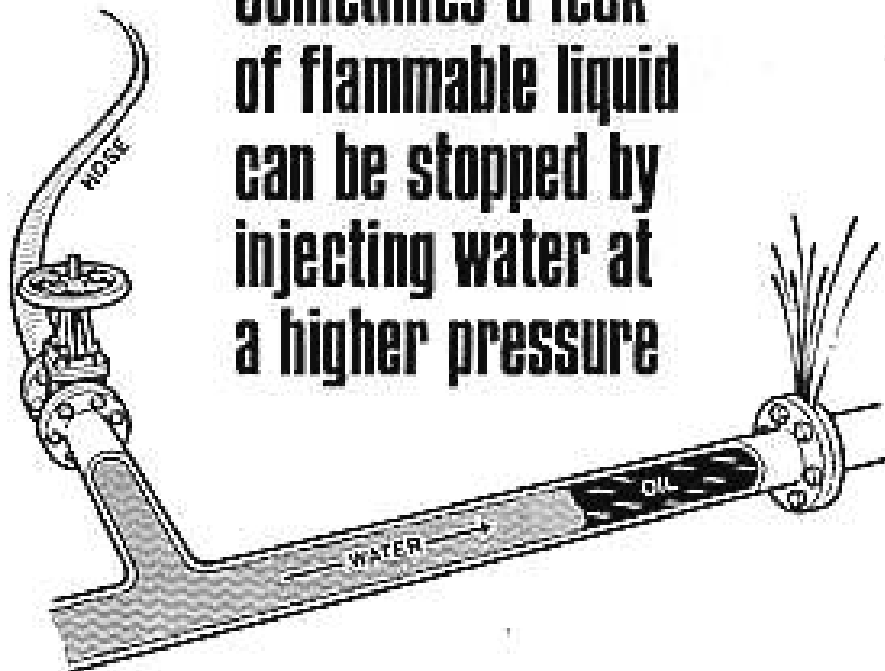
**Sometimes a leak
of flammable liquid
can be stopped by
injecting water at
a higher pressure**

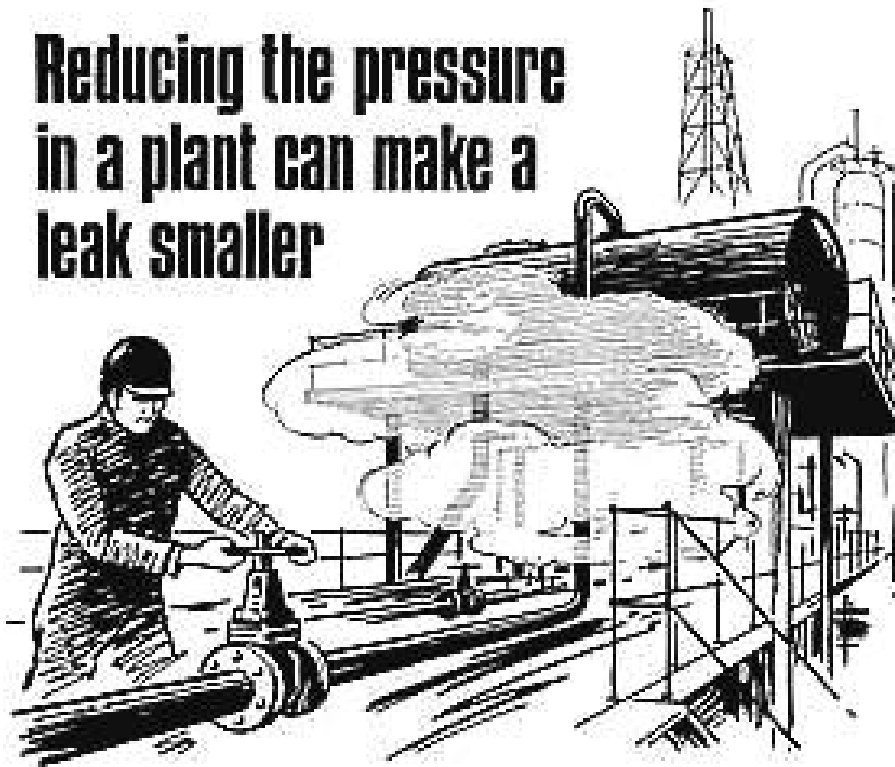
**Reducing the pressure
in a plant can make a
leak smaller**

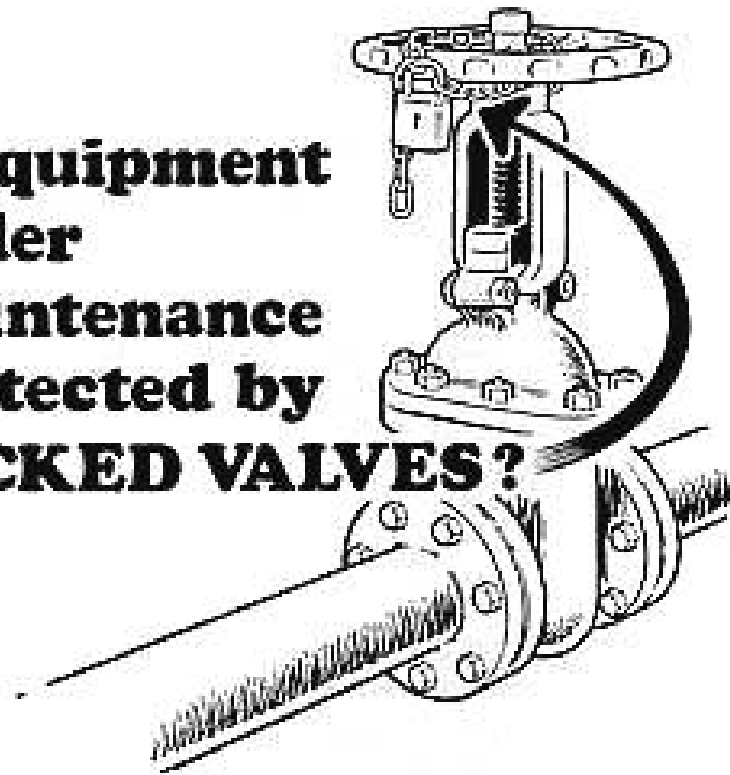
**Is equipment
under
maintenance
protected by
LOCKED VALVES?**

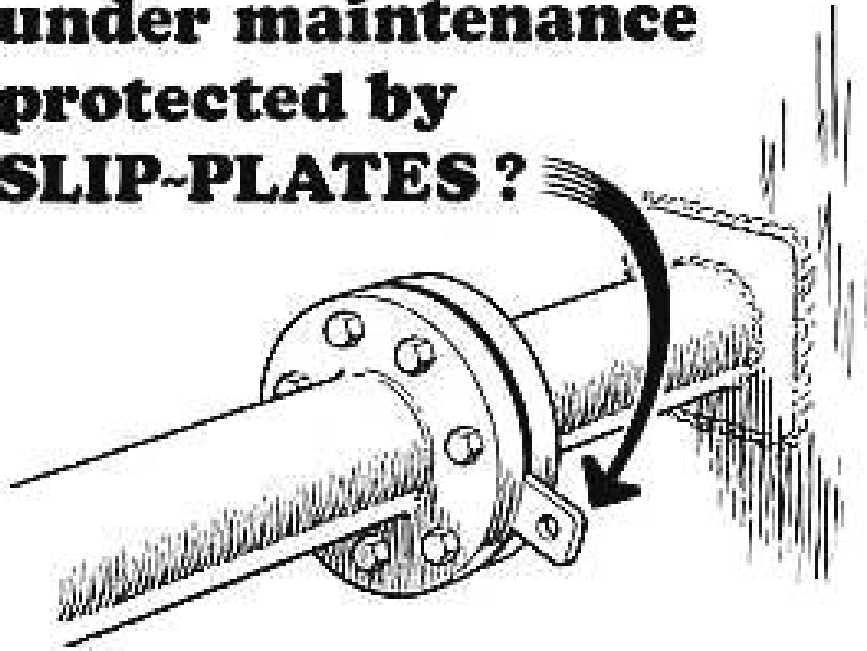
**Is equipment
under maintenance
protected by
SLIP-PLATES ?**

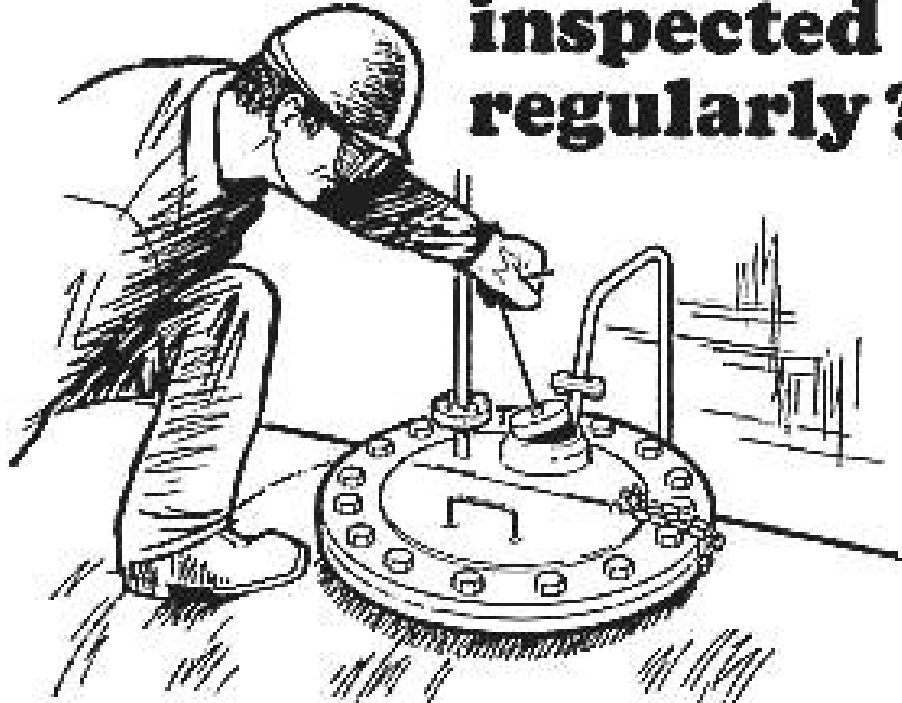
**Are flame traps
inspected
regularly?**

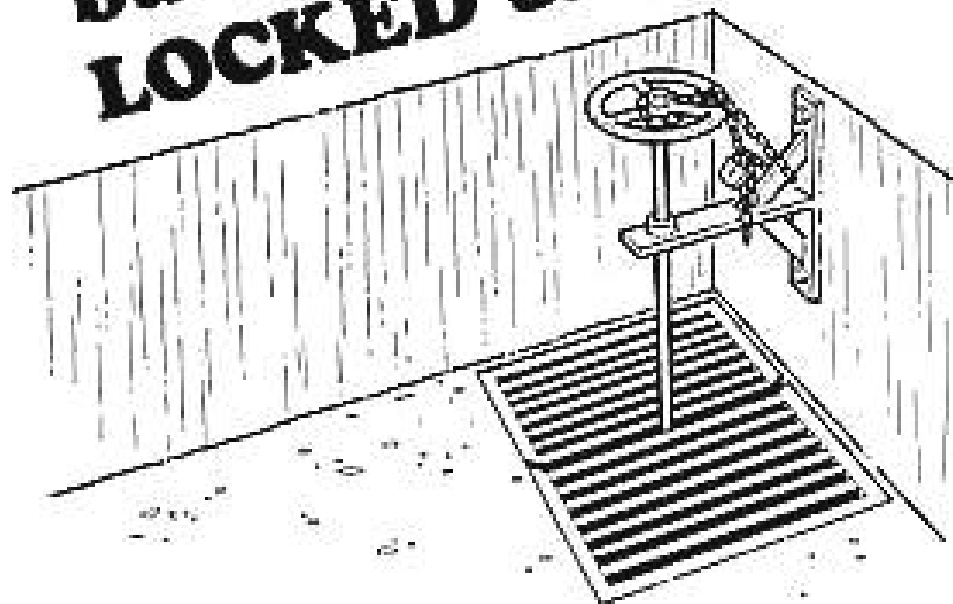
**Are drain points on LPG
and other hazardous liquids
double-valved or blanked?**

**Are bund drain valves
LOCKED SHUT?**

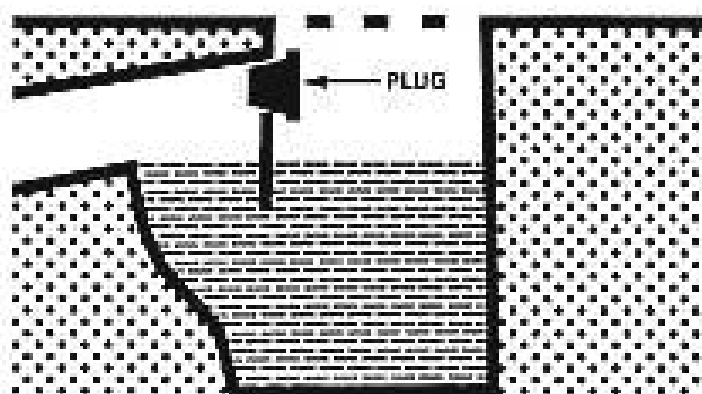
The plug was missing from the rodding hole so oil vapour got out past the U-bend
A DRAIN CAUGHT FIRE

CHECK YOUR DRAINS

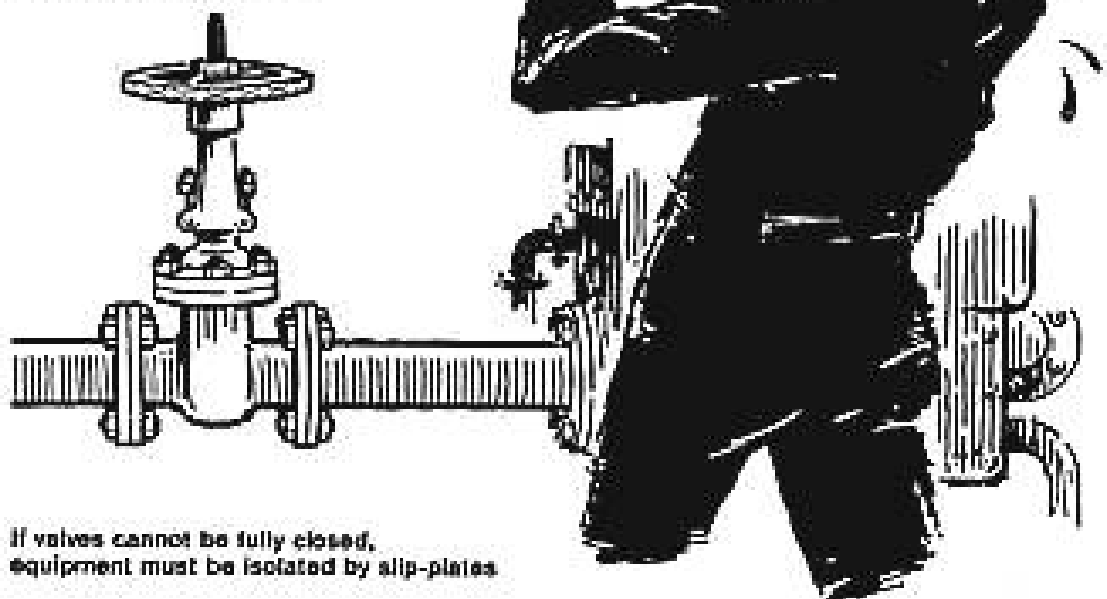
While the fitter was dismantling
the equipment

OIL SPRAYED OUT

The protruding spindle shows
that the isolation valve was not
fully closed.....

Dirt in it cleared suddenly

A process supervisor closed the valve as far as it would go. He realised that the spindle was projecting and that the valve was not fully closed but he could not close it any more and he assumed that it was blocked with debris. He opened the drain valve on the equipment and proved that the isolation valve was not leaking. There was no other isolation valve further back. He therefore, issued a permit for the fitter to dismantle the equipment. It was a quick job so he did not ask for a slip-plate to be fitted. He locked the isolation valve (this should have been shown on the drawing).

While this fitter was dismantling the equipment the choke suddenly cleared and oil sprayed out.

If valves cannot be fully closed,
equipment must be isolated by slip-plates.

If a valve cannot be closed fully - as in this case - a slip-plate should be fitted, even for a quick job. The slip-plate is fitted under controlled conditions and should the choke suddenly clear while it is being fitted, the situation is under control.

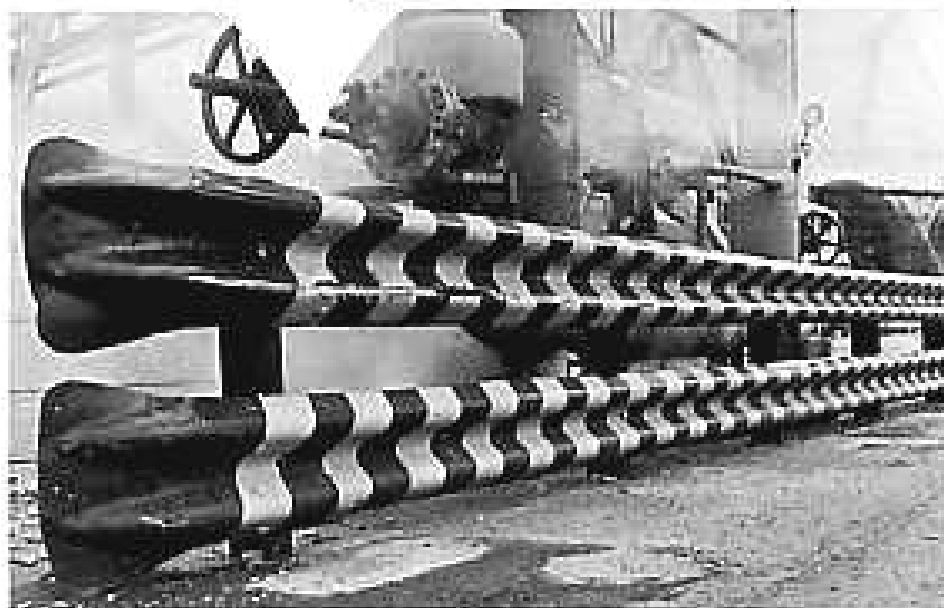
This crash barrier prevented a spillage

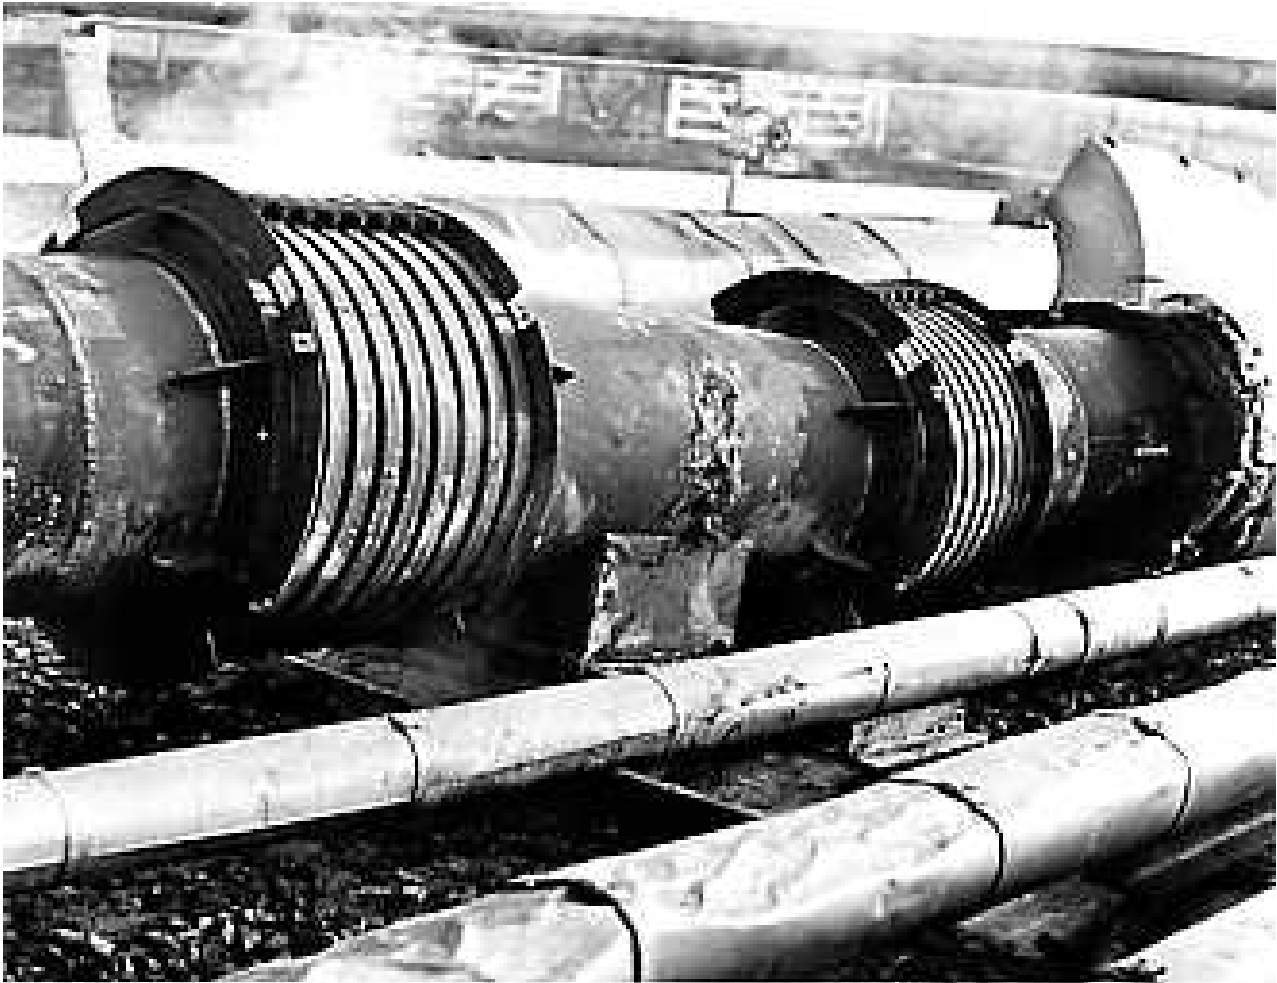
LP STEAM MAIN EXPANSION BELLOWS AND ANCHOR FAILURE.

Some low pressure piping carrying non-hazardous fluids is not registered. However that is not to say that it is immune from failure. This photograph is of an anchor with axial expansion bellows units on either side installed in an LP steam main. Failure was initiated through operating the main at a temperature in excess of that for which it was designed. It is likely that the damage took place many months, if not years, ago though it was only noticed within the last six months.

We should all be observant whilst carrying out the daily round and common tasks.
