fire and explosion at
sheephead container depot, Renfrew
January 1977

On 4 January 1977, a serious fire and explosion occurred at the Braehead Container Clearance Depot at Renfrew in Scotland.

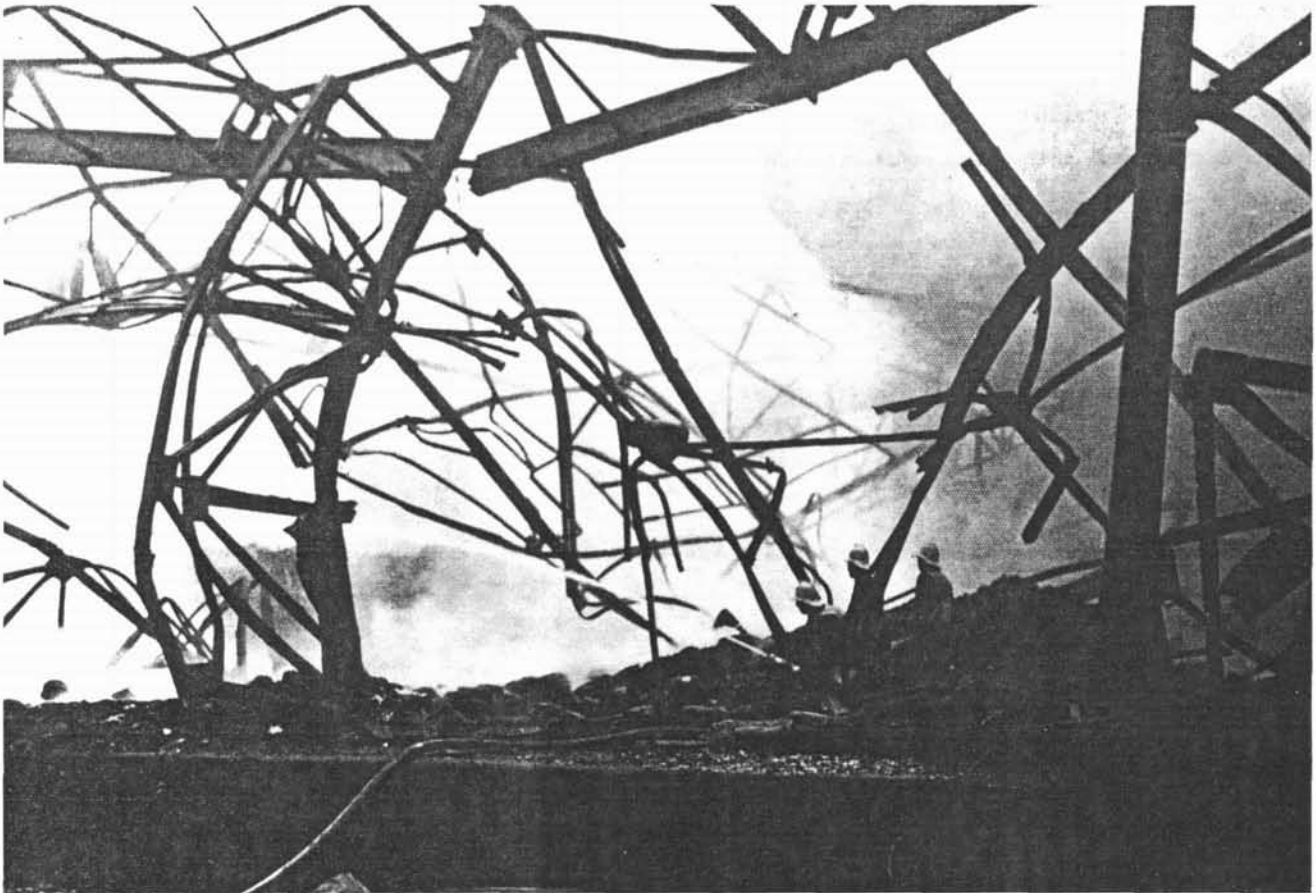
Fig 1 Fire-fighting at the seat of the blaze in Shed A (Courtesy of the Firemaster, Strathclyde Fire Brigade).

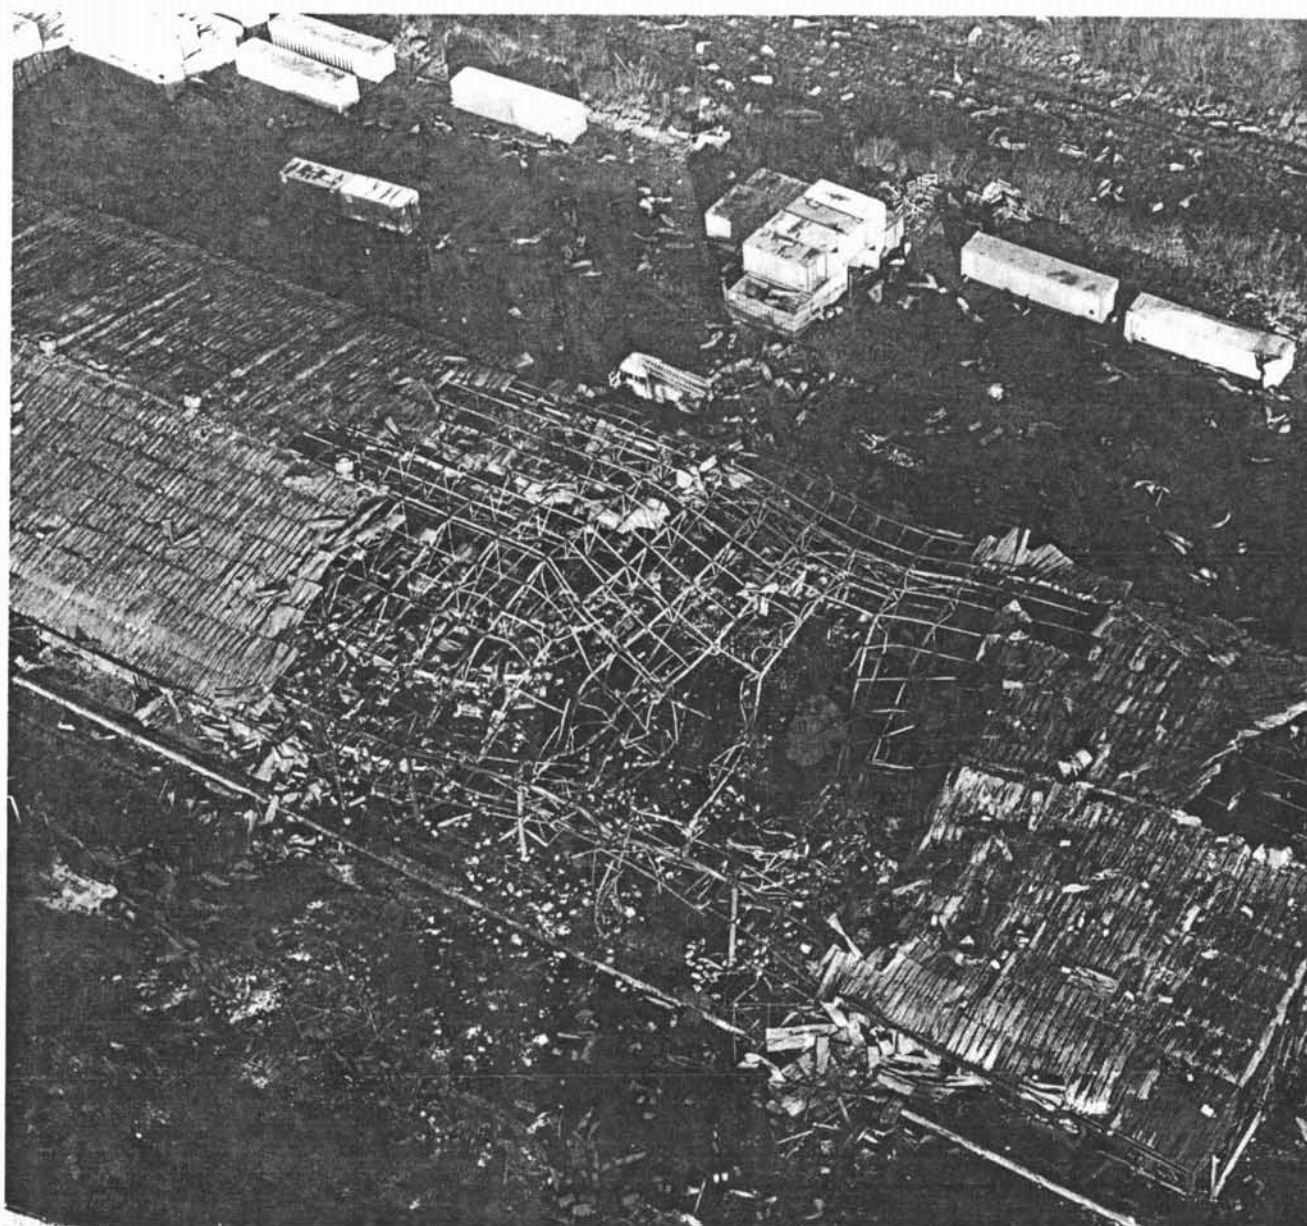
24 The extensive damage caused to Shed A in the explosion is clearly shown in Fig 2 where an impression of the scale can be gained from noting the two men standing in the bottom left-hand corner. Flying debris, consisting mainly of open drums containing residual sodium chlorate, corrugated steel roofing sheets and

Fig 2 The seat of the explosion in Shed A.

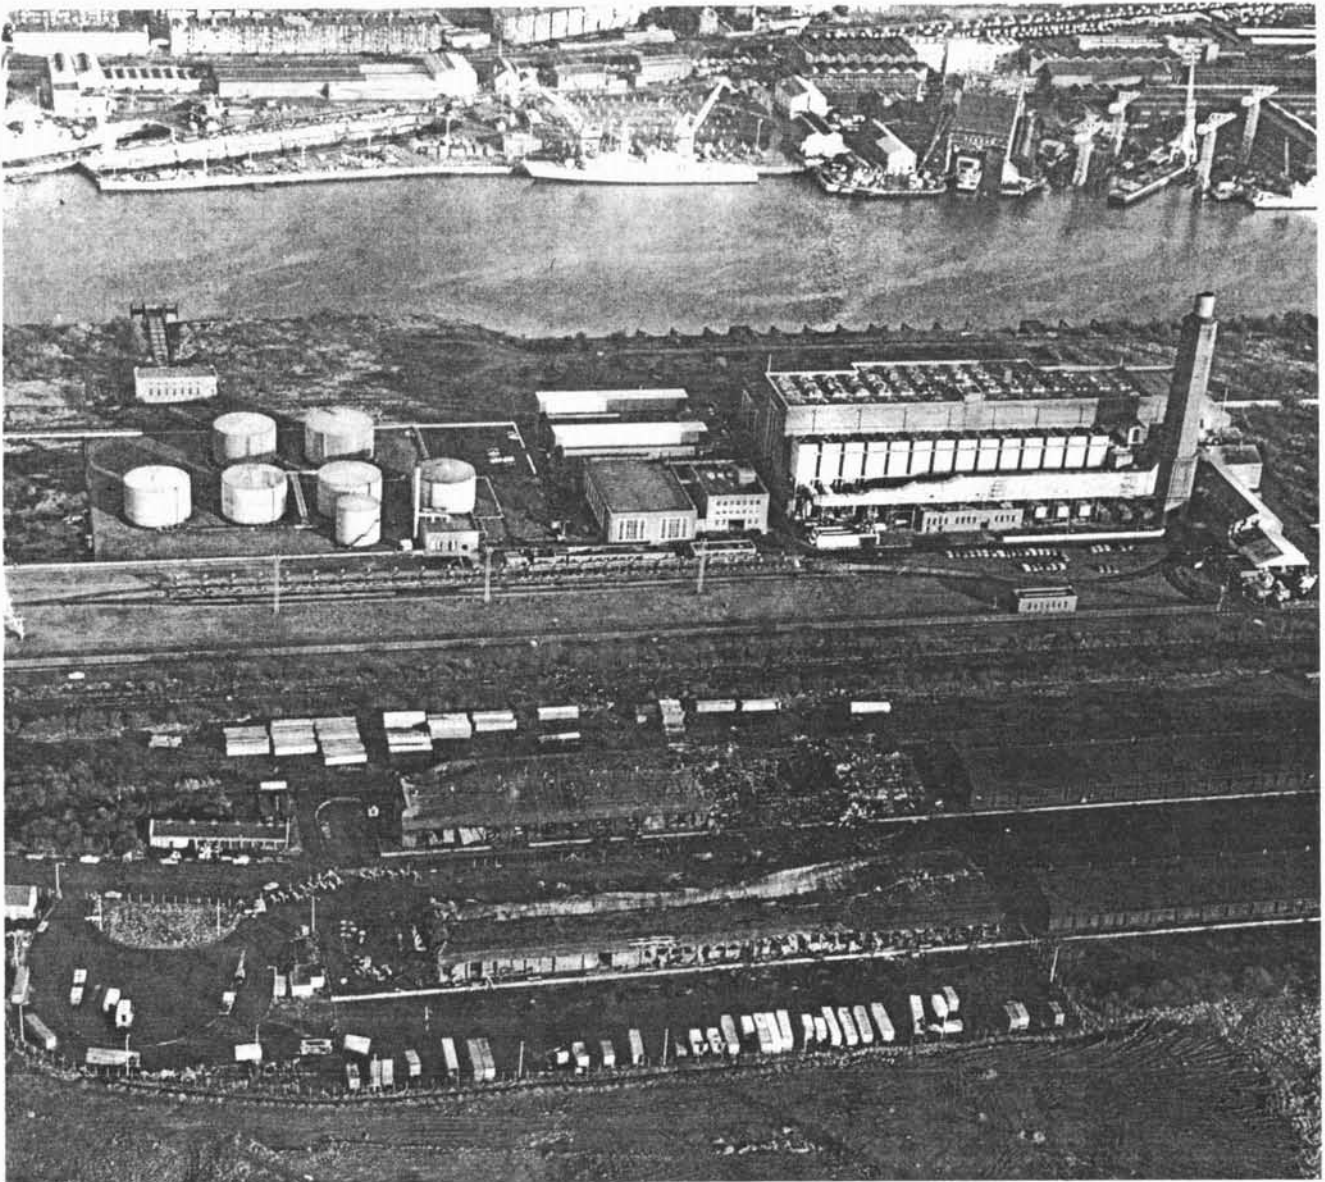
burning pieces of timber from the pallets, was distributed mainly over the area shown in Fig 3 with a distribution pattern as indicated by that of the sodium chlorate drums shown in Appendix 4, Fig 2. Pieces of steel roofing sheets were reported as having fallen up to 2.8 km (1.75 miles) from the site of the explosion. Pieces of the lighter debris from the burnt bituminous covering of the roof sheets were scattered over an area extending more than 8 km (5 miles) from the explosion in the direction of the south-westerly wind, estimated at 14 knots according to recordings at nearby Glasgow Airport.

25 The blast from Shed A blew in the side wall and doors of Shed C and the evidence indicates that the blast travelled right through Shed C, blowing out the opposite side of the shed, which can be seen in the foreground of Fig 3. Burning debris was seen falling over the fuel tanks of the nearby power station. These tanks, which are prominent in Fig 3, have a maximum capacity of 30 000 tonnes of heavy residual fuel oil. This fuel storage

Fig 3 General aerial view of the damaged site.

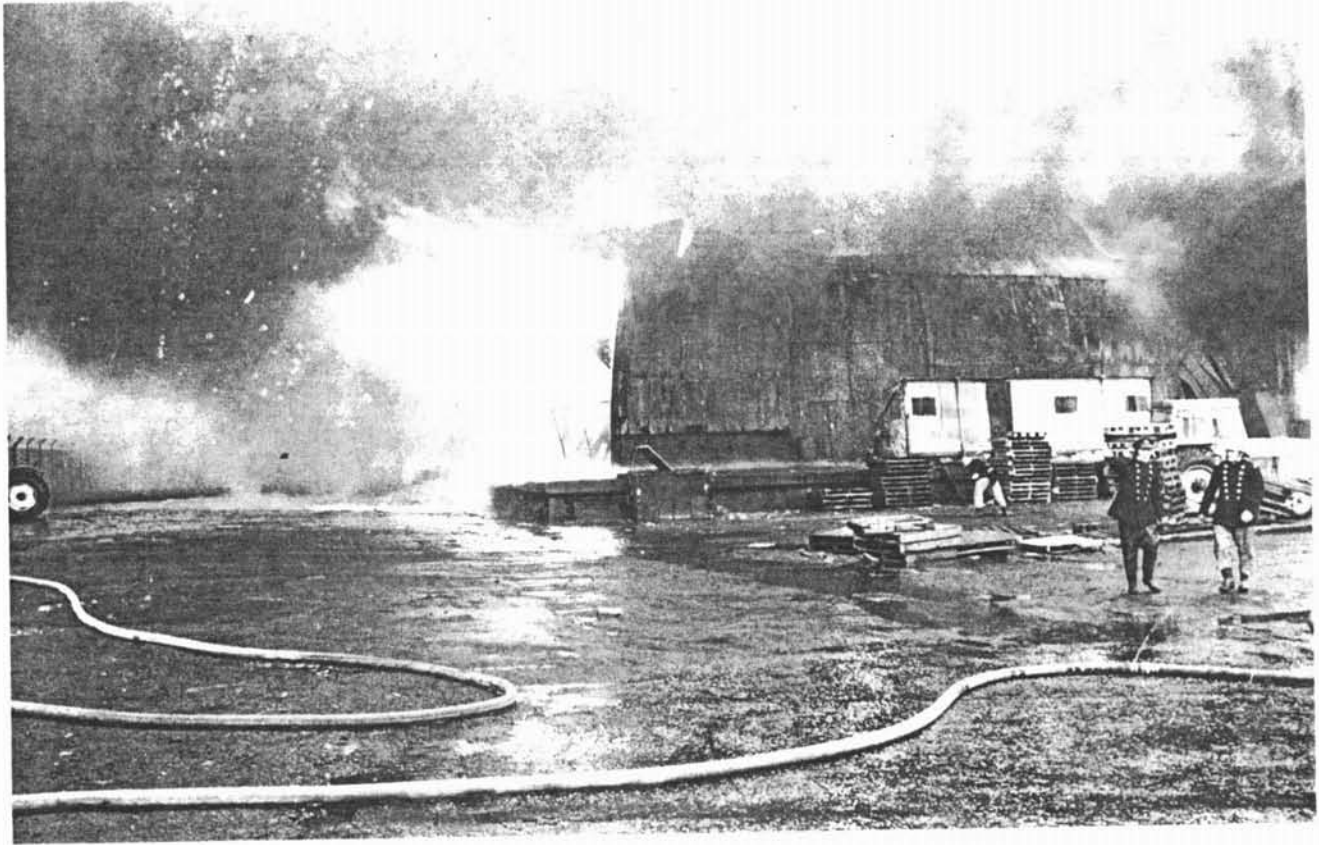
Fig 4 Whisky ablaze in Shed C (Courtesy of the Chief Constable Strathclyde Police).

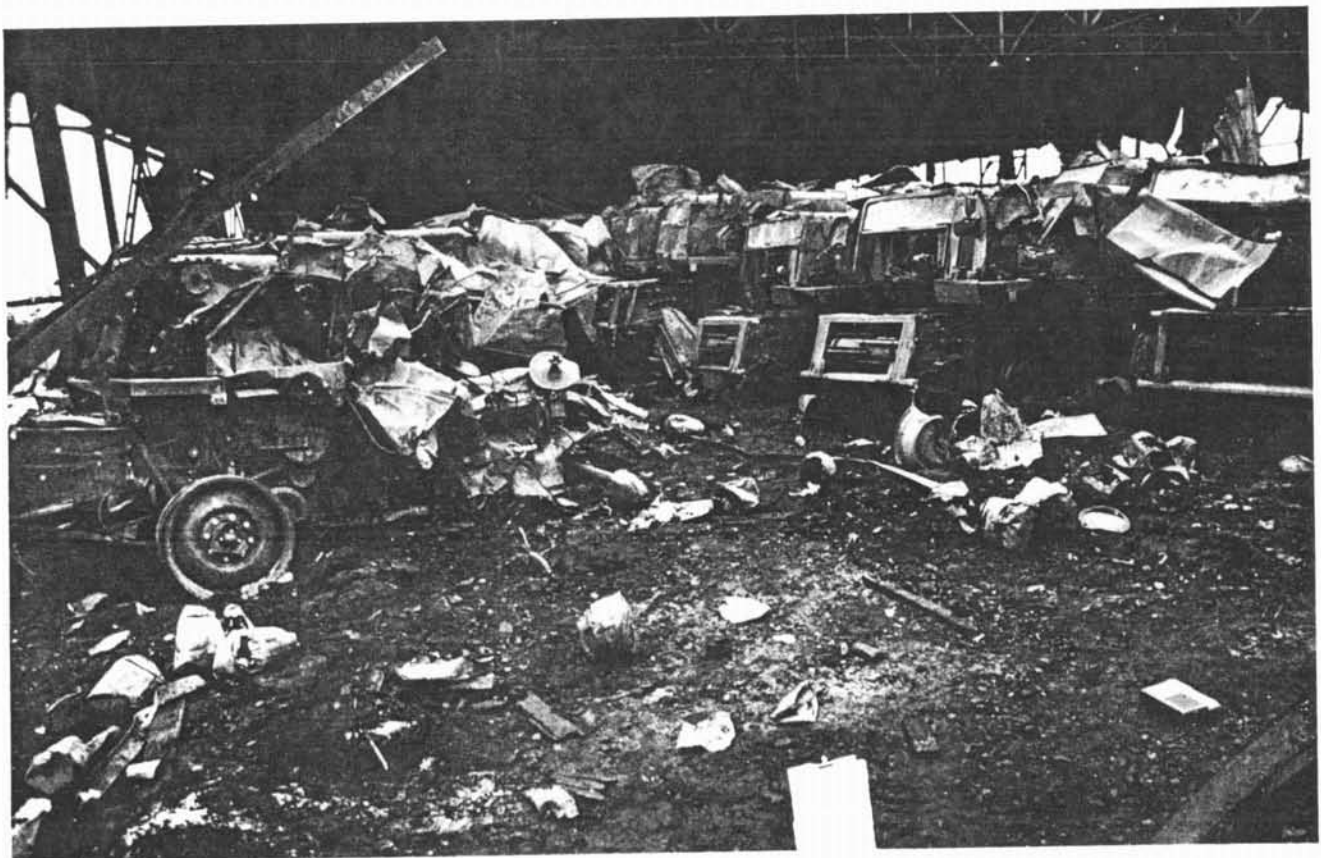
Fig 5 Crater 3 and the main damage area of combine harvesters.

middle of the shed near the sources of the fire (Fig 5). Some drums in the north west corner of the shed, which had evidently contained oil, were seen to have exploded and it is also possible that these could have been responsible for the first two bangs.

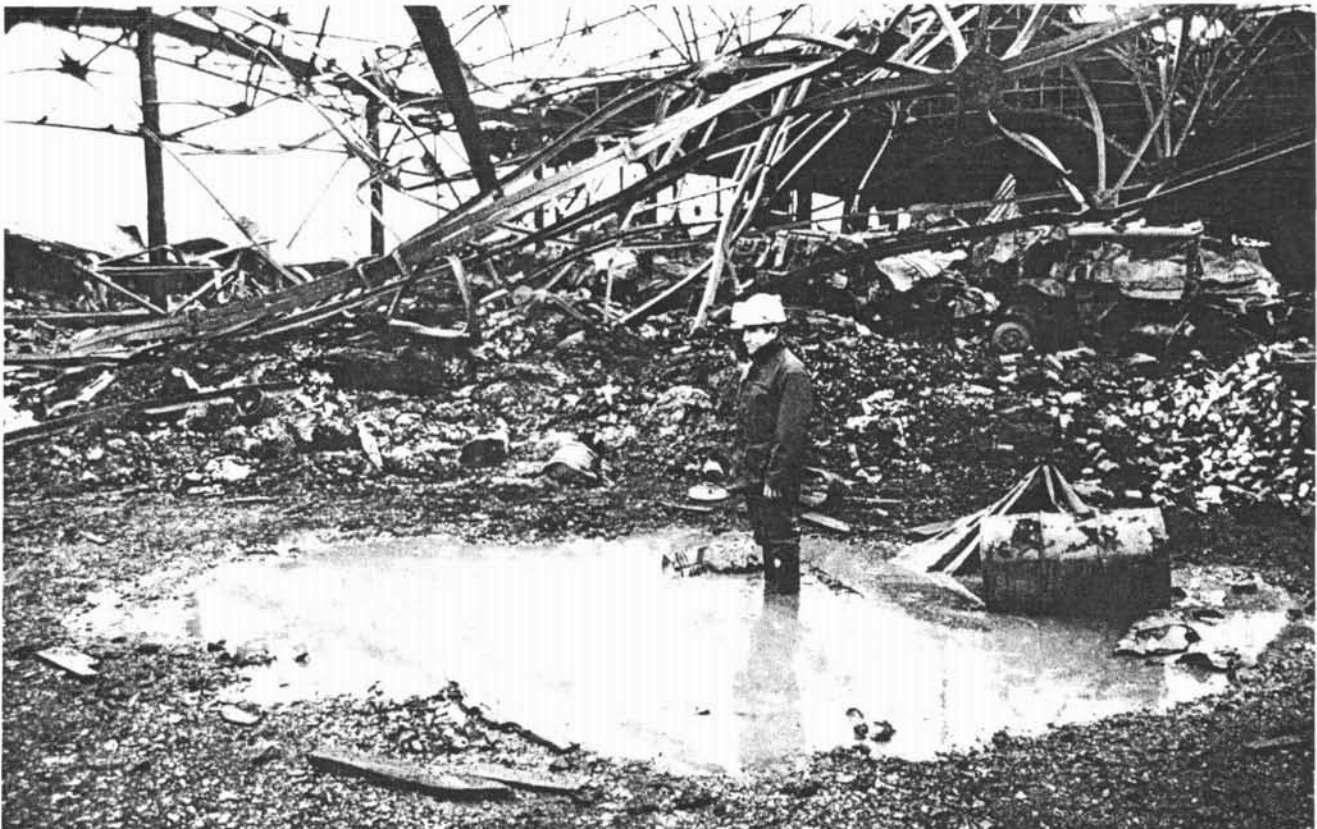
31 The damage at the seat of the explosions was consistent with explosions having taken place at the craters numbered 1 to 5 in Appendix 4, Fig 5. Craters 1 and 4 (Fig 6) were clearly caused by the principal explosions and their location coincided with that of the sodium chlorate prior to the explosion (as shown re-constructed in Appendix 1) where the sodium chlorate would have been intensely heated by the fire. Fig 7 shows the uprooted stanchion in crater 4. This stanchion and its foundation had been completely uprooted with its foundation from a depth of some 0.6 m (2 ft) and was displaced inwards 0.9 m (3 ft), which was consistent with the whole roof area having ballooned upwards at the time of the explosion. The disintegration of the steel framework of the roof had been finally brought about by the failure of bolts, but at least one of the roof truss bracing members was found to have completely sheared at the time of the explosion.

Fig 6 The major crater, No 1 (App 4, Fig 5), with piled remains of milk powder behind.

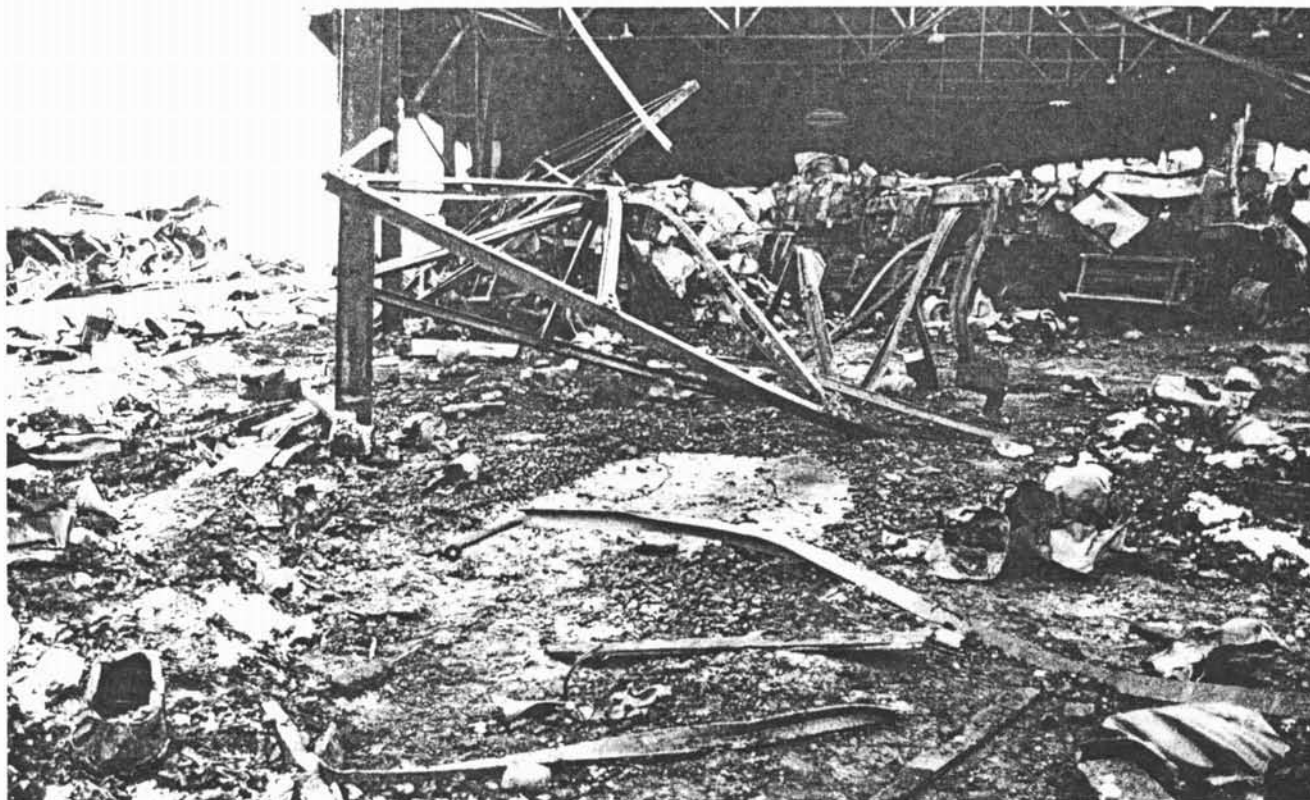
Fig 7 The uprooted stanchion with crater No 5 (App 4, Fig 5) in foreground.

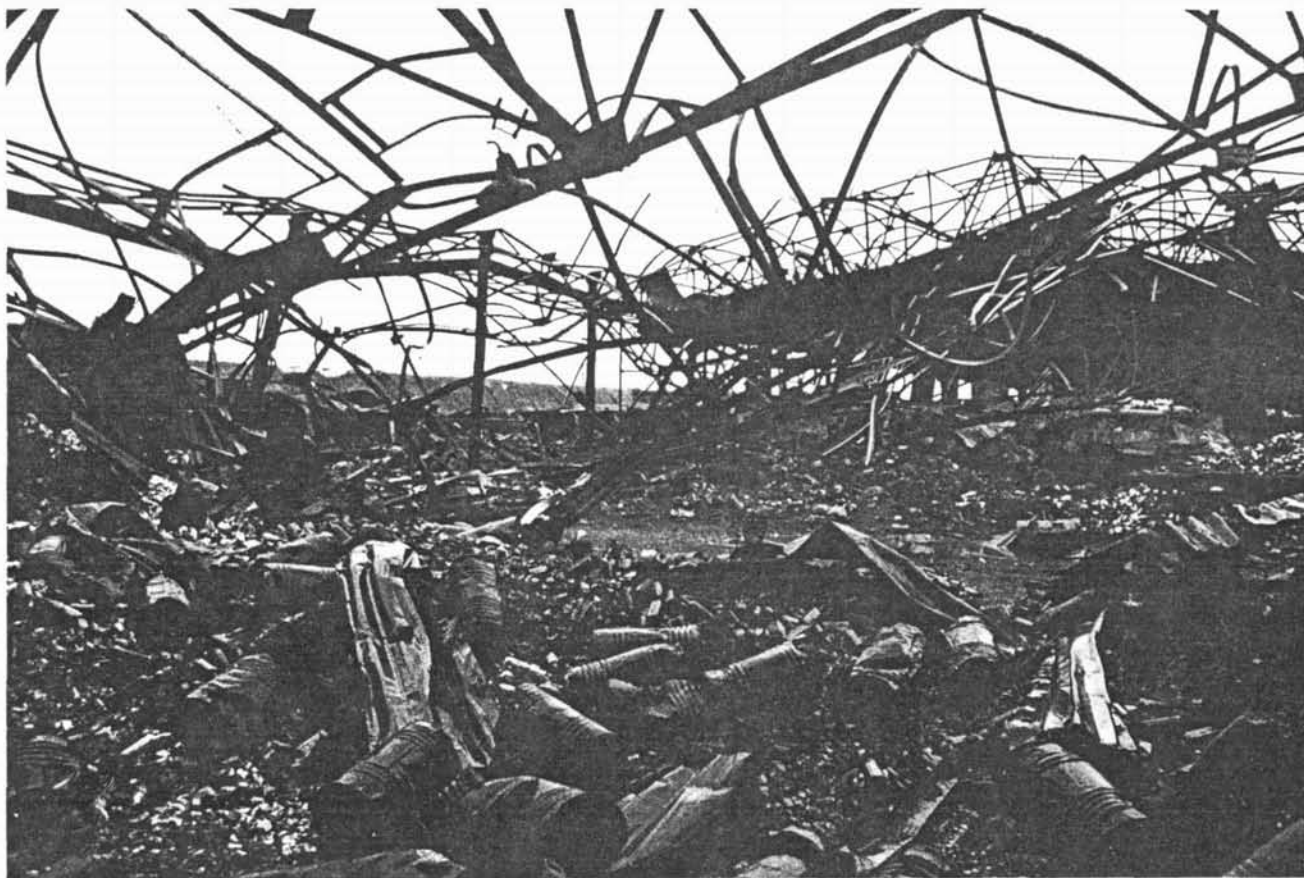
Fig 8 General view of the seat of the explosion with damaged drums of sodium chlorate in the foreground.

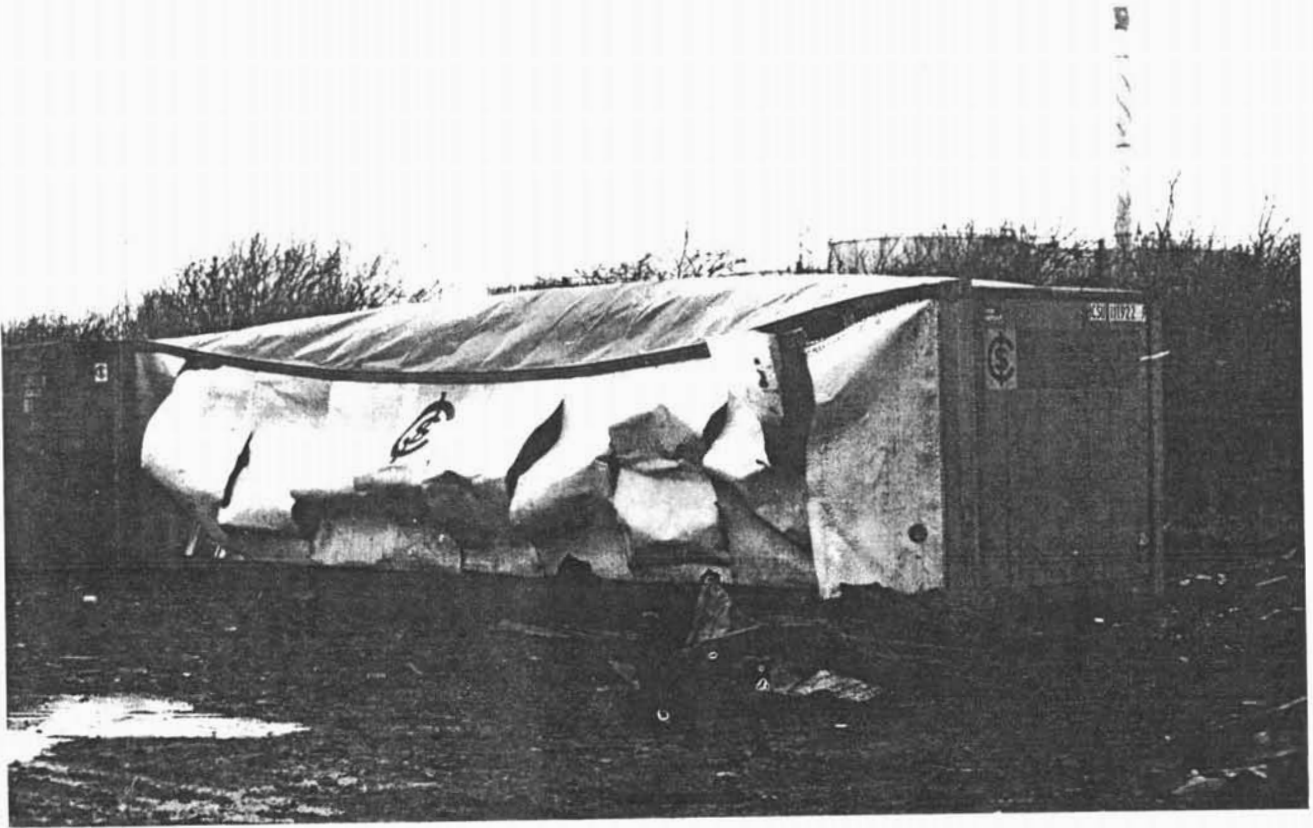
Fig 3 Container.

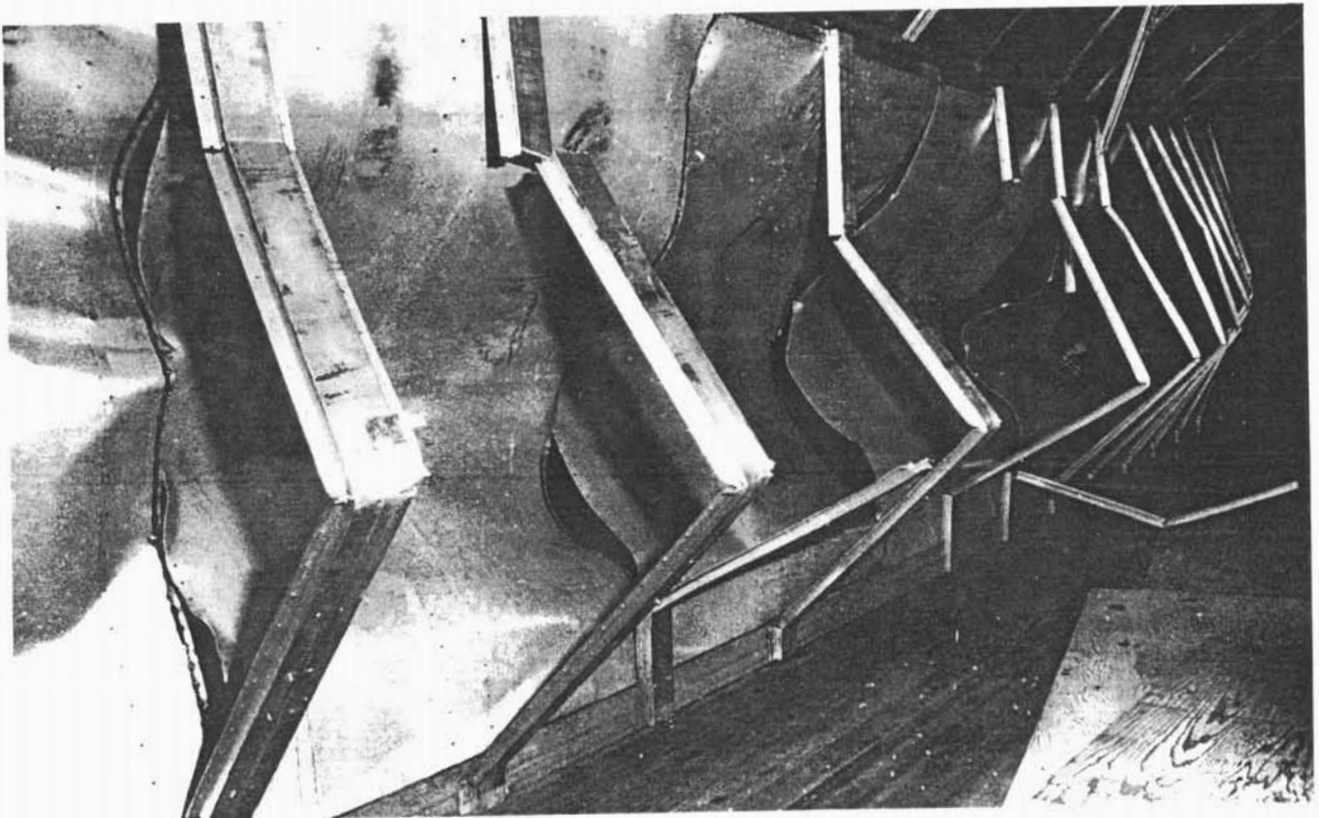
Fig 4 Interior of container.
