Safety practice

Natech risk management in Japan after Fukushima – What have we learned?

Summary

The Great East Japan earthquake and tsunami in 2011 triggered multiple releases, fires and explosions at chemical process installations. Based on the analysis of available accident data, this article identifies the main impacts and consequences and highlights gaps in Natech prevention, preparedness and response. It also presents changes in Natech risk management implemented in Japan after the earthquake and tsunami.

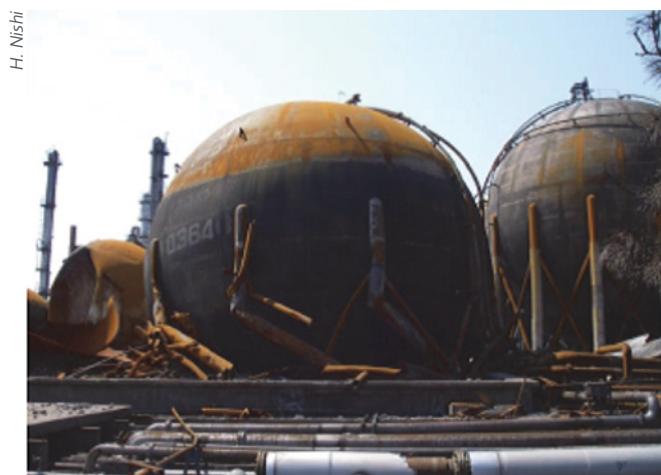
Figure 2 – Buckling of tank legs due to earthquake

An example of a major Natech accident caused by the earthquake were the fires and explosions at the LPG tank farm of a refinery in Chiba. Damage to the support braces of a tank during the main earthquake shock and buckling of the legs when the aftershock hit, led to tank collapse and LPG release from the severed connected pipes (Figure 2). The LPG spread and ignited, causing several consecutive BLEVEs and eventually destroying all 17 tanks
