Successful implementation of ClearView™ in Fertilizer Industry

Advances in the Digitalisation of the Process Industries

Sr. Process Engineer
Fatima Fertilizer Company Limited
Pakistan

ClearView™ Service Manager
Haldor Topsoe A/S
Denmark

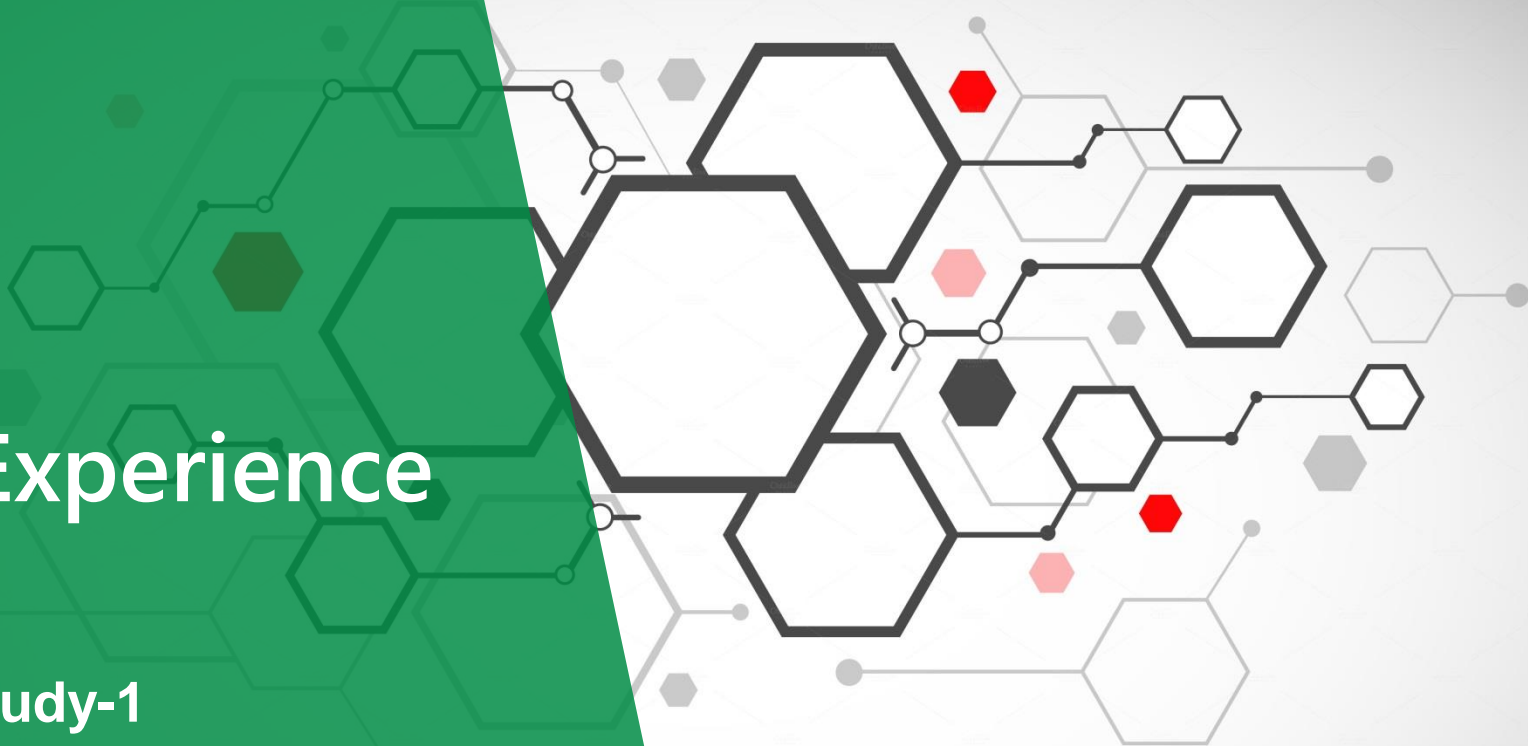
Case Study-1

Case study-1: Sulfur Slip from Feed Purification Section

During May'21, Organic sulfur slip from Desulfurizer increased to 15 ppb from <10 ppb.

Sulfur is poison to Reforming and Shift section catalysts.

- No alarming deactivation of Prereformer in ClearView™
Actual : 0.5% per month (~3 ppb Sulfur slip)
Expected: 2 to 3 % (15 ppb Sulfur Slip)

- Based upon ClearView™ monitoring, no further actions were taken and Catalyst replacement job removed from TA'21.

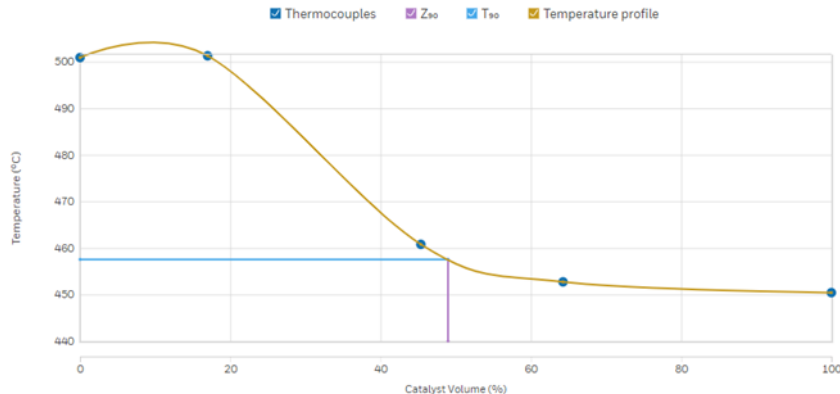
REACTOR TEMPERATURE PROFILE

Pre reformer Deactivation monitoring:

1. z90 based upon simulated temperatures
2. Deactivation progression with time

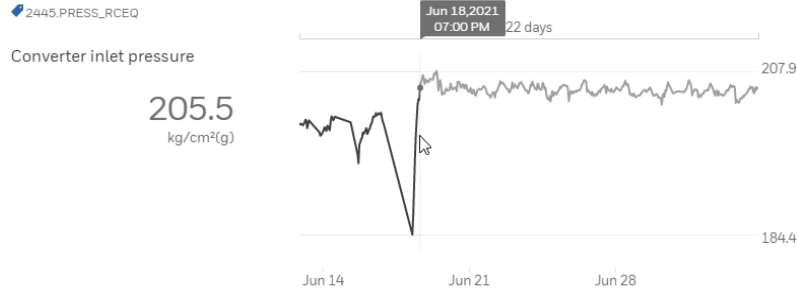
Loop pressure initially increased but remained stable afterwards.

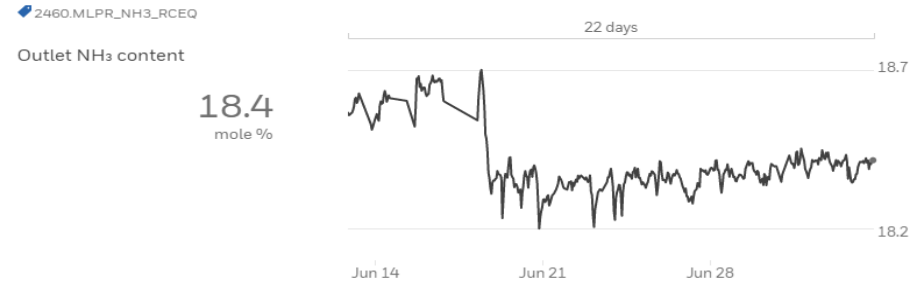
Outlet ammonia concentration initially decreased and then remained stable.

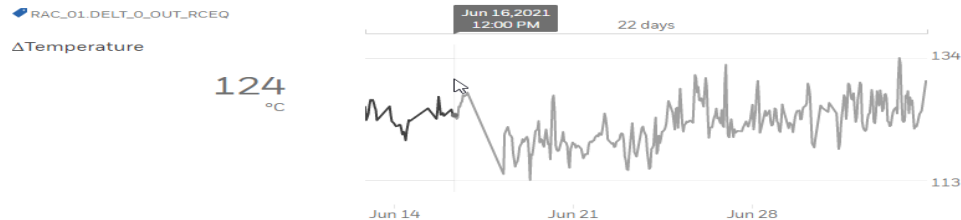
DT of bed-1 initially decreased but improved to previous operating.

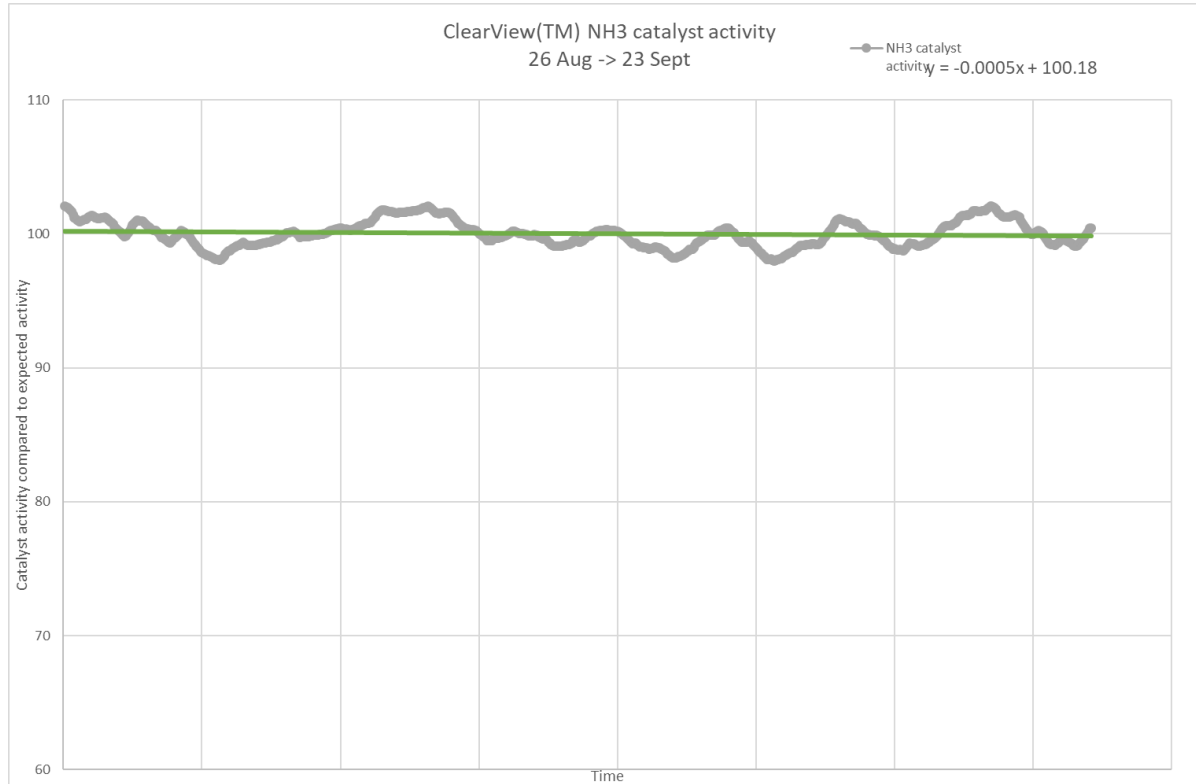
Clearview™ simulation, Catalyst activity is fairly stable

Based upon Stable catalyst activity in ClearView™, it is concluded that an Immediate shutdown of the plant is not required to fix this leakage.
