Human-Factors and Automation-Related Accidents in the Railway Industry

Mona A. Rad, Lianne Lefsrud, Michael Hendry & Daniel Blais

Hazards 31, November 2021

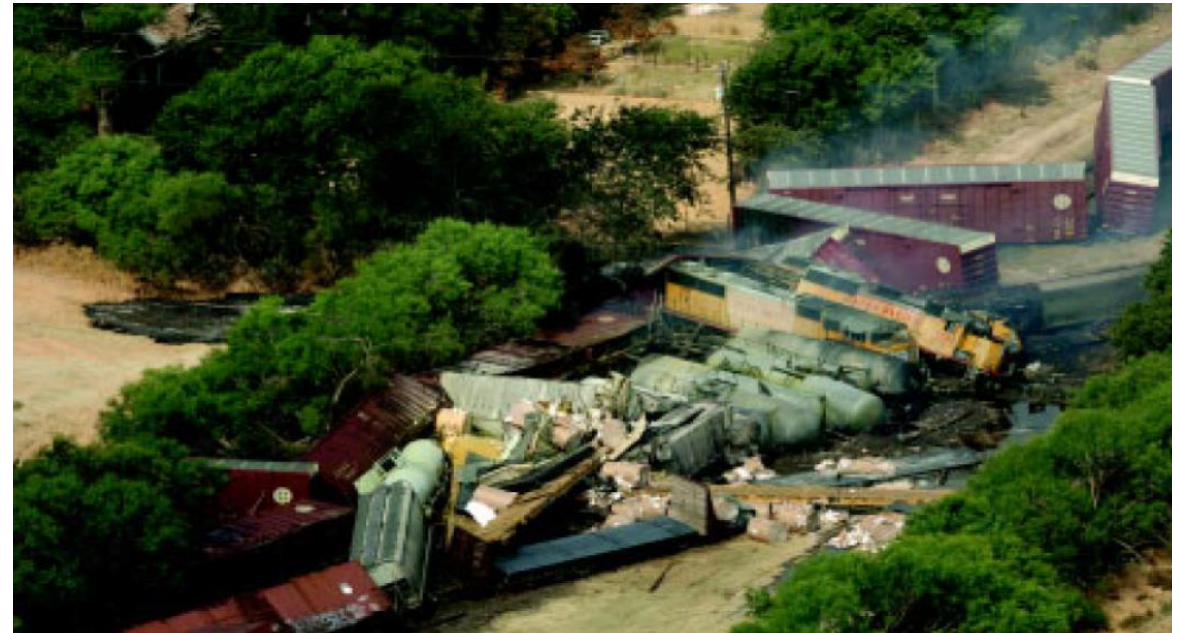
A Union Pacific (UP) train collided with a Burlington Northern (BNSF) train, causing the derailment of four locomotives and 35 railcars and the release of hazardous material.

The crew of the UP train failed to make any attempt to bring the train to a stop in response to the red trackside signal, even when the BNSF train came into view.

The train operator had manipulated the throttle and horn, which prevented the Alerter alarm, and also inputted data into the control system. However, they were in a state of mental fatigue (i.e., were physically awake enough to continue train handling by automatic behaviour) (Stein et al. 2019; NTSB 2006).

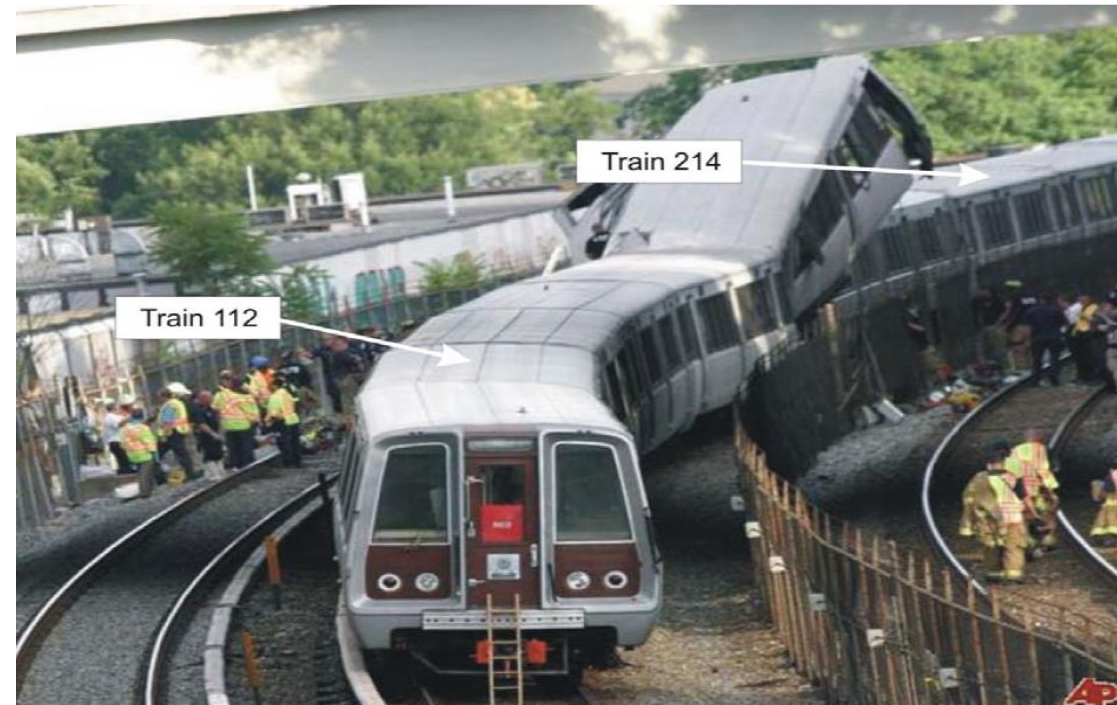
A train-to-train collision occurred in the Washington Metropolitan Area in 2009.

The track circuit malfunction made the automatic train control (ATC) system unable to detect the track was occupied by a stopped train and hence the automatic brake was not initiated to bring the moving train to a halt.

The emergency brake was activated by the operator of the moving train after noticing the stopped train, but there was insufficient time to avoid the crash (Li et al. 2017).

NTSB (2010) pointed out that contributing factors to the accident were lack of a safety culture, lack of a good maintenance plan, and ineffective safety oversight.

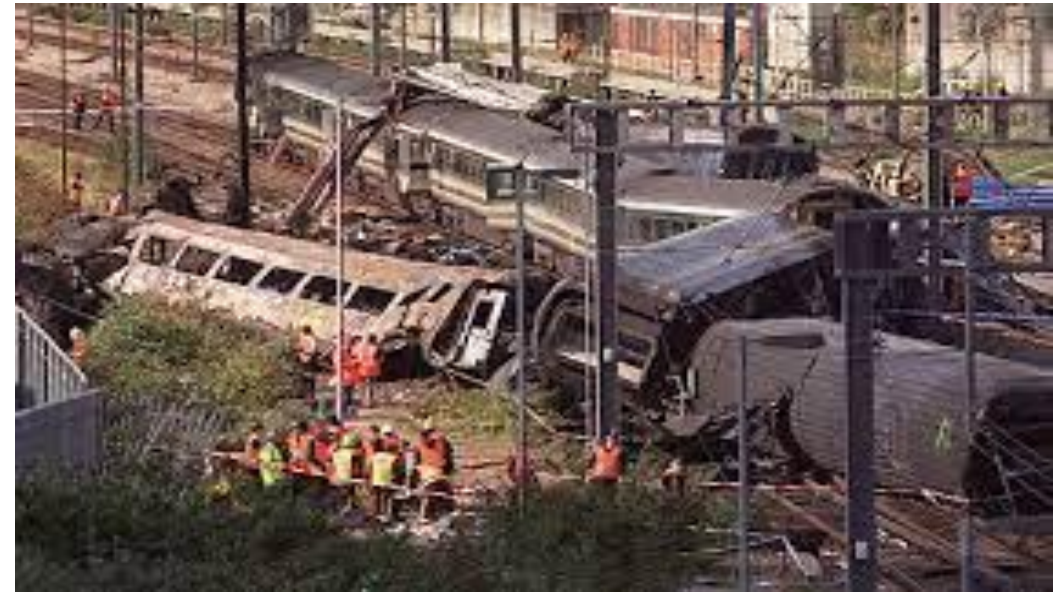
A Turbo train that departed from Paddington failed to stop at a red signal and collided with a high-speed train (HST) approaching the station from the opposite direction on the same line.

The collision followed by derailment and fires.

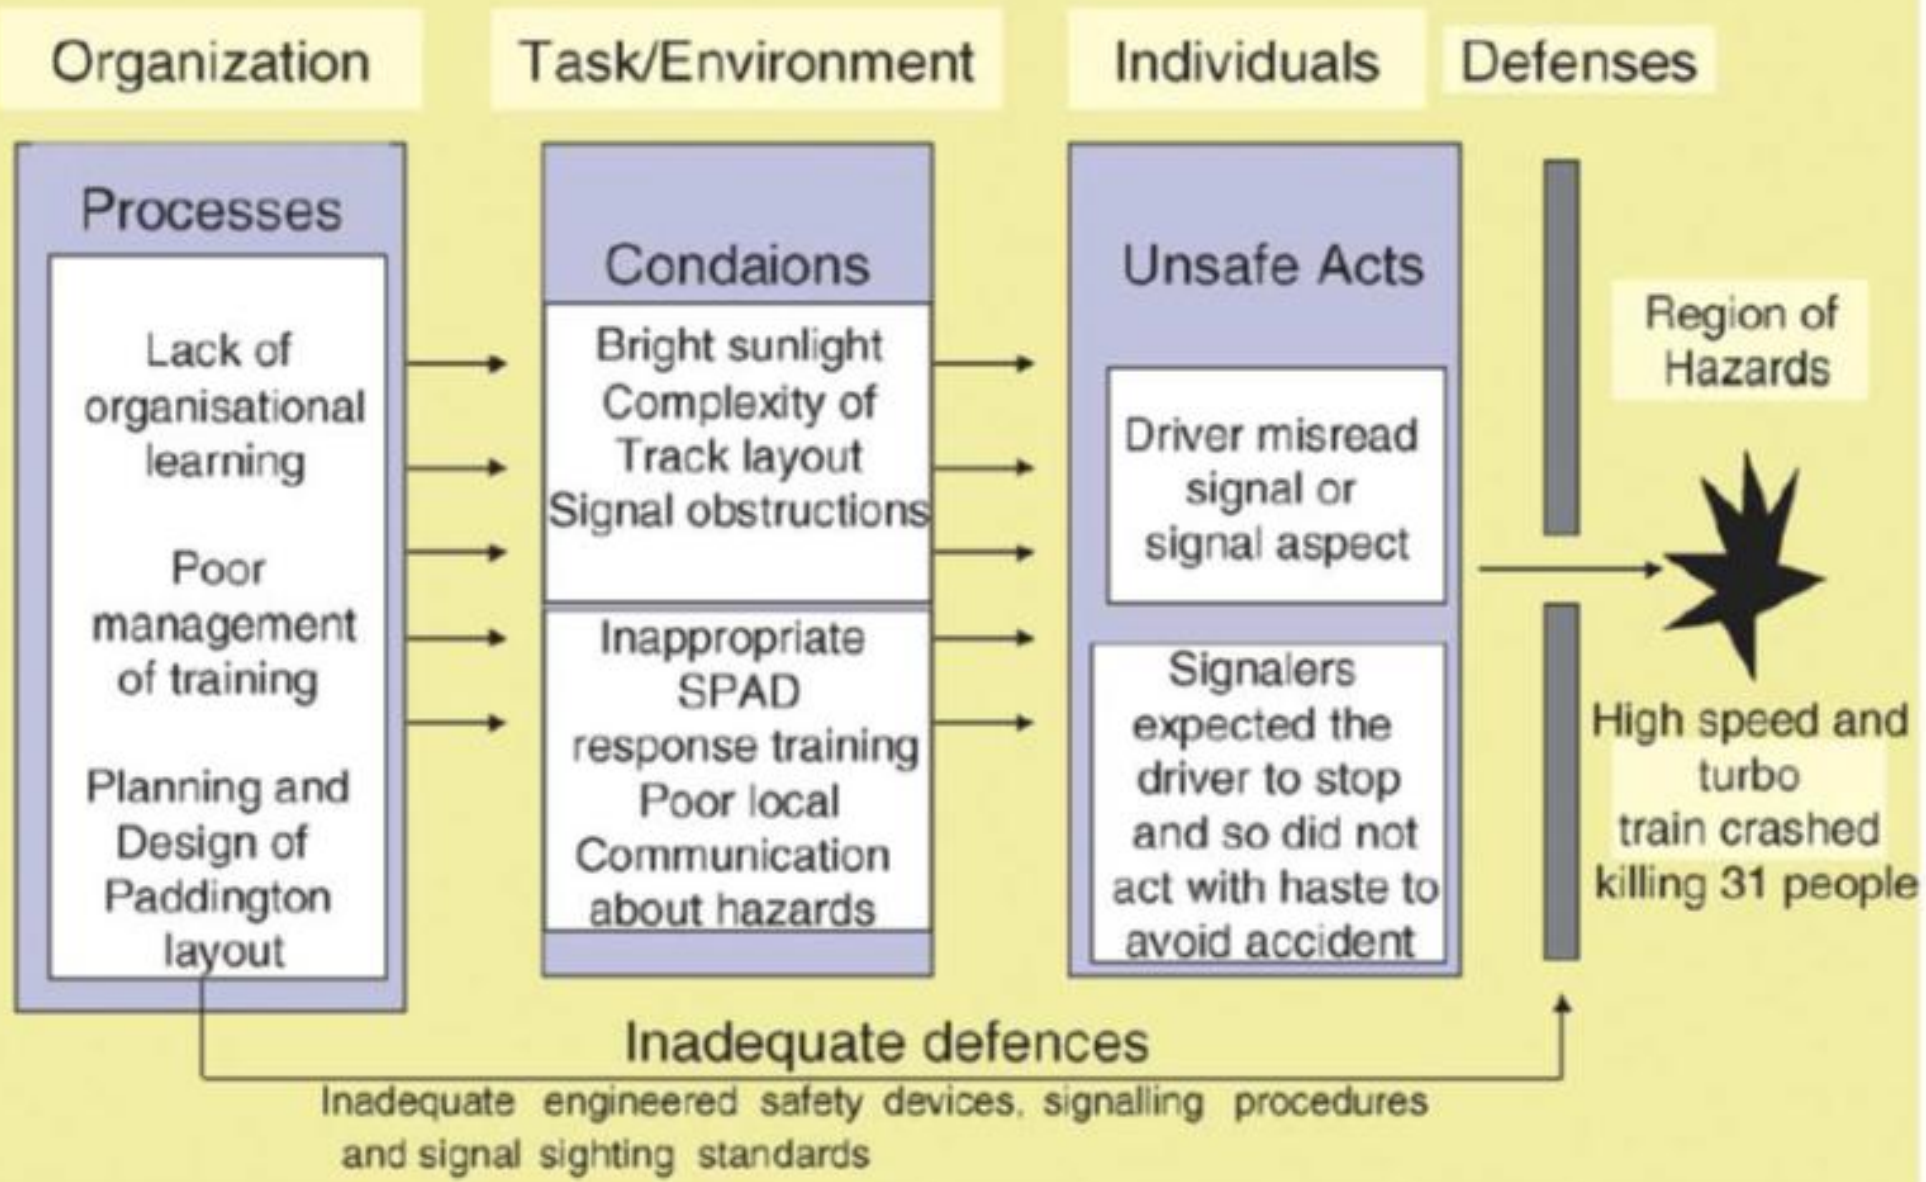
Lawton and Ward (2005) carried out a systematic accident analysis and categorized five contributing factors to the accident:

1. active failures (i.e., the train operator passed the red signal after acknowledging the Automatic Warning System (AWS) alarm and the signaller did not show a timely reaction to the SPAD event)
2. local working conditions (e.g., inexperience, expectation, distraction, strong motor programs, false perceptions, confirmation bias, and situational unawareness)
3. situational and task factors (e.g., track layout, poor human-system interface, poor feedback from the system, and poor communications)
4. inadequate defences (e.g., poorly engineered safety devices, poor signalling, poor policies and standards, and the lack of awareness of hazards)
5. (latent) organizational failures (e.g., no safety improvement measures for SPAD events, no official standards for train operator training)

Figure 1. Systematic accident analysis of the Ladbroke Grove crash (Lawton and Ward, 2005).

In the Ladbroke Grove accident, the train was only equipped with the AWS system which activates the same horn for all restrictive signal aspects (i.e., yellow, double yellow, and red signal aspects), the result was that the train operator misinterpreted the alarm related to the red signal (stop) for the yellow signal aspect.

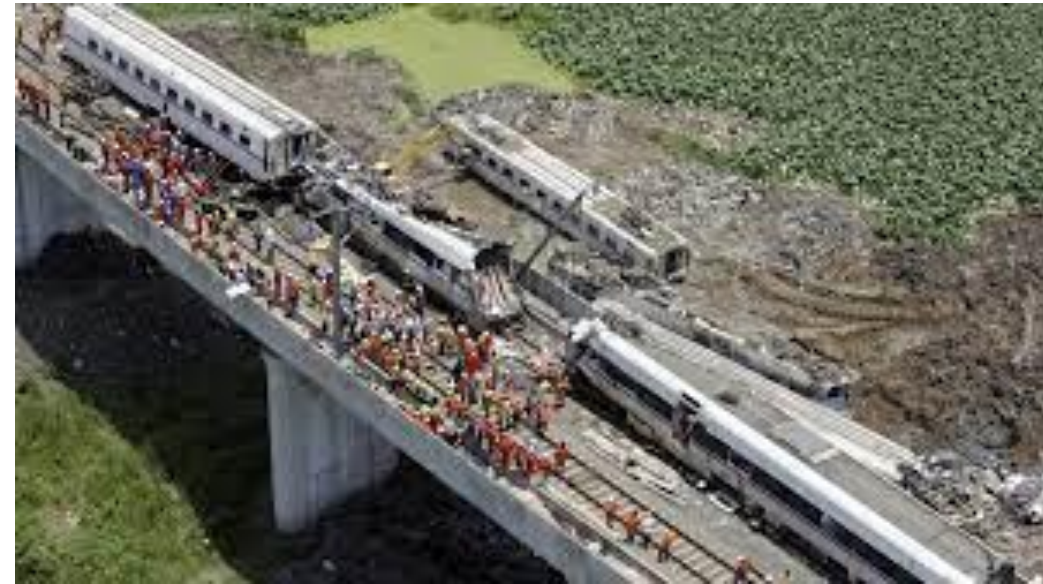
At a speed of 99 km/h, the China Railway Highspeed (CRH) train D301 rear-ended another CRH train, D3115. As a result of this collision, six cars derailed and two went off the bridge.

The signalling and train control system used on the accident line was the Chinese Train Control System (CTCS).

Approximately one hour before the accident, severe lightning at this location resulted in a flaw in the control system.

Due to the track circuit breakdown, D301 neither received information about D3115 nor stopped automatically and the two trains then collided.

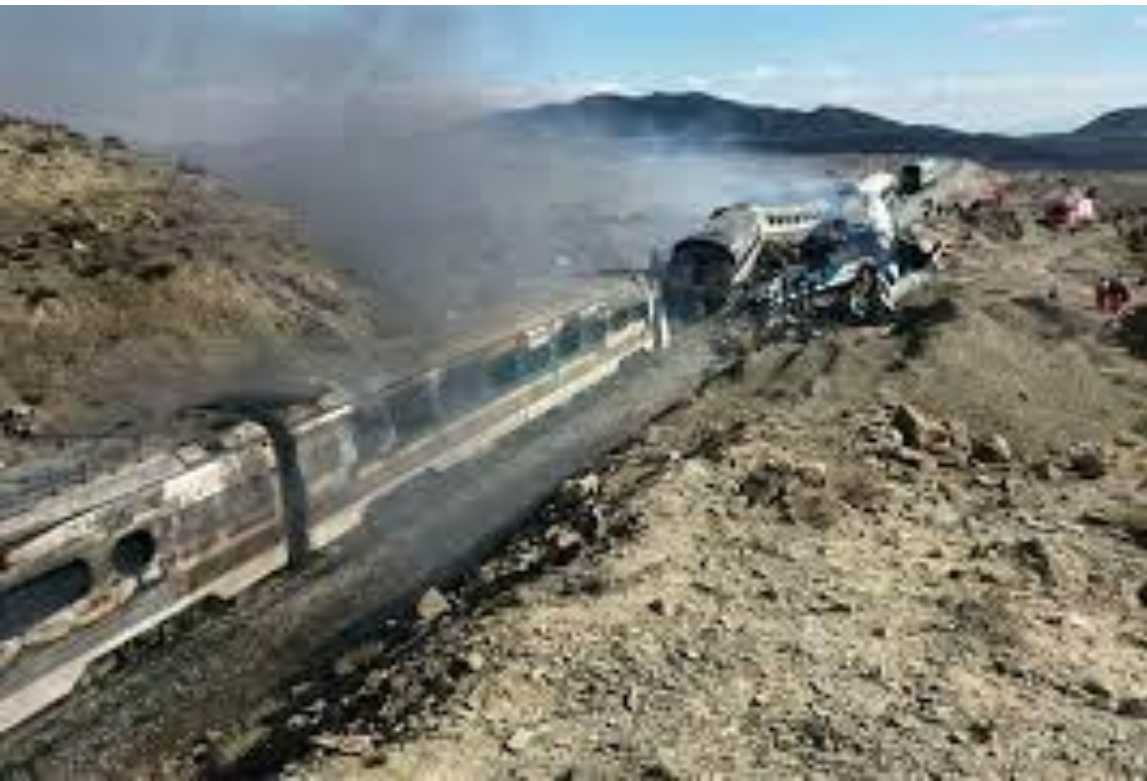
Two passenger trains collided in a rear-end collision followed by fire.

The first train stopped due to technical problems in its brake system associated with cold weather.

Then, the second train controlled by the automatic train control (ATC) system stopped after seeing the red signal of the block.

Meanwhile, the shift for the Centralized Traffic Control (CTC) operator changed and the new CTC operator permitted the second train to resume their journey.

Although different factors such as human error, complex operation process, poor safety management system, and environmental factors contributed to this accident, the faulty ATC system played a pivotal role.
