Incident

The Hamlet chicken processing plant fire — outcomes and good practices for avoiding a recurrence

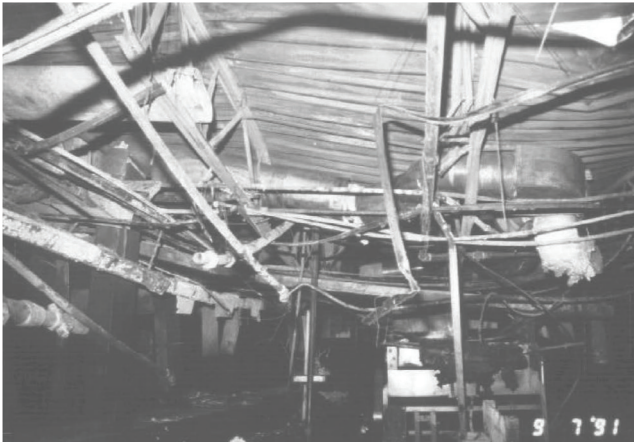
Figure 2 – Severe damage to steel girders and roof supports above the cooker vat

thus adding to the extent of the conflagration, which destroyed much of the surrounding equipment and building structure. Figure 2 shows damage to steel girders and roof supports above the cooking vat and, in Figure 3, a section of collapsed roof above the vat, can be seen². From this photograph, it is possible to conclude that the roof insulation was sandwich panelled, though the available literature does not state this. Witnesses who survived said that much of the plant was enveloped in fire and smoke in less than two minutes. Workers had their visibility almost eliminated and oxygen was rapidly consumed in the blaze. Hydrocarbon-charged smoke was, in effect, all that was left of the breathing atmosphere, as confirmed by autopsies on the deceased. Most died of smoke inhalation, not burns. The violent nature of the fire is illustrated by Figure 4.

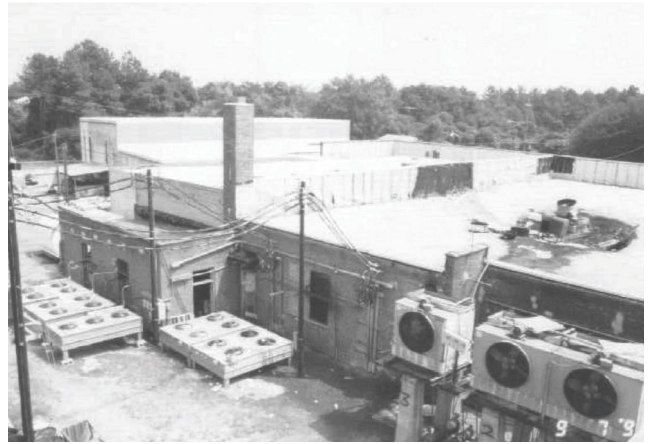
Figure 3 – Aerial view showing the collapsed roof above the cooker vat

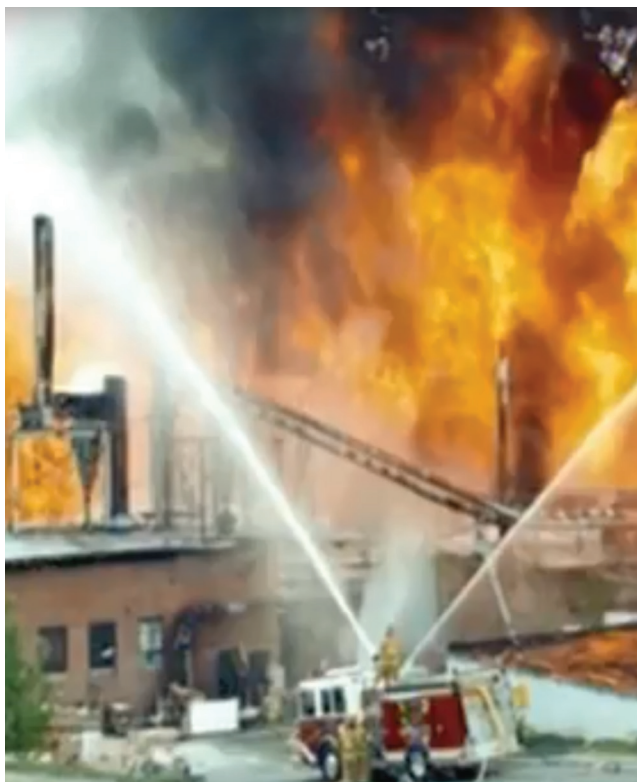
Figure 4 – The fire raging in and around much of the plant⁴
