Human Performance and the Fourth Industrial Revolution

Roger Stokes, Principal Engineer, BakerRisk Europe Limited, Chester

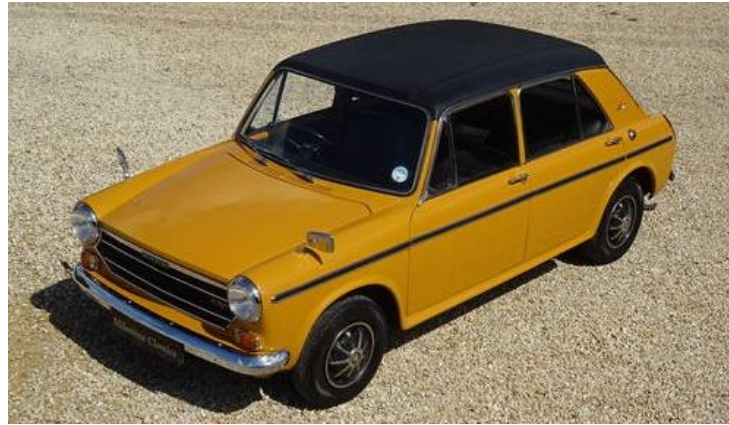
Figure 1: Austin 1300 GT, circa 1970 (Car and Classic, 2020)

From a personal perspective, I can relate back to my first vehicle. At 17 years old, I became the proud owner of an “H” (1970) registered Austin 1300 GT with a 1275 twin carburettor engine pushing out 56 bhp, as shown in Figure 1. (This one was 7 years old when I bought and it eventually went to the scrapyards).

The most sophisticated electrical system was the ignition coil and there was a bank of electro-mechanical relays under the bonnet that used to get stuck and needed hitting with a hammer from time to time.

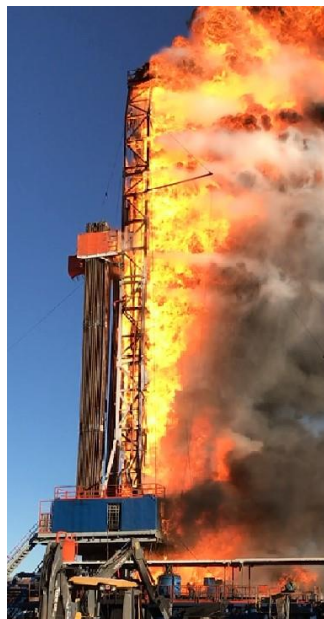
Figure 4: Blowout in Oklahoma

The result of these errors can be seen in Figure 4.

The introduction of a new automated checklist system coupled with apparently inadequate training or understanding of the new system on the part of the operator was a key causal factor with this incident.

Not enough mud was pumped down an underbalanced well whilst drill pipe was removed (a process known as “Tripping”). This led to a blowout and fire that killed five workers. As usual, there were many factors that contributed to this incident. One of them was that there was a new electronic version of a trip sheet, which included a feature that automatically calculated the fluid balance in the well, rather than relying on a manual calculation. Unfortunately, the operator was not trained in the use of the electronic trip sheet and this contributed to the significant gas influx to the well prior to the blowout. The drillers had also turned off the alarm system that was giving excessive nuisance alarms, masking more critical alarms. The CSB report (*CSB, 2019*) states (with sections underlined by the author):

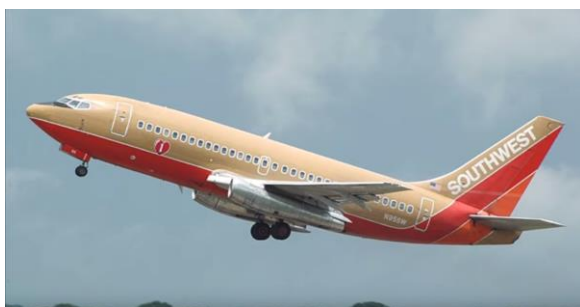
Figure 5: Early 737 200 model (*Airways Magazine, 2020*) **Figure 6: 2018/2019 Model 737 MAX** (*MRO-Network.com, 2020*)

In brief, the 737 Max was the fourth generation of the 737 that was originally introduced in 1968, before the introduction of sophisticated electronic flight instrumentation systems. The subsequent design iterations included the addition of more sophisticated electronic systems, although the basic flight control systems remained electro-mechanical and hydraulic (rather than full “fly by wire” systems).

A key factor that was common to both disasters was a new automated system, MCAS (Manoeuvring Characteristics Augmentation System) that was installed to counter, automatically, a nose-up tendency that arose due to the requirement to mount the more efficient (and larger diameter) CFM engines slightly further forward and higher up under the wing (Figures 5 and 6). The MCAS system activates if a single angle-of-attack sensor (Figure 7), which operates on the same principle as a weathervane, goes beyond a pre-set limit, depending on airspeed, altitude and flaps settings. The provision of this system was advantageous to Boeing and the airlines/pilots since it prevented the Max from having different handling characteristics to that of its predecessors.

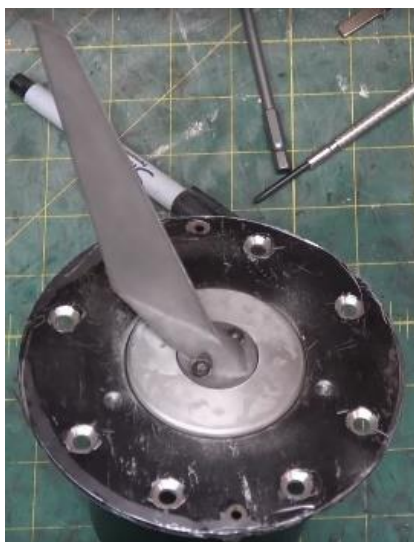
Figure 7: Typical angle-of-attack sensor

In both cases, the MCAS system (Figure 8) activated erroneously, due to a fault with the single angle-of-attack sensor. In the case of the Lion Air incident, it could have involved a mis-calibration following a repair and with the Ethiopian incident, it might have been a bird-strike. With the stabilizer trim bar tilting the nose down, in both cases the pilots fought to maintain level trim by

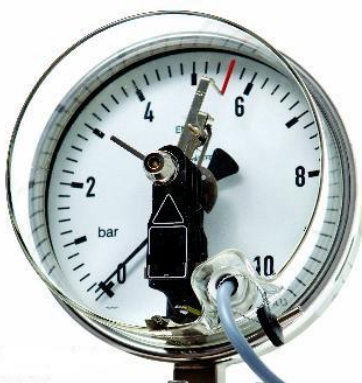
Figure 11: Analogue pressure gauge and alarm

Referring back to the process industries, during the 1980’s, one chemical manufacturing site started to introduce digital pressure gauges (Figure 12) to replace the analogue ones (Figure 11).

About six months after several of these were installed, the site issued a safety bulletin about the high pressure alarm settings. On the old analogue instruments, it was not an issue if the alarm was set at full scale (or even slightly beyond) but with the digital systems operating at 4-20mA, there were cases where it would allow the high alarm to be set just out of range (saturation), which negated its function. However, it passed a commissioning test that involved the use of a simulated signal sent to the alarm. The problem was only discovered when a final element test was conducted after the system had been in operation for some time, clearly without a functioning high pressure alarm/trip.

The change of the instrument system effectively led to the introduction of a new failure mode that was not realised or understood by the people at the time. A key learning point is that the new technology, especially when associated with safety critical systems, requires a thorough analysis of differences and potential new failure modes. Again, these factors would be properly considered via a robust MoC system.

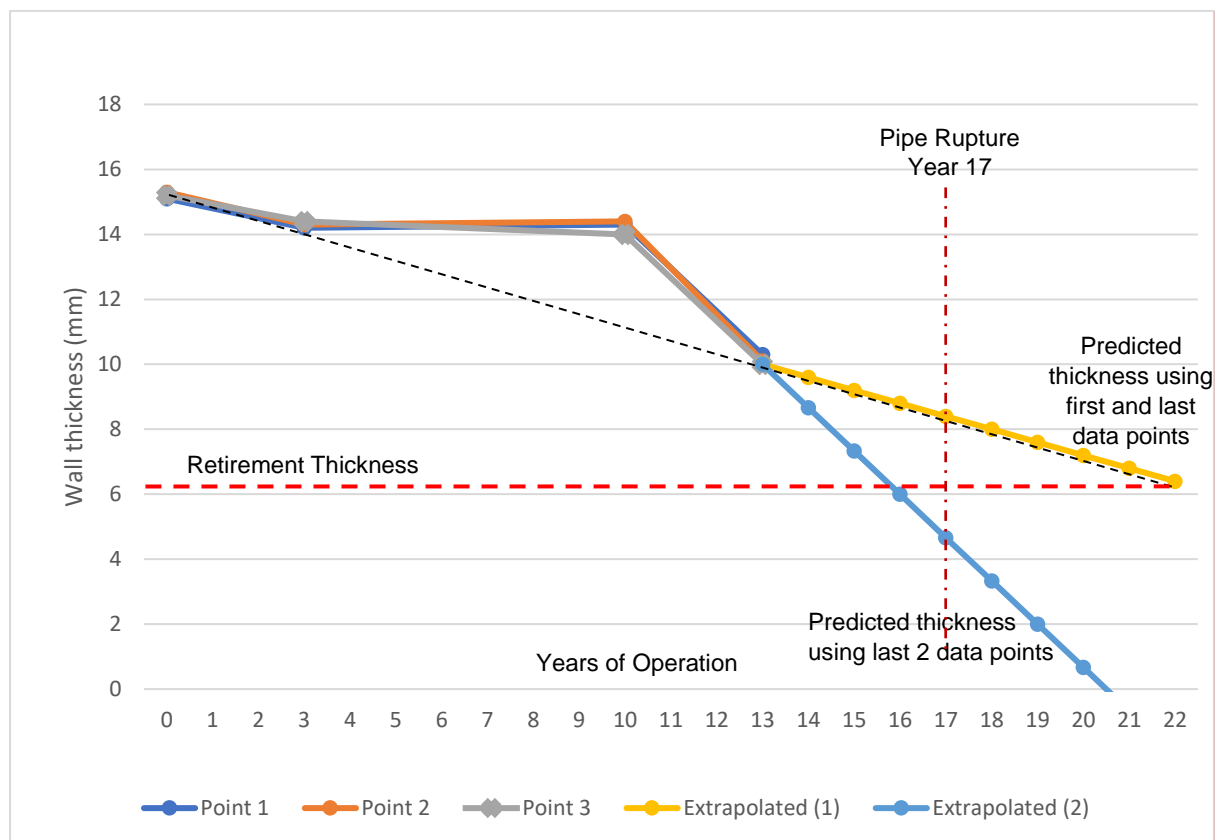
Figure 13 – Trend data for metal wall thickness measurements

The user of the software was able to select the data points to calculate the estimated retirement date of the asset. In the 13th year of operation of the pipeline, the thickness checks and the software calculation showed that there was another 9 years to go before the retirement thickness was reached. Trend data was not plotted.

The pipe ruptured in the 17th year of service resulting in an LOC, major vapour cloud explosion and multiple fatalities. The investigation found that a causal factor involved the way the data was selected via the software for calculating the retirement date.

The very first and the most recent data sets had been selected, which gave an estimated retirement date in year 22. However, the corrosion rate had increased in recent years, and had the last two data points been used, the retirement date would have been given as year 16 and various warning flags would have been raised before the failure occurred. This is demonstrated by the graph in Figure 13, where the blue line (Extrapolated 2) shows a much higher rate of metal loss than the yellow line (Extrapolated 1).

The engineers were apparently unaware of the way the columns of data had been selected in the program (possibly by a supervisor who was not fully aware of the criticality of the data selected) and the output from the software, in the form of tables of data, was relied upon for asset replacement decision-making. Human factors associated with the selection of applicable data for trend plotting resulted in the failure to accurately predict end of life. The lack of plotting of trend data was also a factor in the issue being hidden from the engineers.
