## Incident

# Revisiting the Jonava ammonia tank rupture – 35 years on

Ewan Stewart, IChemE Australia Deputy Chair, Australia

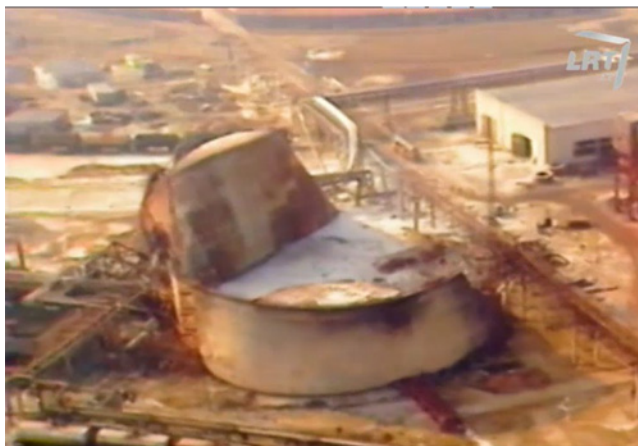
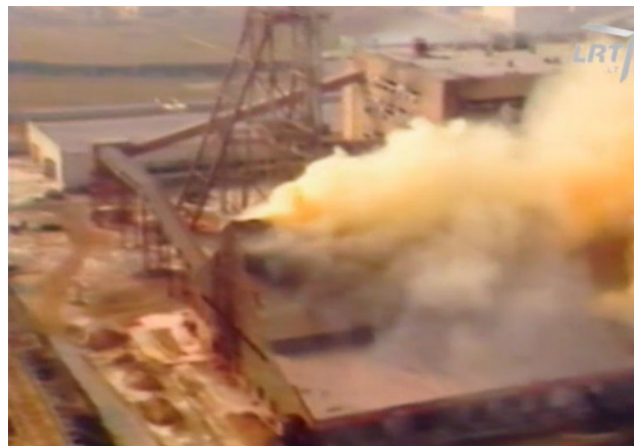
Figure 4 – Aerial views of collapsed ammonia storage tank (<https://www.lrt.lt/mediateka/irasas/2000260243/jonavos-azoto-avarija-bei-jos-pasekmes>)

the pressure increased steadily until the relief valves opened. However, this was not enough. The pressure became too much for the storage tank, which tore from its base, broke away from its anchors and rocketed through its reinforced concrete containment bund, coming to rest some distance away.

Questions were raised as to why the tank failed at its base rather than at its roof to shell seam as would normally be expected. This was found to have resulted from an innovative footing design aimed at cost reduction. Modelling carried out at the soviet design house had justified the use of thinner support slabs than was industry practice. This flexible footing allowed the over-pressured tank to "balloon-up" at its base whilst the anchors held its edges rigidly in place. These competing forces led to the tank rupturing at one side. Similar cost-saving initiatives were responsible for the lack of strength in the concrete bund wall which should have resisted the impact. This was not built to its specified thickness.
