Incident

A sticky problem – new light shone on Boston's great molasses spillage

Tony Fishwick

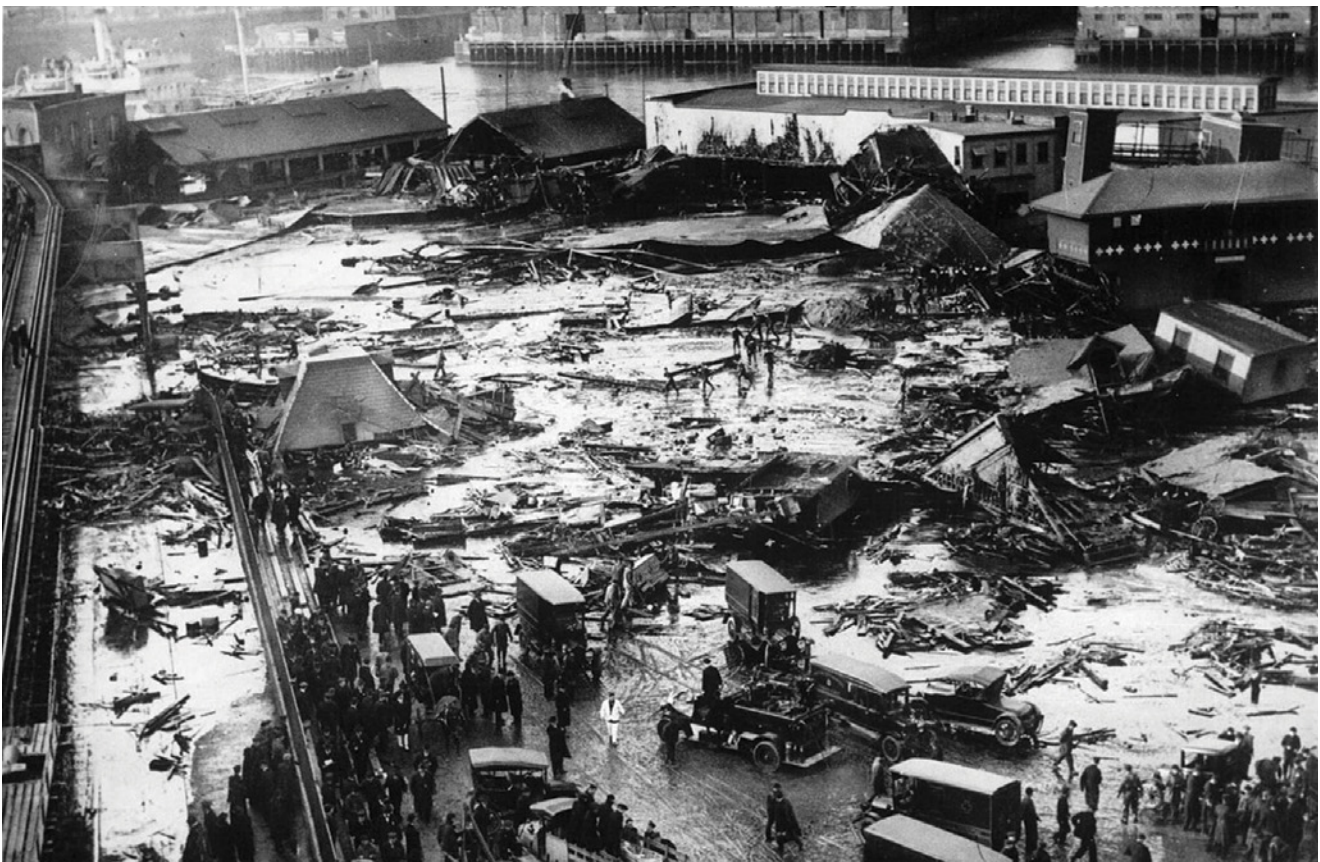
Figure 1 – The devastating aftermath of the Boston Molasses Release: Wreckage of the collapsed tank in the Background, Right, in front of the white building

A storage tank, owned and operated by United States Industrial Alcohol (USIA), containing about 2.3 million US gallons of molten molasses burst and disintegrated into seven pieces. The resulting flood killed 21 people, injured about 150 more, swept away timber houses, carried away motor trucks and drowned or seriously injured dozens of horses. The wave of molasses was about 10 metres high and moved at a speed of around 35 mph (56 km per hour). The force of gravity,

acting on the viscous fluid, provided sufficient driving force to account for the speed of the wave. One house became trapped under an elevated railway. A piece of the tank, weighing 2.5 tonnes, was carried 55 m into a playground and a fire station 50 m away suffered severe structural damage. A fireman inside it was one of the dead, trapped underneath a billiard table and a piano. Photographs taken at the time (Figures 1, 2 and 3) give a stark impression of the devastation left behind⁵. In Figure 1, the top of the tank can be seen just in front of the white building on the harbour. Figure 3 is a close-up of the tank top. When the worst of the flow was over, the rescuers became coated in the sticky fluid which then spread over the city and beyond. Passengers in public transport up to 70 km away became stuck to their seats. Fire hoses using the public water supply proved ineffective in swilling away the masses but sea water from the docks worked somewhat more efficiently.

The tank at the time of the accident was almost full to capacity. It was made of structural steel plates riveted together. The bottom of the tank was flat and rested on a foundation of cement and sand mixture laid dry. The roof was conical. It had been designed with a specified safety factor of 3.0 and before being brought into use, was hydraulically tested by running 150 mm depth of water into it. The tank had been known to leak at its seams and to need caulking. After its collapse into seven pieces, it was noted that the bottom had bulged and that there was a depression in the cement/sand base mixture. The principal tear ran from a point in the tank bottom, about 3.5 m from the side, right up the side and through the manhole cover. At every level in the tank, the thickness of the plates was less than that specified in order to get a permit for construction and the *actual* safety factor of the tank was less than the *specified* safety factor. At its weakest point, it was 1.5 compared to 3.0.

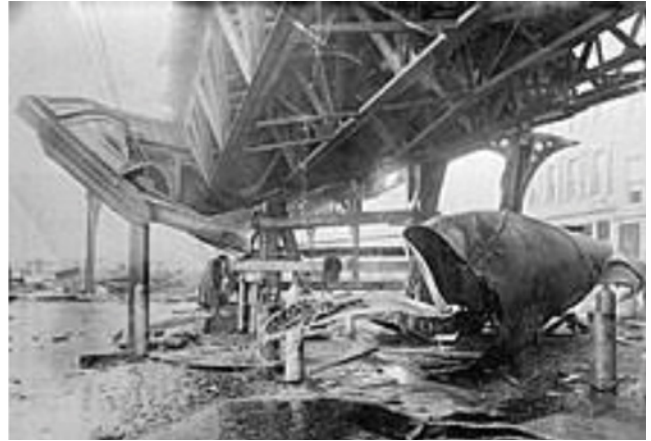
Figure 2 – Damage to an overhead railway

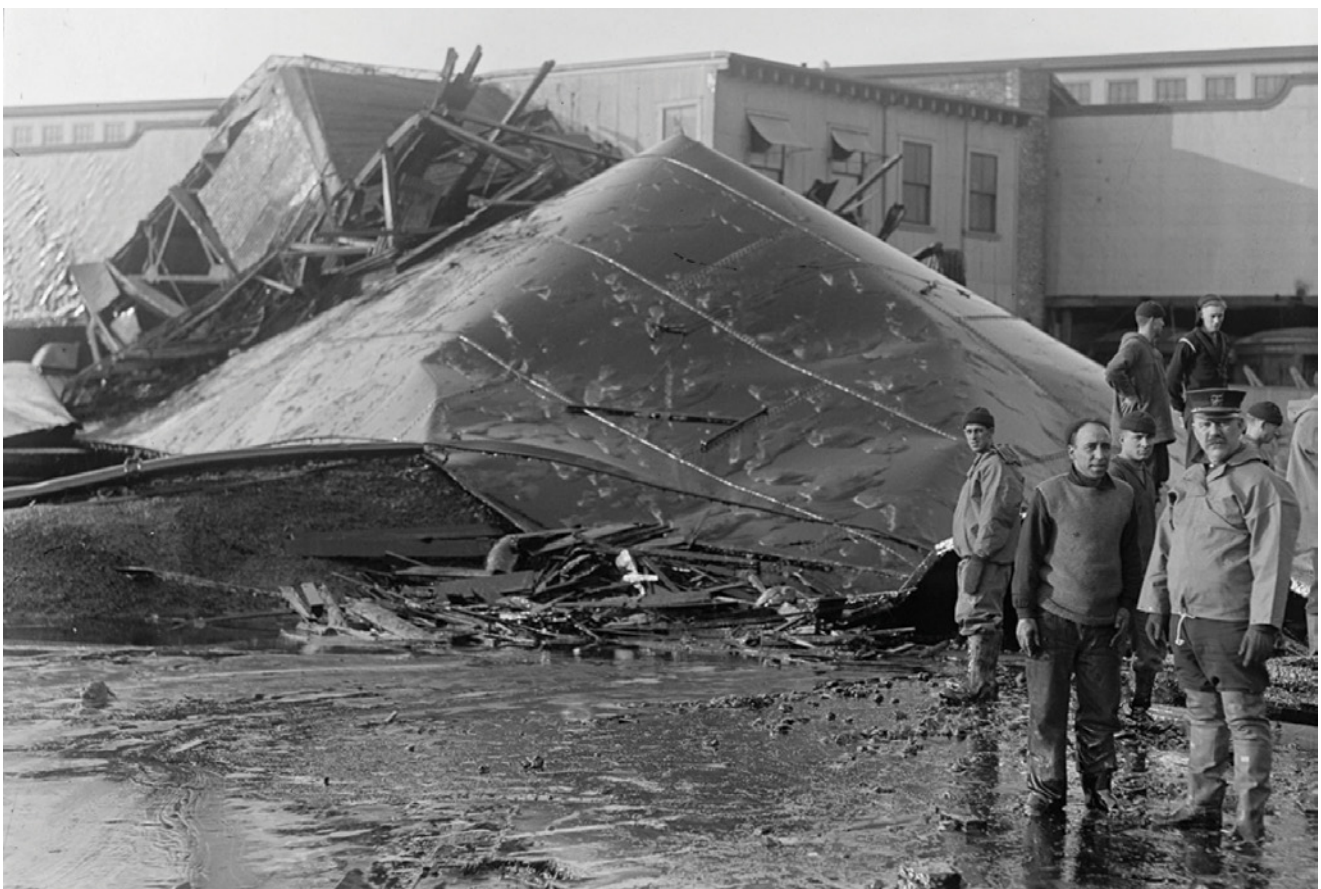
Figure 3 – The molasses tank top
