Risks Associated with Caissons on Ageing Offshore Facilities

D. Michael Johnson, DNV GL, Peter Joyce, BG Group, Sumeet Pabby, BG Group, Innes Lawtie, BG Group, Neil Arthur, BG Group, Paul Murray, DNV GL.

Keywords: Integrity, Ageing, Offshore, Risk, Caisson

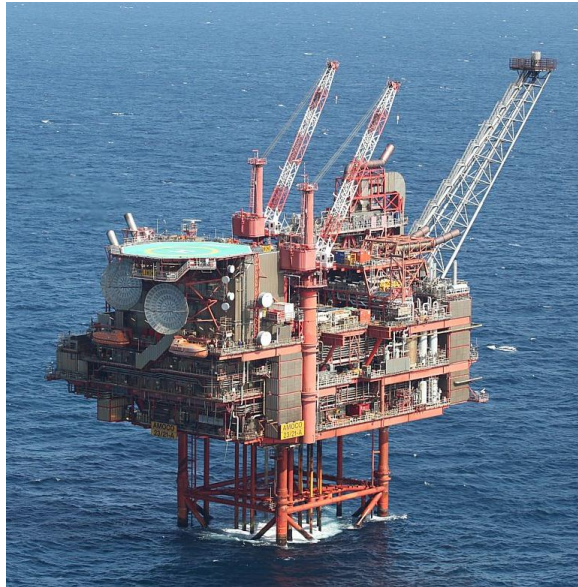
One caisson of particular concern was an open drains caisson on the Lomond facility, which was located above the 20 inch gas export pipeline. Figure 1 shows the Lomond platform and a plan schematic of the jacket showing the path of the gas export pipeline and the caisson.

Figure 1: Lomond Platform and Location of Caisson and Pipeline

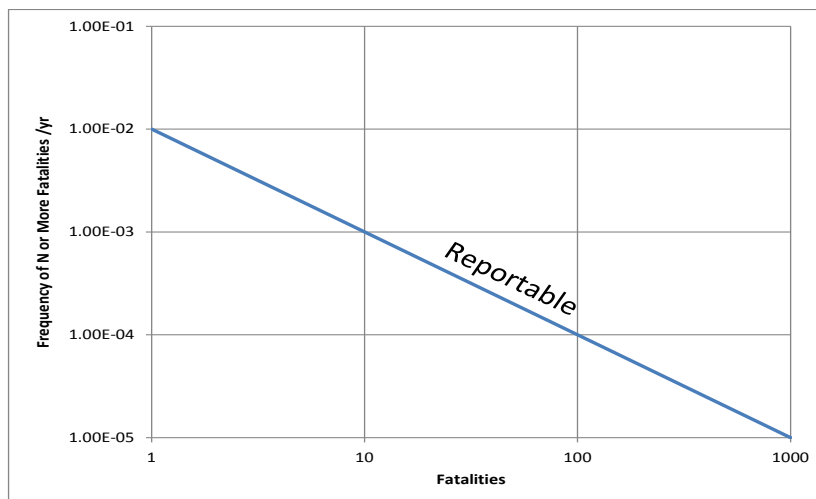
To meet regulatory requirements, BG Group needs to ensure that the calculated Individual Risk is less than 1.0×10^{-3} per year, including the risk from the open drains caisson. However, BG Group had also adopted a societal risk reporting criterion shown in the FN plot in Figure 2. Though not required for regulatory compliance, this criterion was used to identify where risks should be reported to senior management due to the potentially significant combination of safety, commercial and reputation risk. It should be noted that decisions made on the basis of meeting this criterion could easily lead to additional safeguards above those that would be required by a justification of risks being as low as reasonably practicable (ALARP).

Figure 2: Societal Risk Reporting Criterion

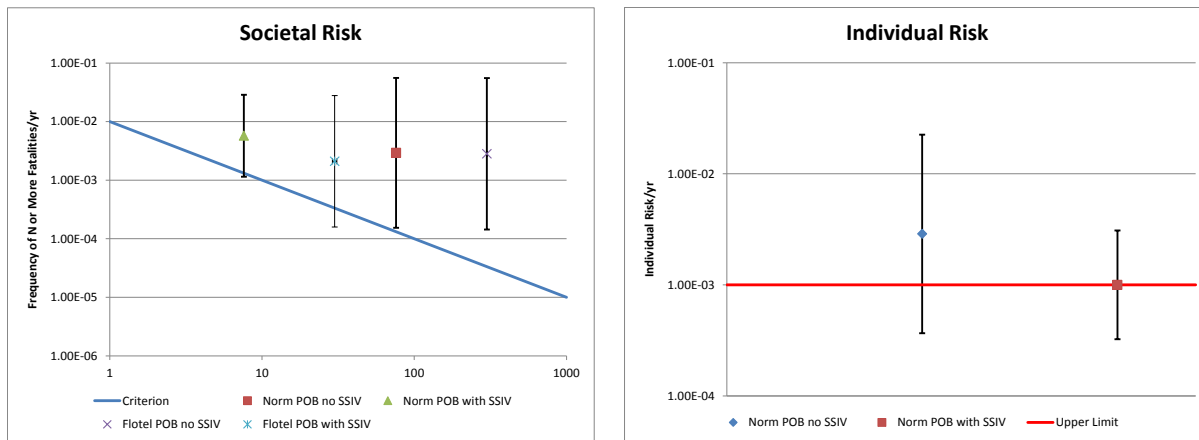
Based on these calculations the upper and lower risk values were calculated. These are plotted in Figure 3, with the mean value being the geometric mean between the upper and lower limits. It should be noted that the societal risk plot provides points that the societal risk curves for the four separate cases being considered would pass through and includes the generic societal risk calculated for the facility QRA, they do not represent four points on a single curve formed by joining the points together.

It can be seen that there was every indication that the individual risks were intolerable and that the societal risks were significantly above the BG Group reporting line, almost regardless of the uncertainty. On this basis BG Group took the only short term risk reduction option available and the platform was immediately shut down and the gas export line was depressurised.

Figure 3: Calculated Risks for Different Cases

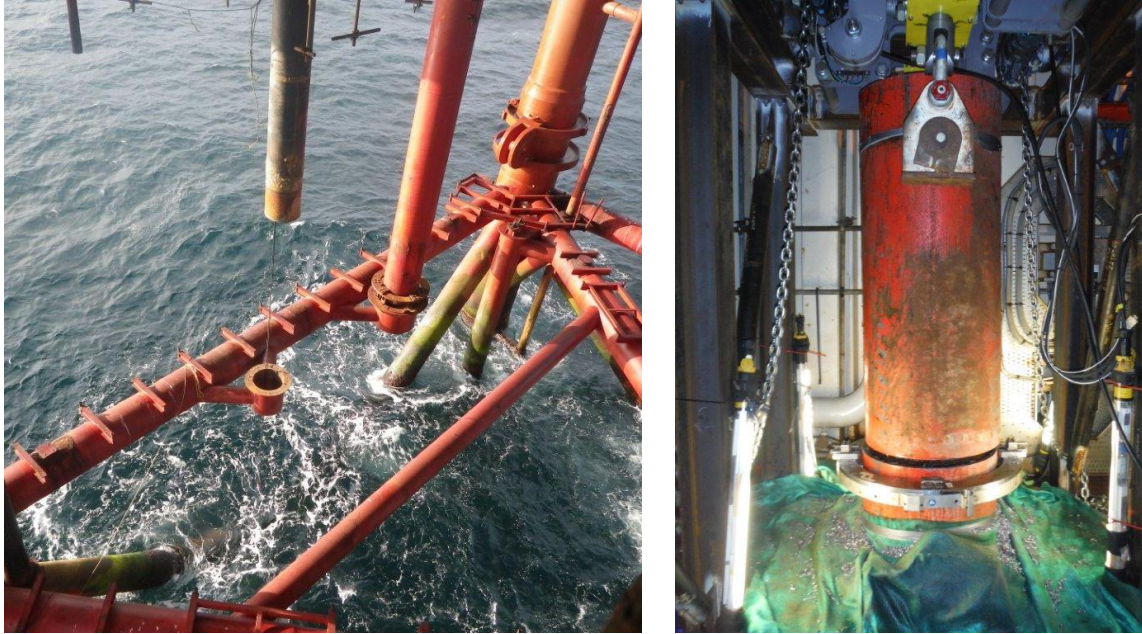
During the following year, the plan for the caisson removal was developed and executed. This involved a repeated sequence of lifting and cutting operations to remove the caisson in sections on the platform topside. Figure 4 shows views of the removal process, with the caisson partially removed retracted on the left and a section being removed on the topside on the right.

Figure 4: Removal of Caisson

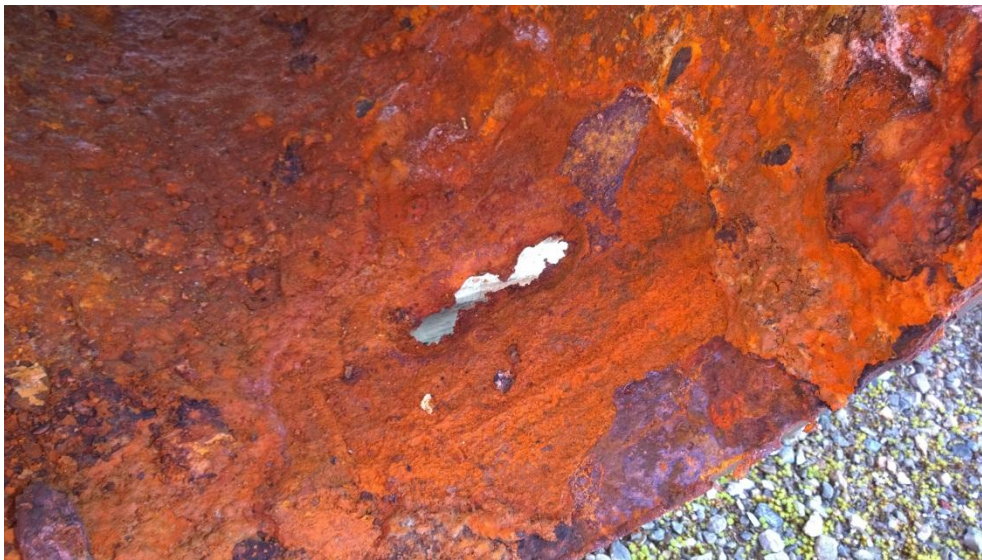
The careful planning of this of the caisson removal allowed the work completed successfully. Examination of the sections removed showed that there were significant defects in some locations, as shown in Figure 5, vindicating the priority given to the removal rather than relying on the restraints for anything other than the minimum time required.

Figure 5: Illustration of Caisson Condition
