Human-Factors and Automation-Related Accidents in the Railway Industry

Mona Ahmadi Rad[1]*, Lianne M. Lefsrud[1,2], Michael Hendry[1], Daniel Blais[3]

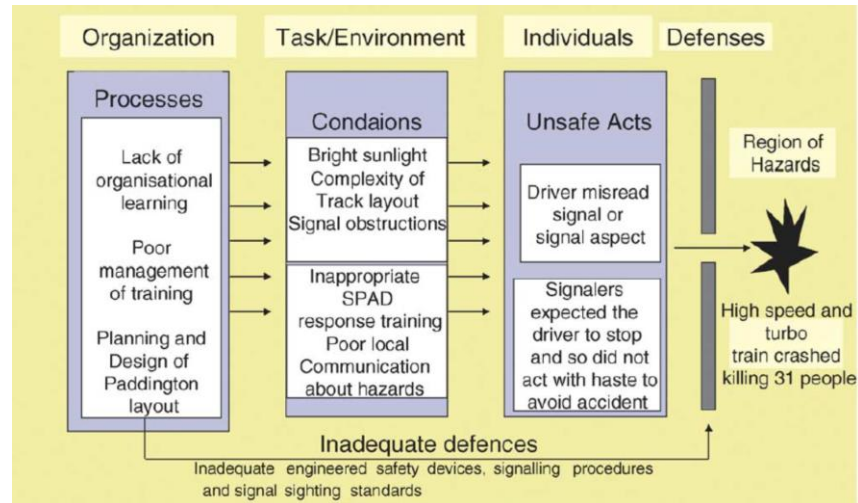
Figure 1. Systematic accident analysis of the Ladbroke Grove crash (Lawton and Ward 2005)

Lawton and Ward (2005) carried out a systematic accident analysis and categorized five contributing factors: active failures, local working conditions, situational and task factors, inadequate defences, and (latent) organizational failures. The explanations for these factors are provided below.

(a) Active failures: The operator of the Turbo train passed the cautionary signal although they acknowledged the AWS alarm. Moreover, the signaller did not show a timely reaction to the SPAD event and did not send emergency stop signals to the Turbo train as well as the HST.

(b) Local working conditions: inexperience, expectation, distraction, strong motor programs, false perceptions, confirmation bias, and situational unawareness were identified as Subcategories for the local working conditions factor. The operator of the Turbo train was a novice that had passed their training just two weeks before the accident. Moreover, they had never experienced a red signal at this point of the line during their training. The evidence shows the train operator habitually canceled the AWS horn as they had been presented with several successive cautionary signals before this red signal.

(c) Situational and task factors: track layout, poor human-system interface, poor feedback from the system, and poor communications were the main situational and task factors that contributed to the accident. The complexity of the layout, multiple signals on the gantry, number of approaches, and obscuration of signals by overhead bridges and electrification equipment caused difficulties in line of sight and poor human-system interface. Furthermore, the AWS system sounds the same horn for all restrictive signals and does not distinguish between cautionary (yellow or double yellow) and stop (red) signal aspects, which creates ambiguity about the current condition and no feedback on the action to be taken by the train operator.

(d) Inadequate defences: poorly engineered safety devices, poor signalling, poor policies and standards, and the lack of awareness of hazards were identified as the main accident causes related to inadequate defences. None of the ATP systems or TPWS were installed on the Turbo train.

(e) Organizational failures: although many SPAD incidents had occurred at this location, no safety improvement measures were implemented to mitigate the risk. Furthermore, there were no official standards for train operator training. In addition, in the development of track and signalling at Paddington Station, safety issues and human factors related to the close proximity of the gantry were not taken into account.

The systematic accident model of the Ladbroke Grove crash is summarized in Figure 1.
