BUNCEFIELD MAJOR INCIDENT INVESTIGATION BOARD

EXPLOSION MECHANISM ADVISORY GROUP REPORT

The Mechanism of the Buncefield Explosion

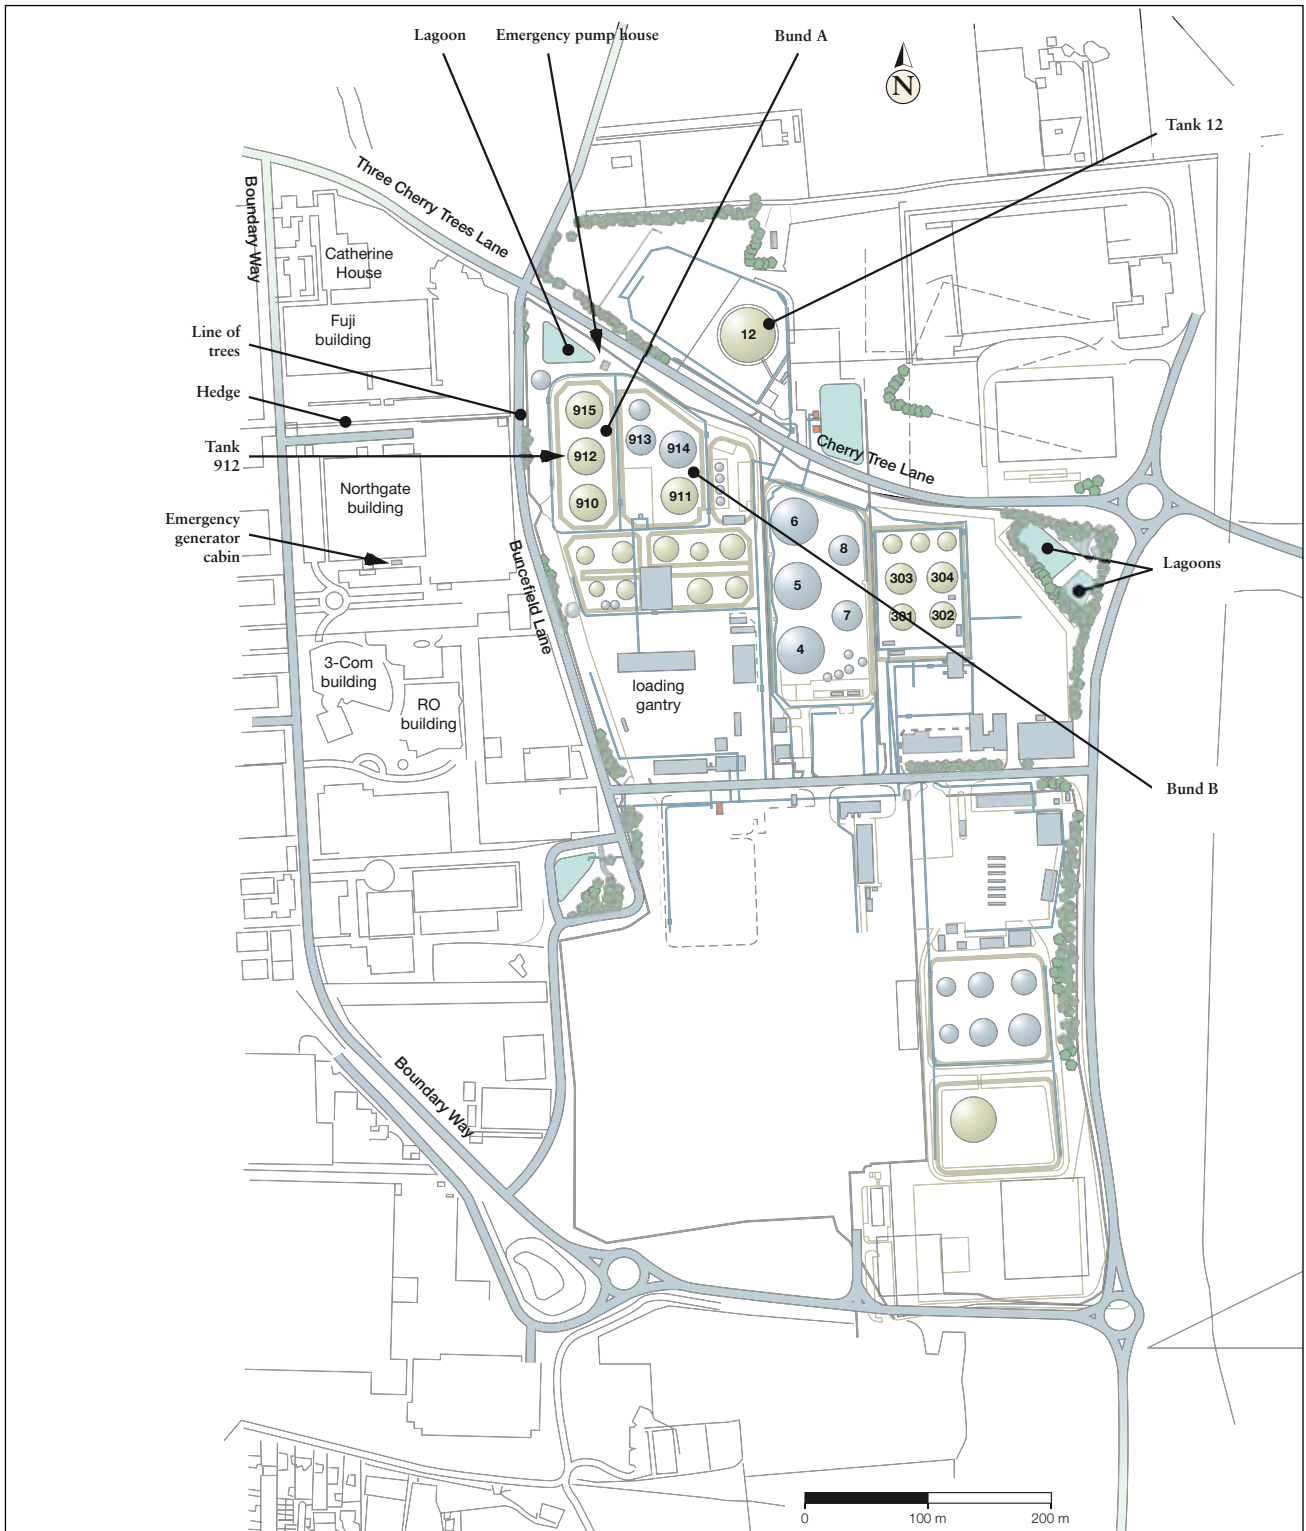
Figure 3 Pre-incident layout of Buncefield depot and immediate surroundings

9 Though there is some uncertainty regarding ignition, the Board’s reports indicate that the emergency generator cabin, on the south side of the Northgate building and the emergency pump house, close to the north side of Bund A, both contained potential ignition sources. These locations are given in Appendix 3, Figure 3. Both buildings show evidence of having been subjected to an internal confined explosion.
